CARLINGFORD PUBLIC REALM SCHEME

Stage 1 Road Safety Audit

MGT0610Rp1010
Carlingford Public Realm Scheme
S4_P01
13 April 2023

STAGE 1 ROAD SAFETY AUDIT

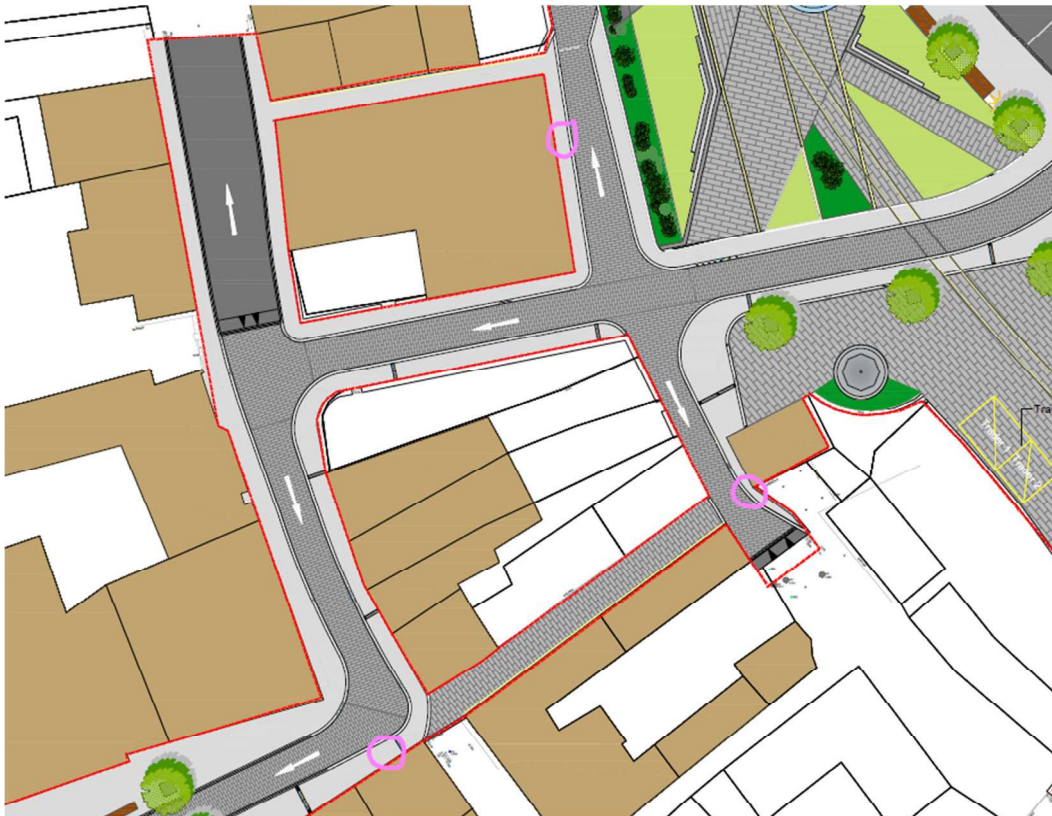
Problem 4.1

Summary & Location – General Footpath Widths across a number of Locations

It is unclear from the drawings provided what footpath widths are being provided. Judging by the space available on site for the provision of footpaths and traffic lanes, and taking into account lighting columns and street furniture, it appears that some sections of footpath are below the desirable minimum width to cater for all mobility types. This could result in pedestrians, or mobility impaired users entering the carriageway and coming into conflict with vehicular traffic.

All footpath widths should be of appropriate widths to cater for all types of road users.

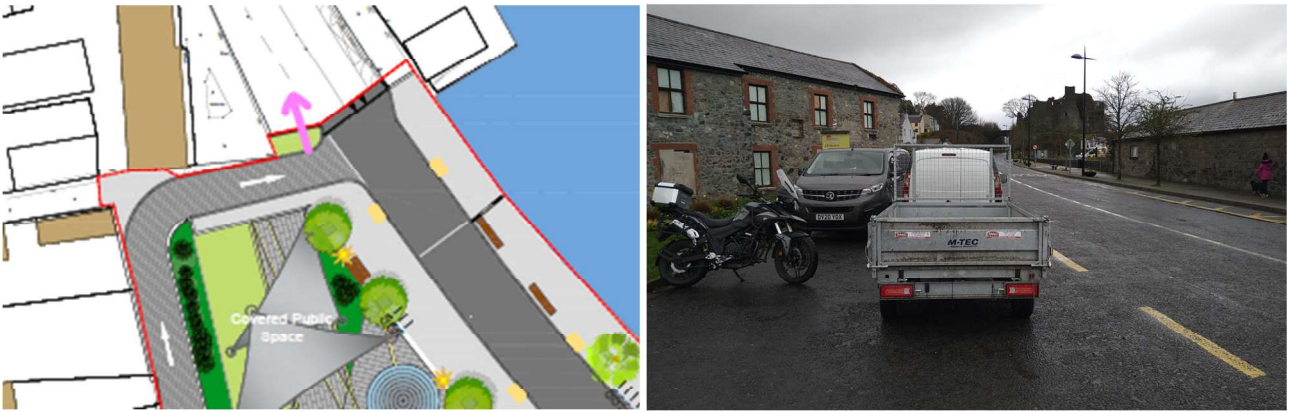
Problem 4.2

Summary & Location – Sightlines at northern extent due to informal parking

There is large paved area to the north of the green space at the northern extent between the hard shoulder and existing grass kerb, that appears from the design to be retained just outside the extent of the scheme. Informal parking was identified on the day of the site visit, with vehicles pulling into this paved area, which obstructs sightlines for vehicles exiting the side-street. This could result in side-impact collisions between exiting vehicles and traffic on the mainline.

Informal parking in this area should be formalised or removed to achieve the required sightlines from the junction.

4.2	Yes	Yes	This is outside of the Works area. LCC to be informed of recommended measures	
4.3	Yes	Yes	Tactile paving to be added at detailed design. Design team will retain a kerb upstand at this point to give clear indication of priority

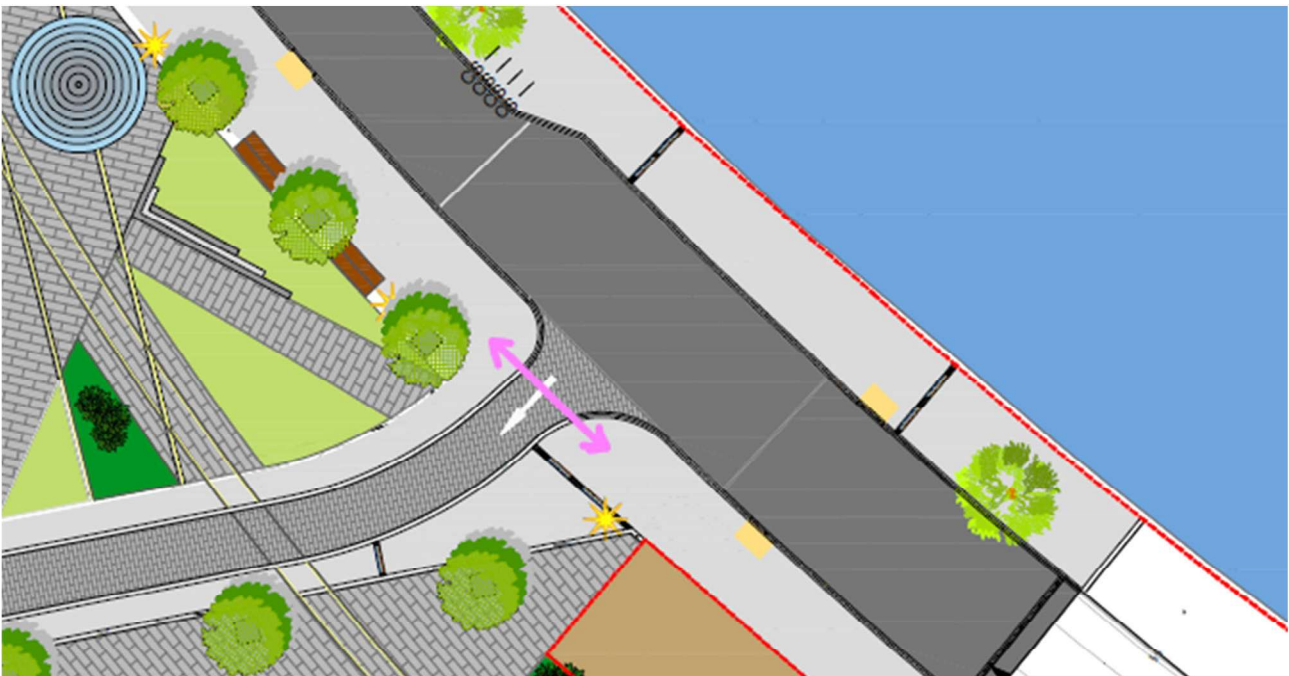
Problem 4.3

Summary & Location – Priority unclear at junction from R173

It is unclear from the drawings who has priority, pedestrians or vehicular traffic, across the priority junction turning into the village centre from the R173. A lack of clear priority could give rise to conflicts between vehicles and pedestrians.

Clear priority should be defined at the junction.

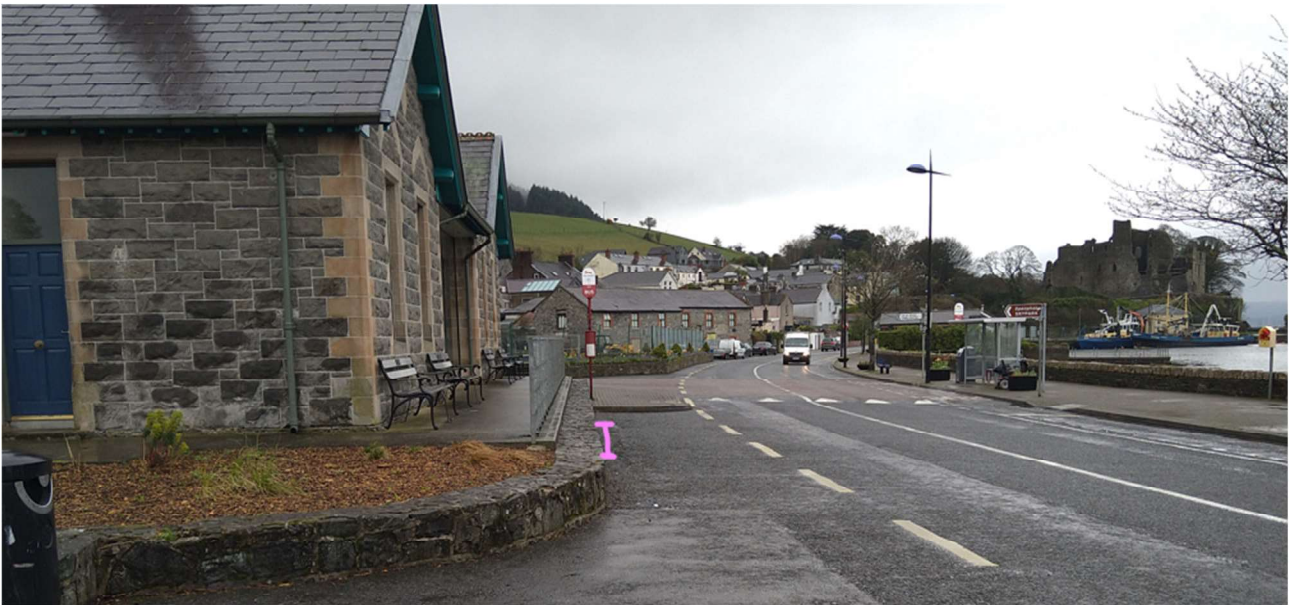
Problem 4.4

Summary & Location – Level Difference between Tourist Office and Carriageway, and Bus-stop Status

There is an obvious level difference between the carriageway hardshoulder and the entrance footway to the front of the Tourist Office. The footway is protected by a railing which is not indicated on the drawing provided. There is also a bus stop outside the Tourist Office, and it's unclear from the drawing what the status of the bus stop is.

It is unclear from the drawings how this level difference is being catered for in the design or how the minimum footway widths will be achieved between the entrance footway and the edge of the carriageway. Insufficient footway widths could result in pedestrian or mobility impaired users entering the carriageway and coming into conflict with vehicular traffic.

Footpath widths should be of appropriate widths to cater for all types of road users and bus stop.

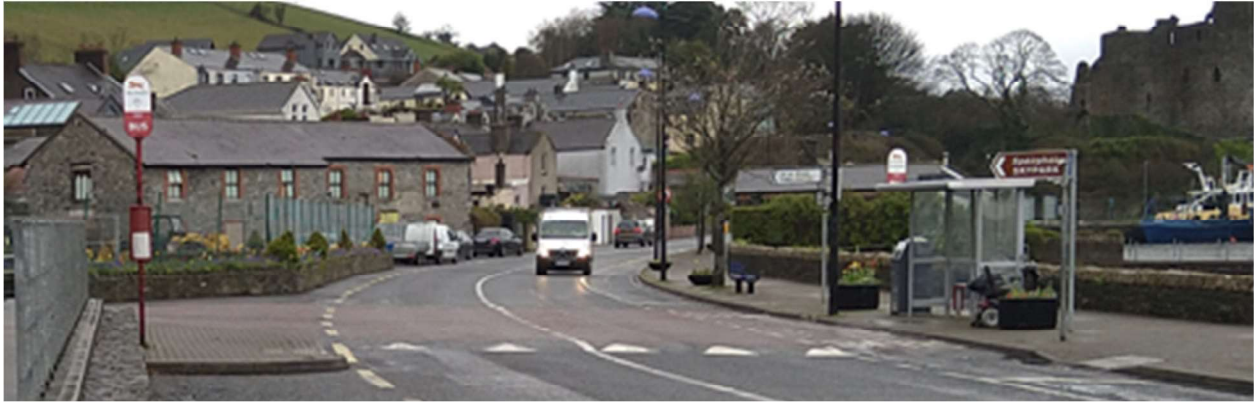
Problem 4.5

Summary & Location – No Provision for Bus Stops outside Tourist Office

There are existing bus stops in place on the R173 outside the Tourist Office. It is unclear from the drawings if bus stops are being retained or provided at defined locations in the proposed scheme. A lack of bus stop facilities could give rise to ad-hoc bus stopping, which could result in potential collisions between buses, traffic and other road users

Appropriately defined provision for bus stops should be provided.

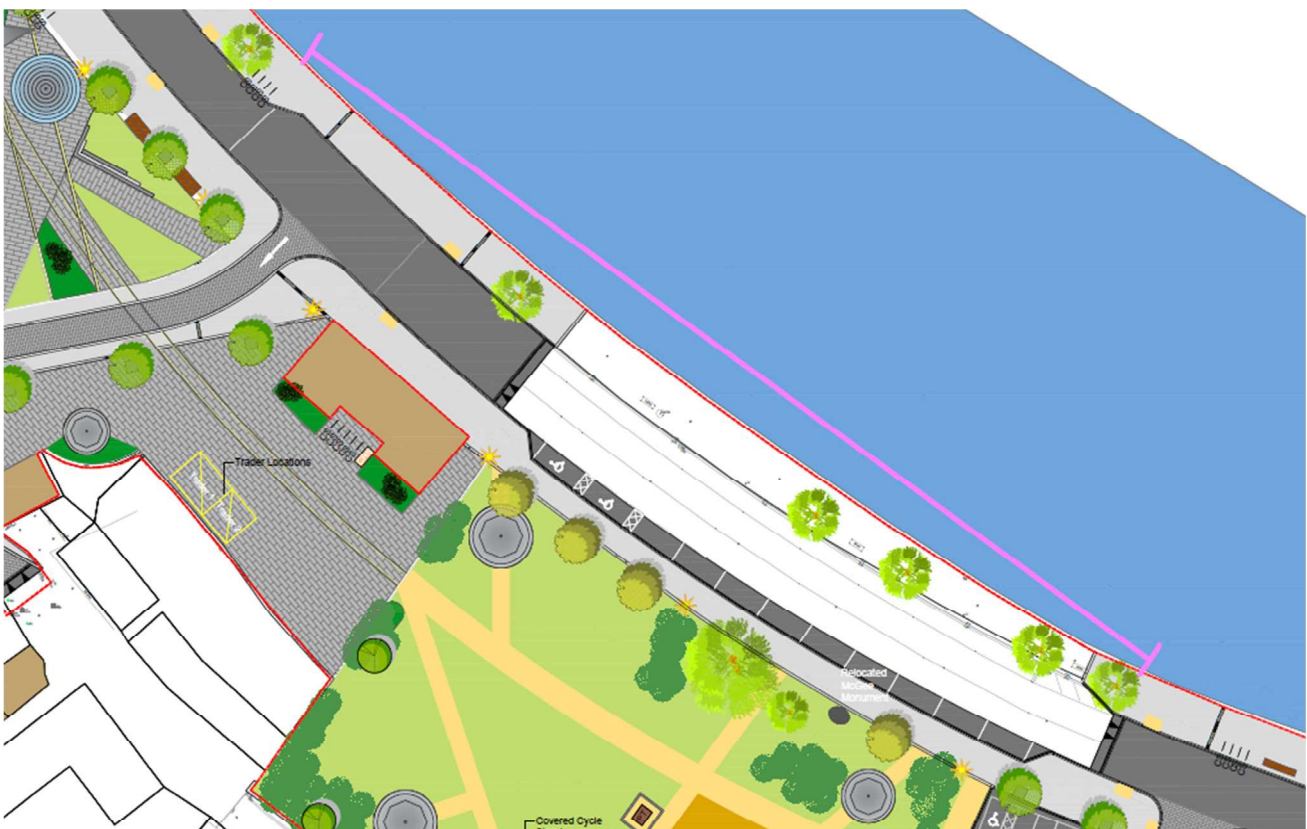
Problem 4.6

Summary & Location – Widened R173 Carriageway outside Tourist Office

The R173 carriageway outside the Tourist Office and proposed park widens out, and it is unclear from the design what purpose of this is for. This could give rise to unwarranted parking or stopping/pulling in, which could give rise to side-swipe or rear-end collisions on the carriageway.

Definition of the carriageway width and its purposes should be clear, and preventative to unwarranted parking or pulling in.

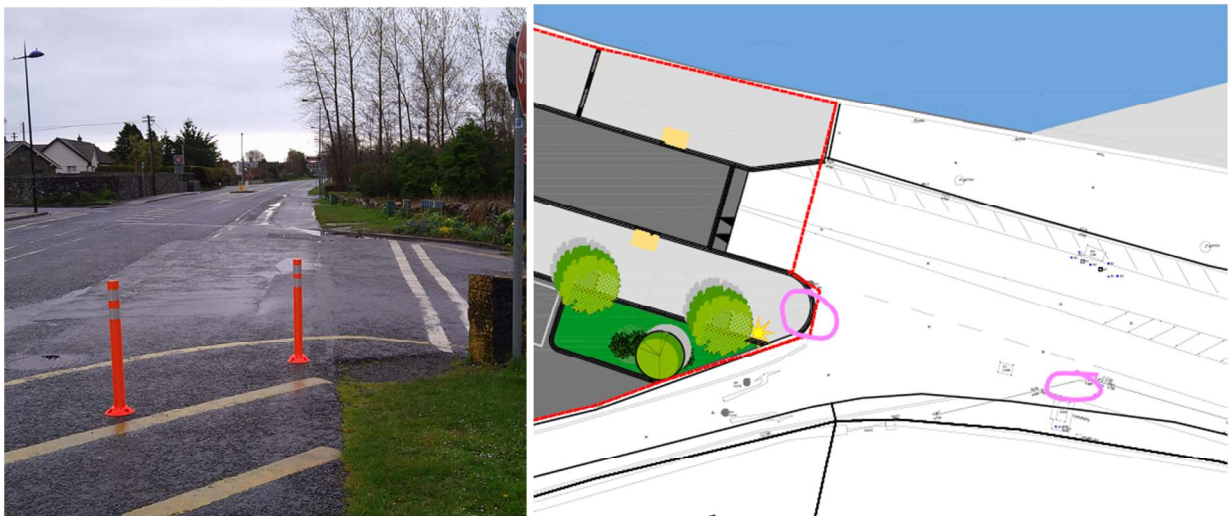
Problem 4.7

Summary & Location – Lack of Footpath continuity at the southern extent footpath

The footpath at the southern extent of the PR scheme at the junction with the R176, terminates at the junction without any appropriate crossing facilities to link to the existing footpath on the southern side of this junction, a key desire line linking to the proposed Southern Car Park scheme to the south. A lack of appropriate crossing facilities, dropped kerbs and tactile paving could result in conflicts between pedestrians and traffic, or pedestrian trips or falls.

Appropriate crossing facilities should be provided at this location.

4.7	Yes	Yes	This is outside of the Works area. LCC to be informed of recommended measures

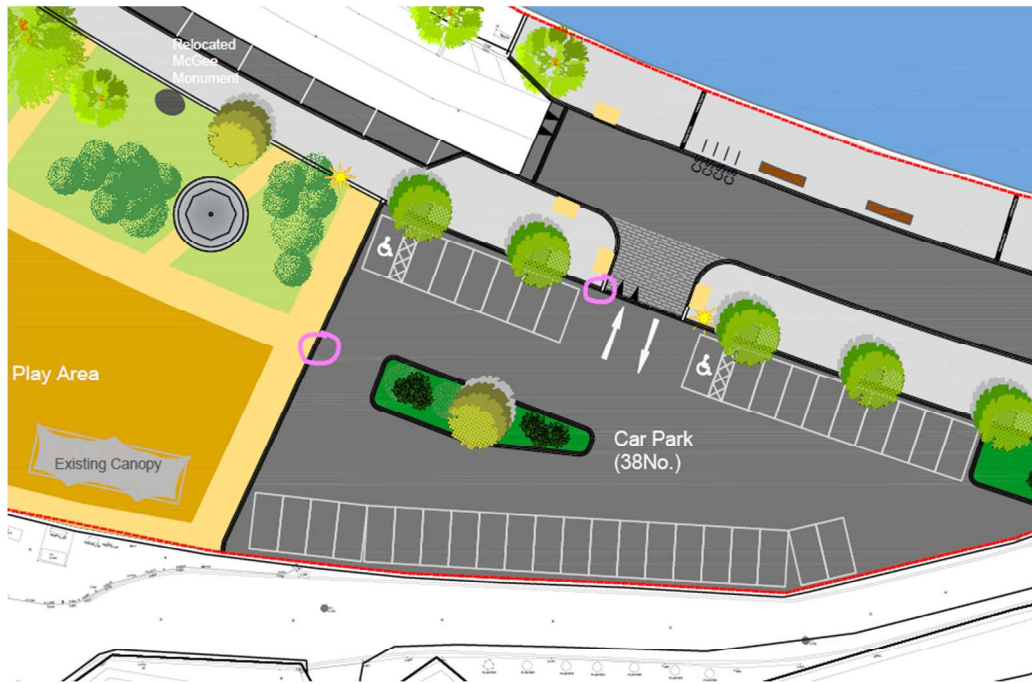
Problem 4.8

Summary & Location – Lack of Pedestrian Access from PR Car Park to the Park & Footpaths

It appears from the drawings that no pedestrian access or dropped kerbs are being provided from the PR car park to the Park or the adjacent footpaths. This could result in pedestrians, and in particular mobility impaired pedestrians, using the vehicular entrance, and coming into conflict with vehicular traffic.

Suitable pedestrian and mobility impaired access facilities should be provided from the car park to the Park and footpaths.

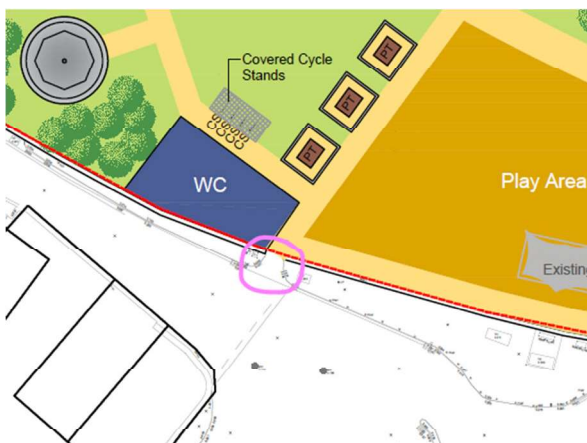
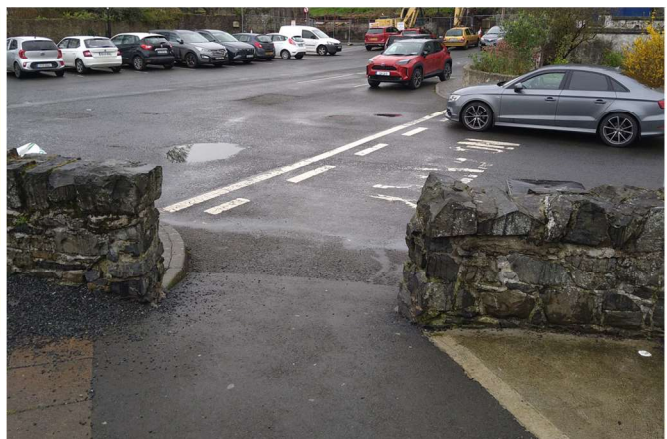
Problem 4.9

Summary & Location – Inadequate Pedestrian Entrance facilities to south of Park

The rear pedestrian entry/exit to the Park and Play Area is steep and exits down directly onto the Old Quay Lane which has limited refuge space between the wall and the live street, without any appropriate pedestrian crossing facilities. This could give rise to pedestrians, including mobility impaired users, exiting the Park directly into the path of oncoming traffic.

Appropriate footpath protection, crossing facilities, and gradients should be provided to cater for all pedestrian desire lines.

4.8	Yes	Yes	<i>Dropped kerbs will be shown clearly at detailed design stage</i>	Alternative measures or reasons accepted by Auditors (Yes/No)
4.9	Yes	Yes	<i>This is outside of the Works area. LCC to be informed of recommended measures</i>

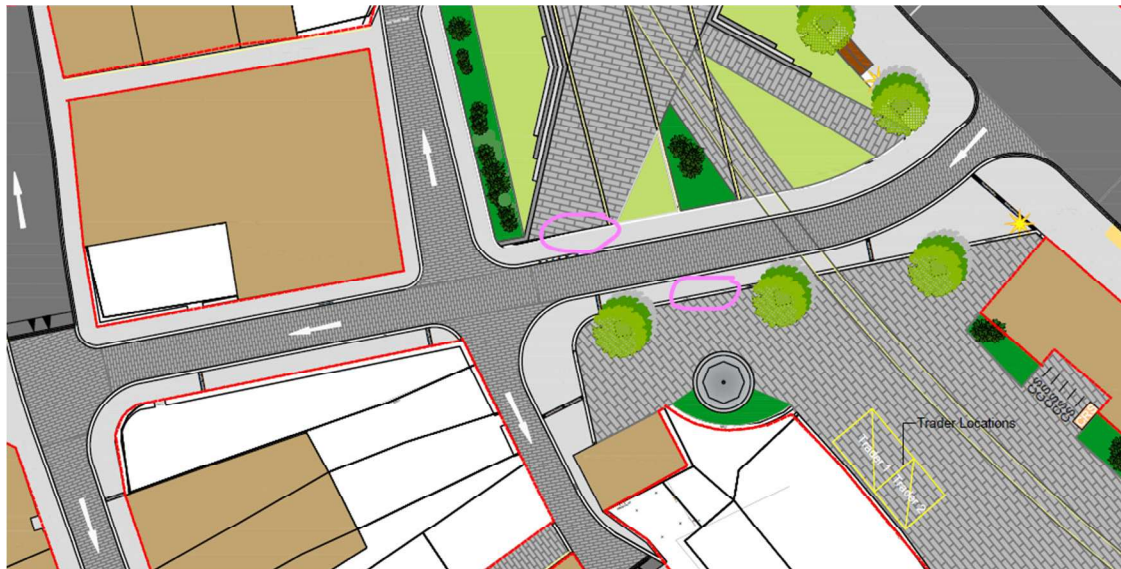
Problem 4.10

Summary & Location – Prevention of Vehicles entering Pedestrian Areas of PR area.

According to the drawings, the level of the carriageway and the footpath on the section below are flush – no vertical segregation. During the site visit, quite a number of cars were observed entering the village along this street. It is unclear what definition or measures will be provided to prevent vehicles encroaching on pedestrian areas, and in particular, to prevent vehicles entering the PR area to the north or the Park area to the south behind the Tourist Office and potential unwarranted parking. This could result in conflicts between vehicles and pedestrians.

Clear definition should be provided to highlight the areas that vehicles can utilise, and prevention measures should be put in place to prevent unwarranted vehicular access to pedestrianised areas.

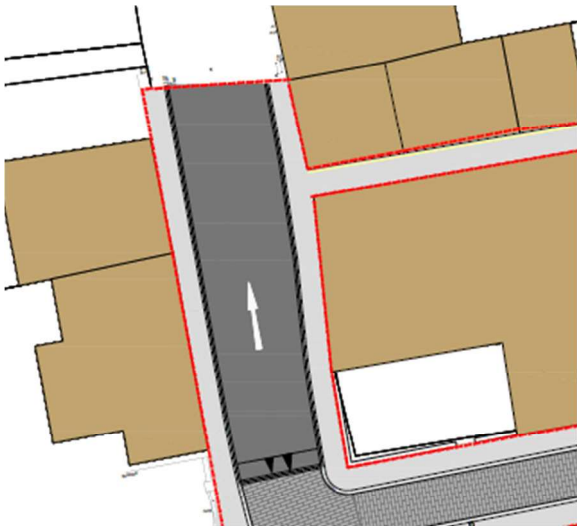
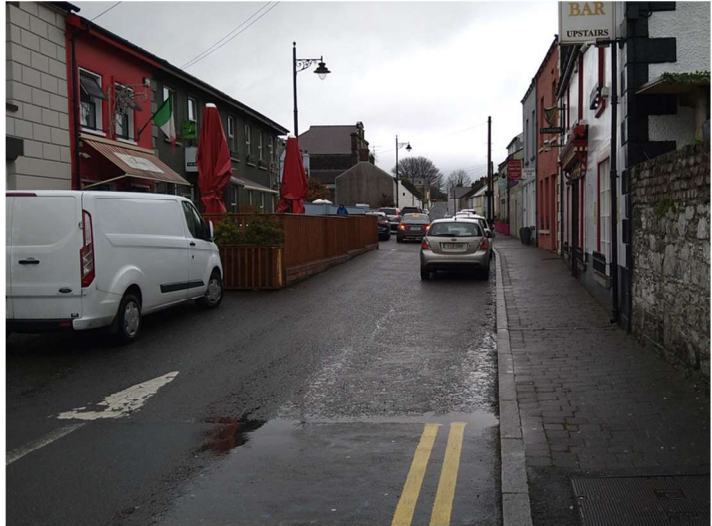
Problem 4.11

Summary & Location – Potential Insufficient Width for all users on Newry Street

It is unclear from the drawings if the outdoor dining area on street is being retained or removed, or if the on-street parking opposite is being retained or removed. Keeping both could result in a lack of sufficient width for all road users, giving rise to potential side-swipe collisions.

Appropriate width for all street elements should be provided.

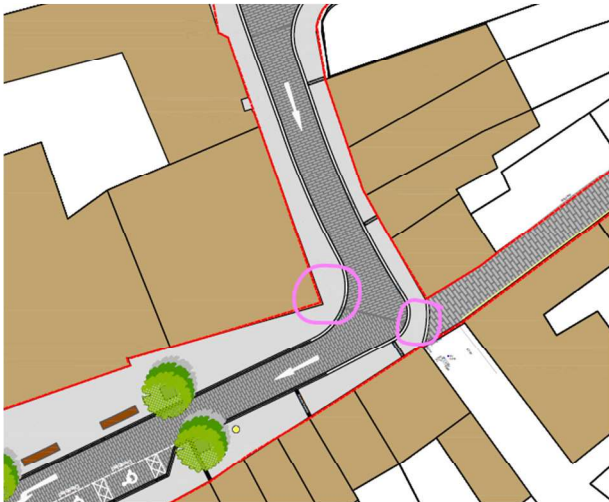
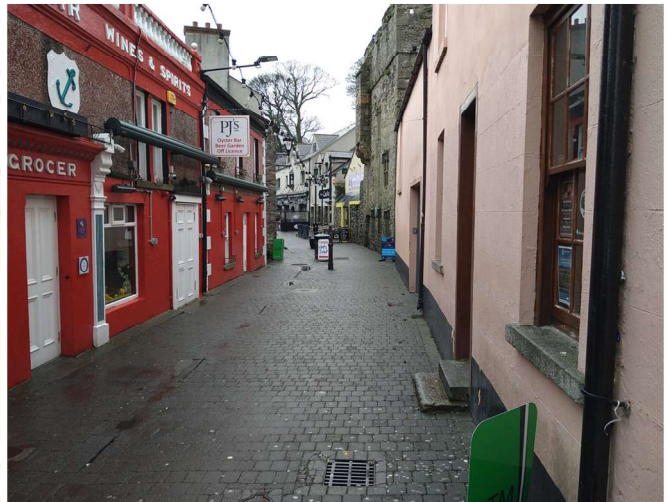
Problem 4.12

Summary & Location – Swept Path and encroachment to pedestrian areas on Market St.

It appears from the drawings that the footpath and carriageway areas on Market St. are at the same level with no vertical segregation. Given that this street, and the junction with Tholsel St. is quite tight, it is unclear if pedestrian desire lines will be safe from overrun of vehicles onto the paths, particularly at the bend. There also does not appear to be any measures to prevent vehicles entering the pedestrianised Tholsel St. This could give rise to conflicts between pedestrians and vehicles in these areas.

Ensure a swept path analysis is carried to determine sufficient space for vehicle to negotiate the streets without encroaching on footpath areas, provide measures to prevent vehicular access onto Tholsel St.

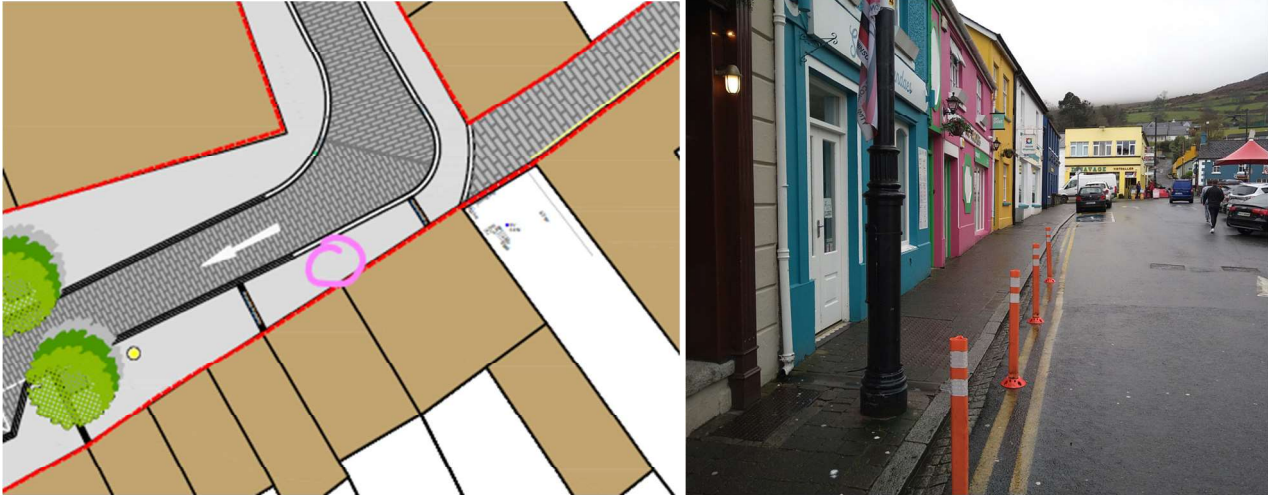
Problem 4.13

Summary & Location – Effective Footpath Width on Market St. due to Lighting Column

It is unclear from the drawings if the existing public lighting columns are being retained or removed/relocated. At this location on Market St. there would appear to be insufficient width for mobility-impaired pedestrians to negotiate around the existing lighting column. This could result in pedestrians entering the carriageway, and coming into conflict with traffic.

Ensure suitable footpath width for all pedestrian users is provided.

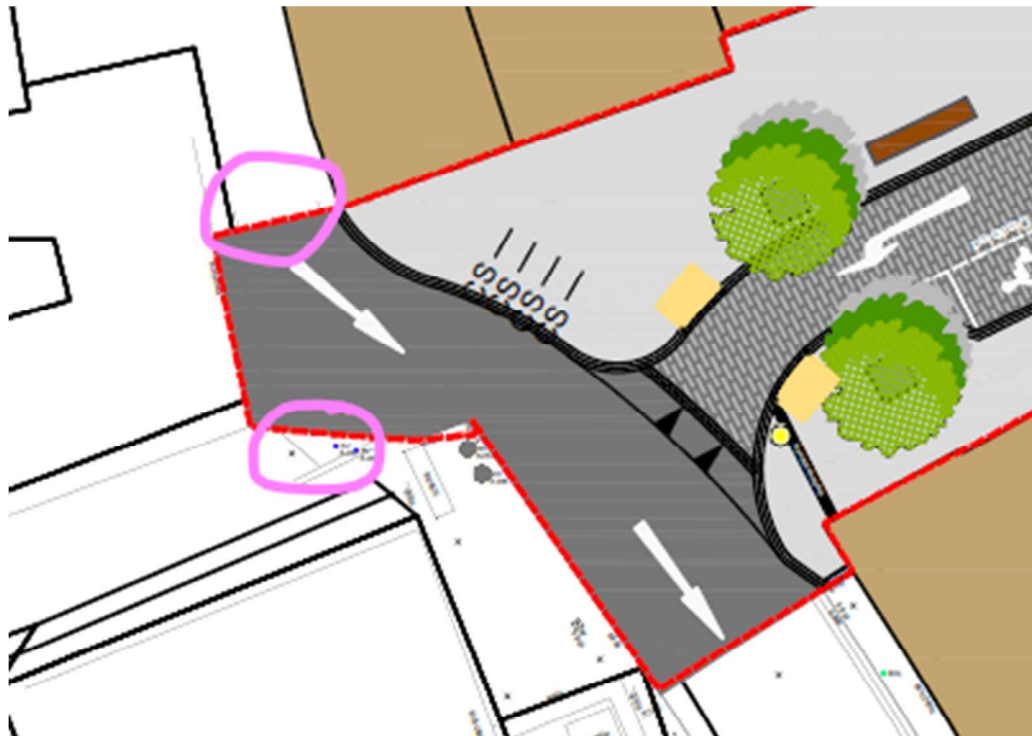
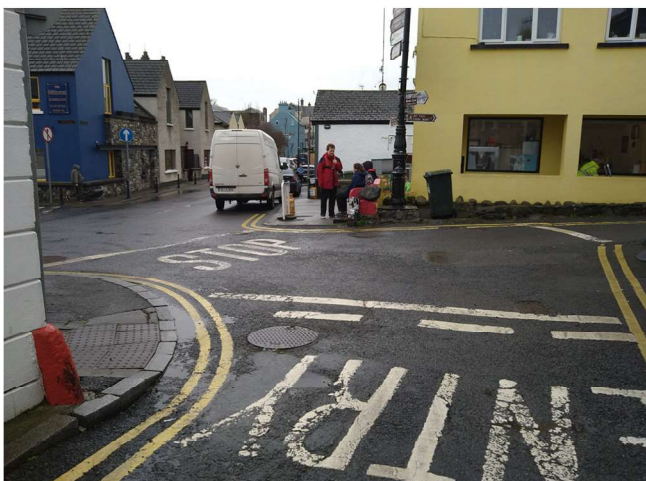
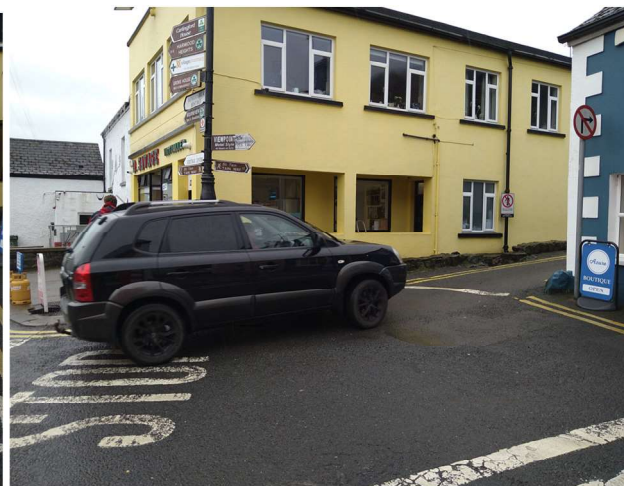
Problem 4.14

Summary & Location – Junction Operation / Priority at Back Lane / River Lane junction at western extent.

Both the existing arrangement and the proposed arrangement at this junction of Dundalk St. / Back Lane / River Lane is not clear. The proposal is for a one-way traffic flow from both Market St. and Back Lane to Dundalk St. However, it was witnessed on site, traffic driving from Market St. across the junction and west up River Lane. There is also insufficient width for vehicles to pass one another in this area, and the sightlines around the junction are severely restricted. This could give rise to head-on or side-swipe collisions, or conflicts with pedestrian in the area.

The arrangement of the junction and its allowable movements should be made clear, and should be safe for all users.

4.14	Yes	Yes	<i>Road markings will be added at detailed design to give clear indication of priority. LCC to be informed of recommendation of one-way system as this is outside of the works area</i>

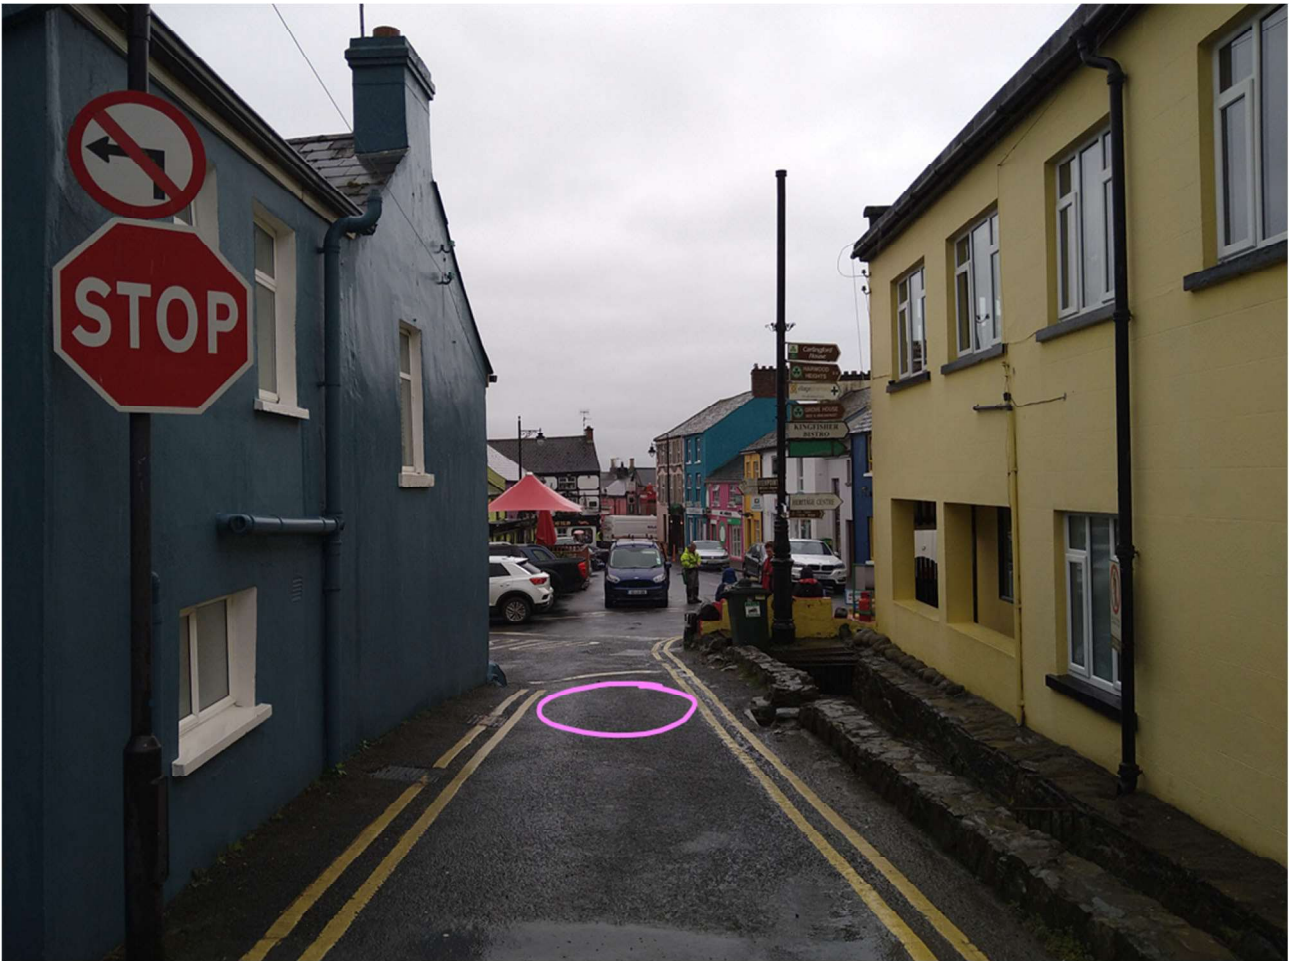
Problem 4.15

Summary & Location – Lack of Stop Markings on River Lane

No road marking drawings were provided with the audit. On site there are no Stop Markings on the carriageway at the exit from River Lane. Drivers approaching the junction may misinterpret the existing markings, and may fail to appreciate or stop for traffic coming from Back Lane, resulting in side-swipe collisions.

Provision of appropriate road markings in accordance with best practice should be considered on the approach to this junction.

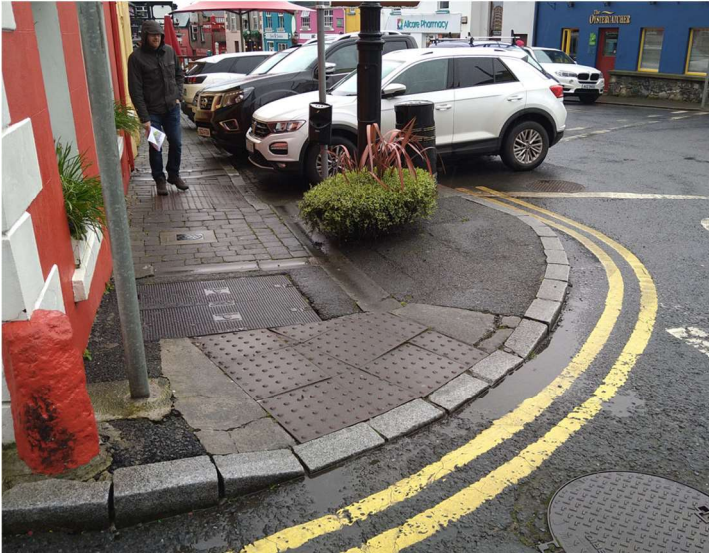
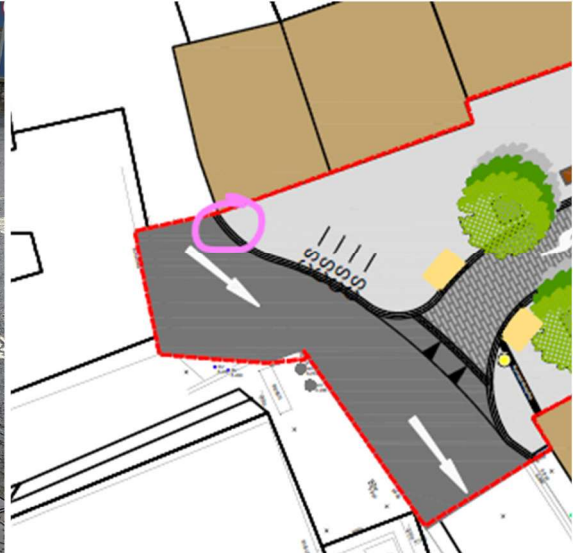
Problem 4.16

Summary & Location – No Provision of Dropped Kerb access for Pedestrians from Back Lane.

There is an existing dropped kerb and pedestrian access at the corner of the junction near Back Lane. The design drawings propose to remove this, meaning that any pedestrians, in particular mobility impaired pedestrians coming from Back Lane, will have to travel on the carriageway and into Market St carriageway in order to access the footpaths.

Provide appropriate access to footpaths for all pedestrian types from Back Lane/River Lane

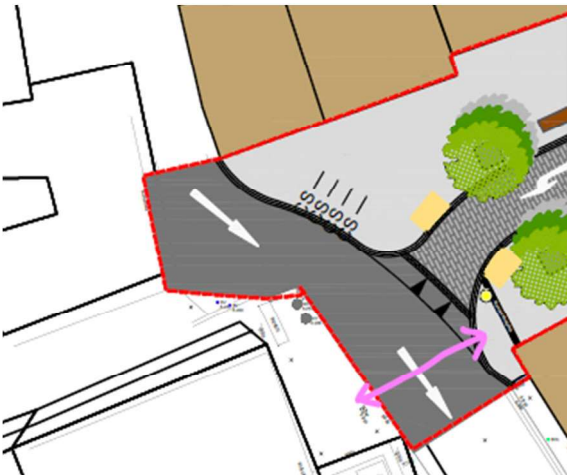
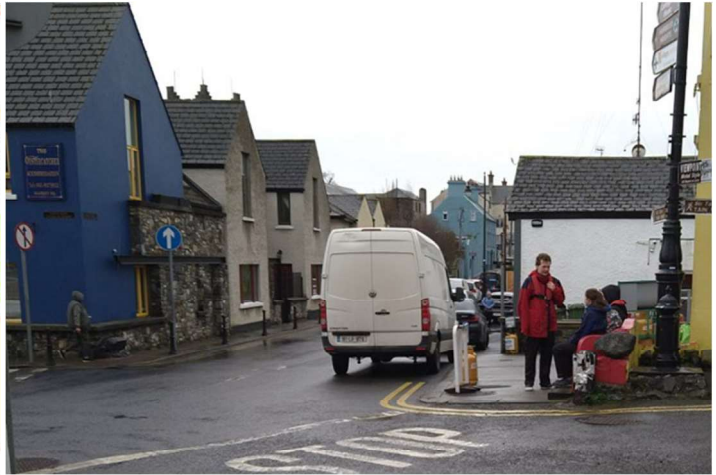
Problem 4.17

Summary & Location – No Crossing Facilities provided between Market St. and D. Savage’s shop.

No crossing facilities have been provided to cater for pedestrian desire lines between Market St. and Dundalk Street west. This could result in unwarranted crossing and conflicts with vehicles, or pedestrian trips or falls.

Provide appropriate crossing facilities between Market St. and the area in front of the shop on the Western side of Dundalk Street.

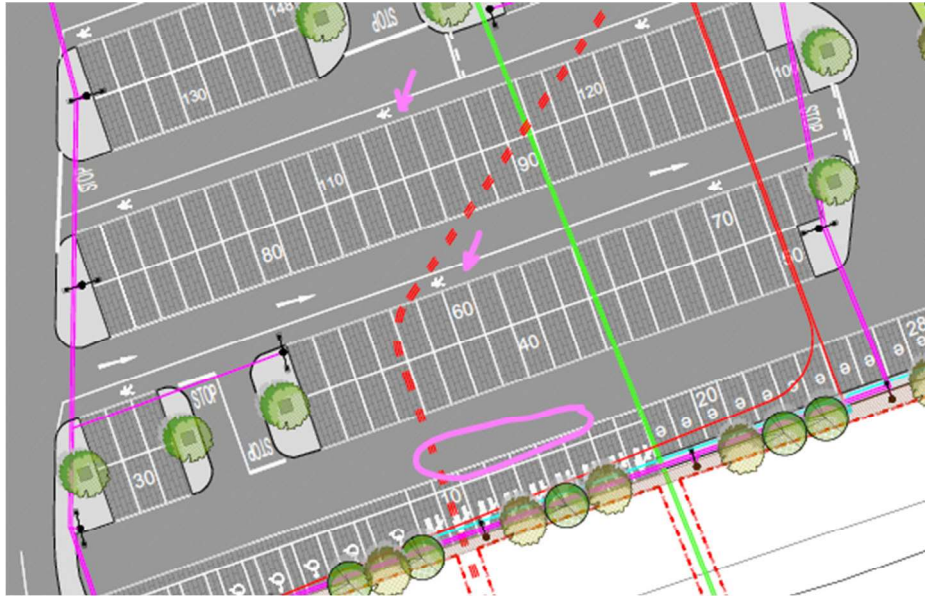
Problem 4.18

Summary & Location – No pedestrian demarcation on western aisle of Southern Car Park

Pedestrian pathways have been demarcated in the proposed design for 2 of the 3 aisles in the Southern Car Park, yet none have been provided in the western aisle. A lack of consistency and segregation on this aisle could give rise to collisions between pedestrians and vehicles.

Provide pedestrian demarcated pathway on western aisle also.

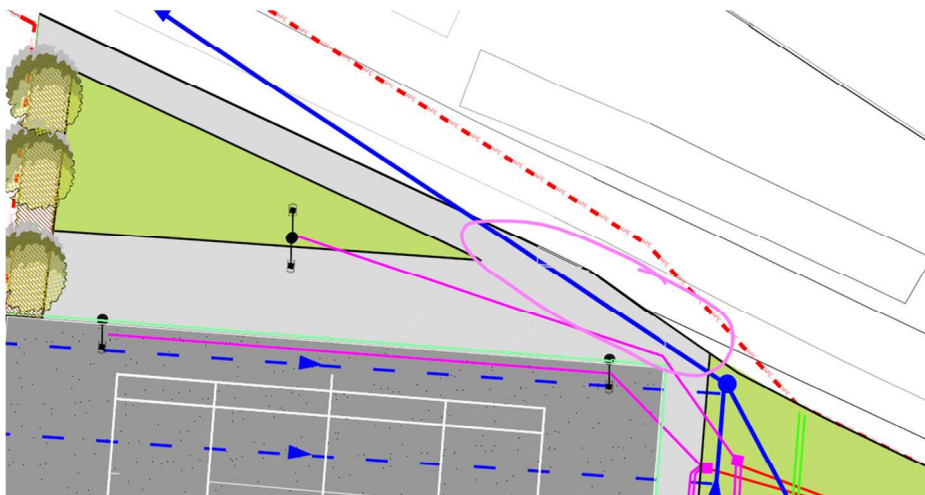
Problem 4.19

Summary & Location – No dropped kerb access for pedestrians from Ghan Rd to back entrance.

It is unclear if dropped kerb access has been provided for pedestrians entering the tennis courts and back entrance to the Southern Car Park. This could give rise to pedestrian falls.

Provide dropped kerb access for pedestrians from Ghan Road.

Problem No. in Report	To be Completed by Designer		Describe alternative measure(s). Give reasons for not accepting recommended measure	To be Completed by Audit Team Leader
	Problem accepted (Yes/No)	Recommended measure accepted (Yes/No)		
4.18	No	No	<i>Pedestrian pathways have been included on sections where traffic flow is one way and therefore sufficient space is available to provide. The area described in this problem is a two-way traffic flow and therefore cannot be provided</i>	Alternative measures or reasons accepted by Auditors (Yes/No) Yes (Delineation arrows should be provided in order to define traffic flow directions on all aisles)
4.19	Yes	Yes	<i>Dropped kerbs will be provided at detailed design</i>

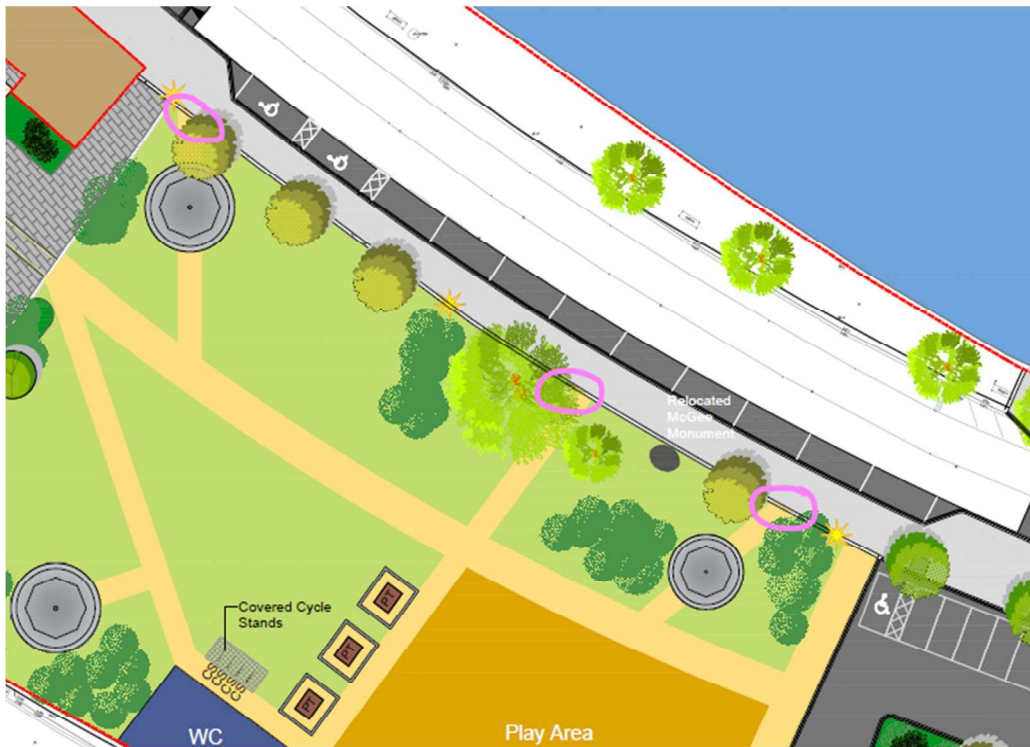
Observation 5.1

It is unclear if the internal paths within the park area linking to the eastern side, access out onto the footpath along the R173 and parallel parking.

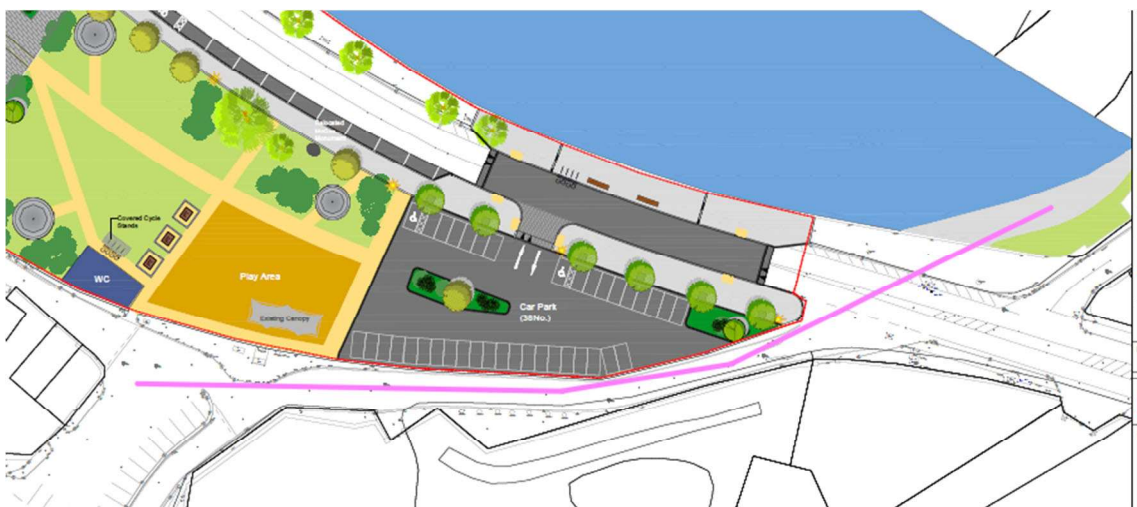
Observation 5.2

The desire line between the Harbour Area and the Existing Car Park behind the new park is not catered for.

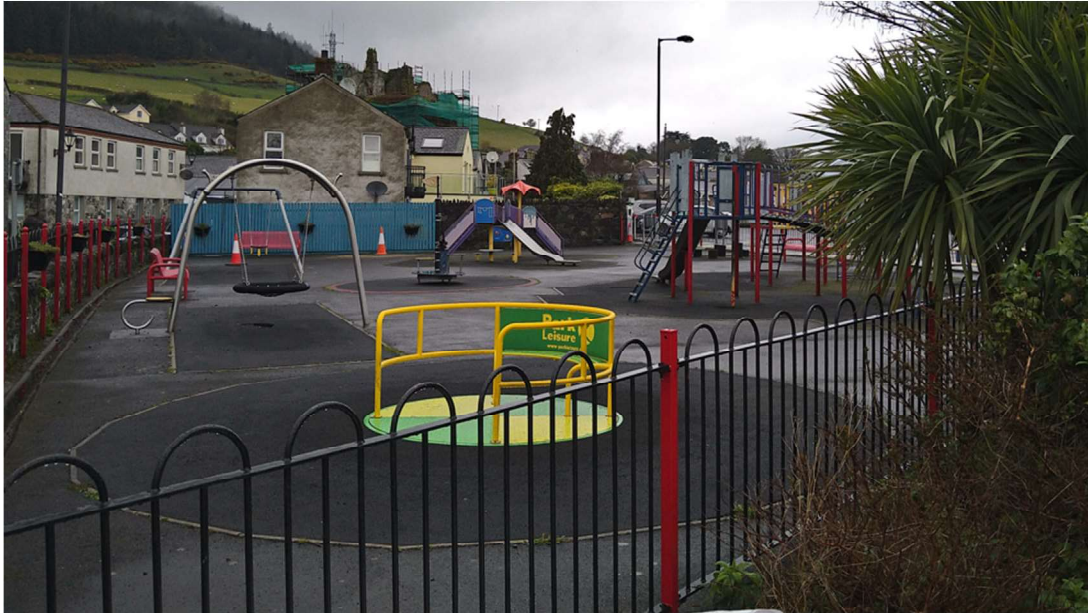
Observation 5.3

The existing playground is fenced in. It is unclear if the proposed playground is fenced in.
