LOUTH COUNTY COUNCIL

APPROPRIATE ASSESSMENT SCREENING REPORT

PROPOSED PLAYGROUND,

ARDEE ROAD, COLLON, CO. LOUTH

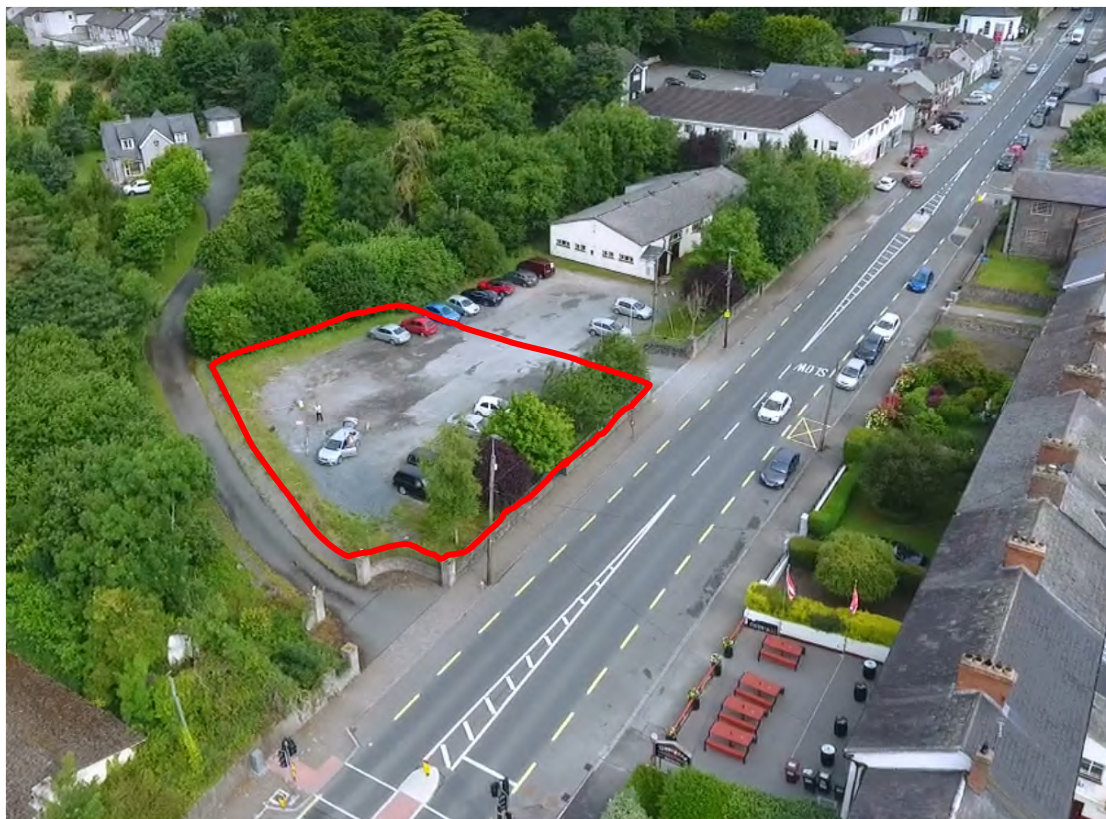
Plate 1. UAV Aerial photograph (40m elevation) at a location to the southeast of the site facing in a north-westerly direction (red outline shows the approximate outline of the site)

The proposed works area for Collon is approximately 957m² in footprint and is proposed for the southern end of the carpark (see Figure 7. Site Location and Surrounding Property). This area lies directly to the north of a residential access road which provides access to a parochial house located approximately 50m west of the site (see Plate 1 below).

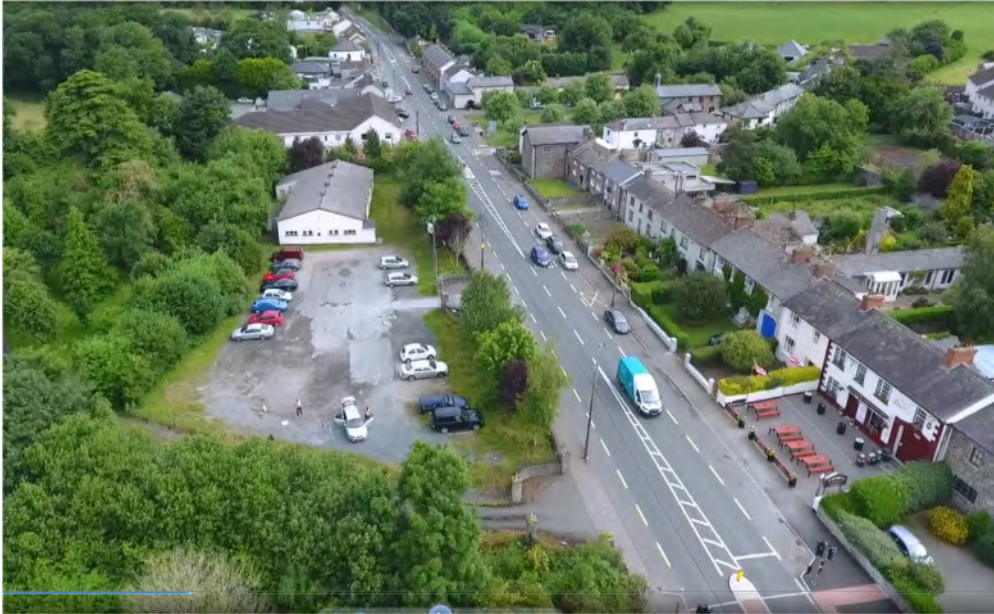
Plate 3. UAV Aerial photograph (40m elevation) at a location to the south of the site facing in an northerly direction

The Ardee Road/N2 National Road is located to the east of the site. To the east of the N2, a row of residential property is located. A public house is located to the east of the site on the eastern side of the

N2 National Road. Approximately 80m to the northeast of the site is located the village centre, which is known as Market Square (see Figures 6 & 7 and following Plate 3).

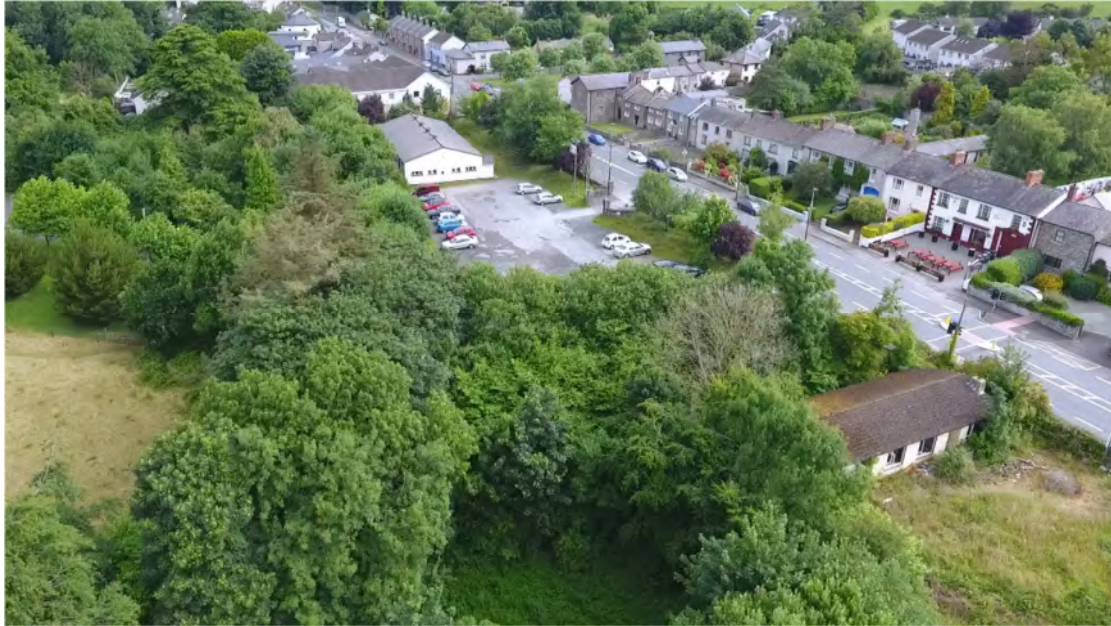
Plate 4. UAV Aerial photograph (40m elevation) at a location to the southwest of the site facing in an north-easterly direction

A mature planted woodland area is located to the northwest and west of the existing carpark which separates the site from the residential property (i.e., a parochial house) to the west of the site. The access road to this residence also forms the southern boundary of the carpark. Further to the south and southwest of the access road, is located further mature woodland. Within this woodland is located a derelict residence and a derelict shed. It is understood that the derelict residence site to the south will be redeveloped in the future as housing (see Plate 4 below).

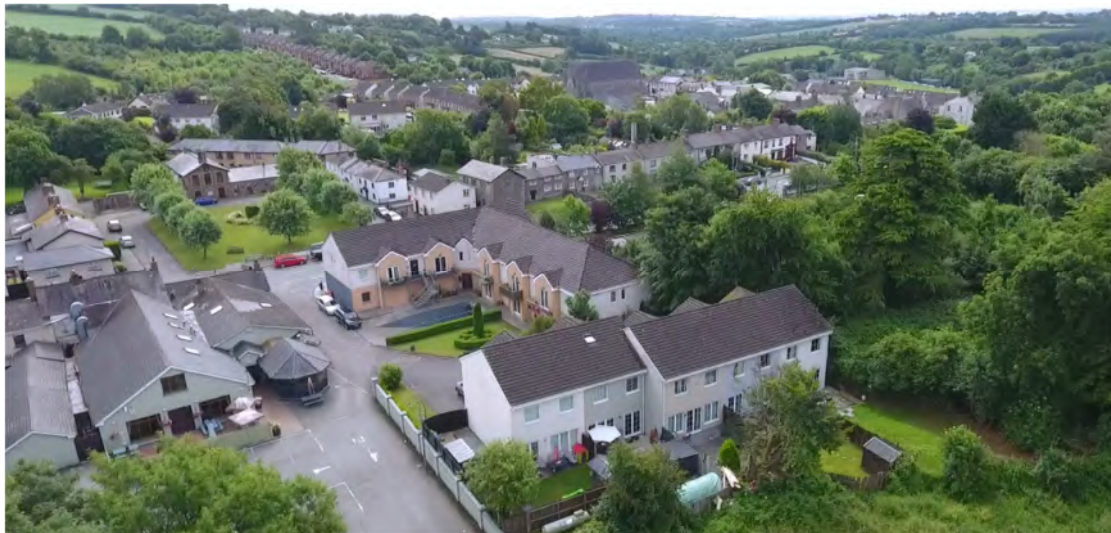
Plate 5. UAV Aerial photograph (40m elevation) at a location to the northwest of the site facing in a south-easterly direction showing the apartment complex to the north of the Parish Hall (note Market Square to east of the apartment complex)

A complex consisting of ground floor commercial property with 2nd and 3rd storey apartments complex is located to the north of the Parish Hall (see Plate 5 below). A public house and restaurant are located approximately 100m to the north of the Parish Hall and to the north of the afore-mentioned complex.

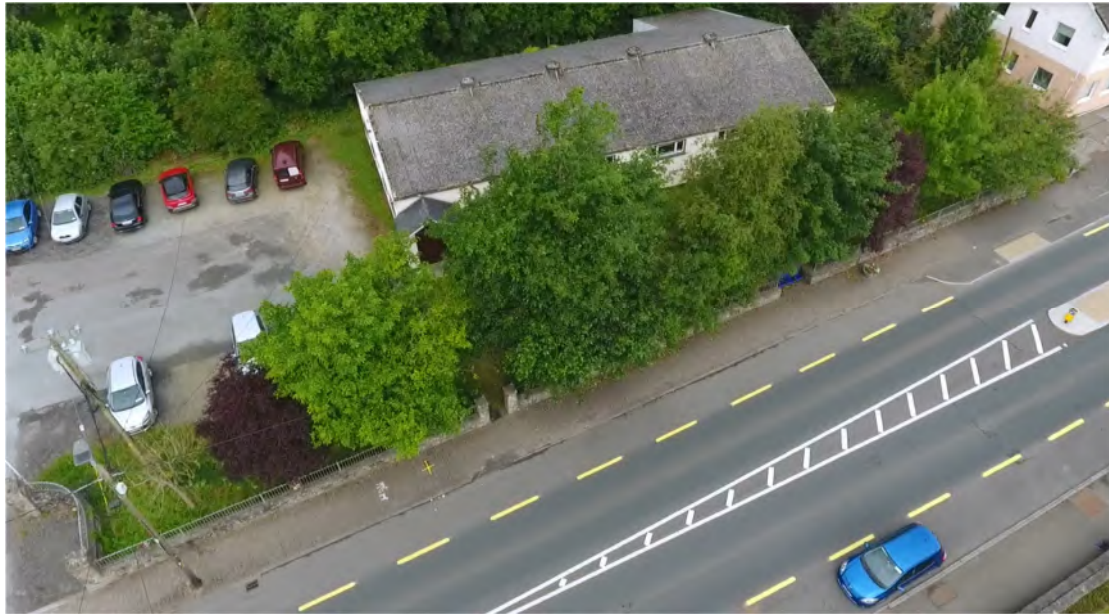
Plate 6. UAV Aerial photograph (40m elevation) at a location to the northeast of the site facing in a westerly direction showing line of trees to the East of Collon Parish Hall

The eastern boundary of the Parish Hall, running along the N2 road, is lined with a various assortment of planted trees (see Plate 6 below).

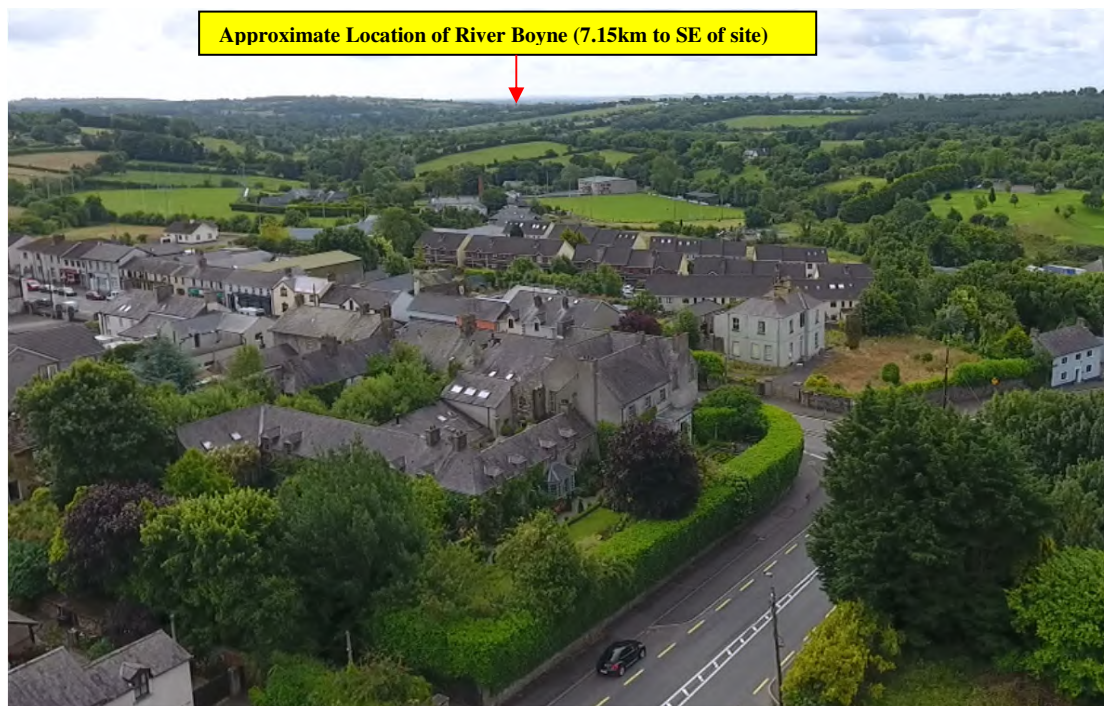
Plate 8. UAV Aerial photograph (40m elevation) on southern edge of site facing in of south-easterly direction towards River Boyne and River Blackwater Bay SAC and SPA

The site is approximately 6.3km to the northwest of the River Boyne and River Blackwater Special Area of Conservation (SAC) (No. 002299) and 7.15km to the northwest of the River Boyne and River Blackwater Bay Special Protected Area (SPA) (No. 004232) (see Figures 1 to 5, Table 1 & Plate 8 following).

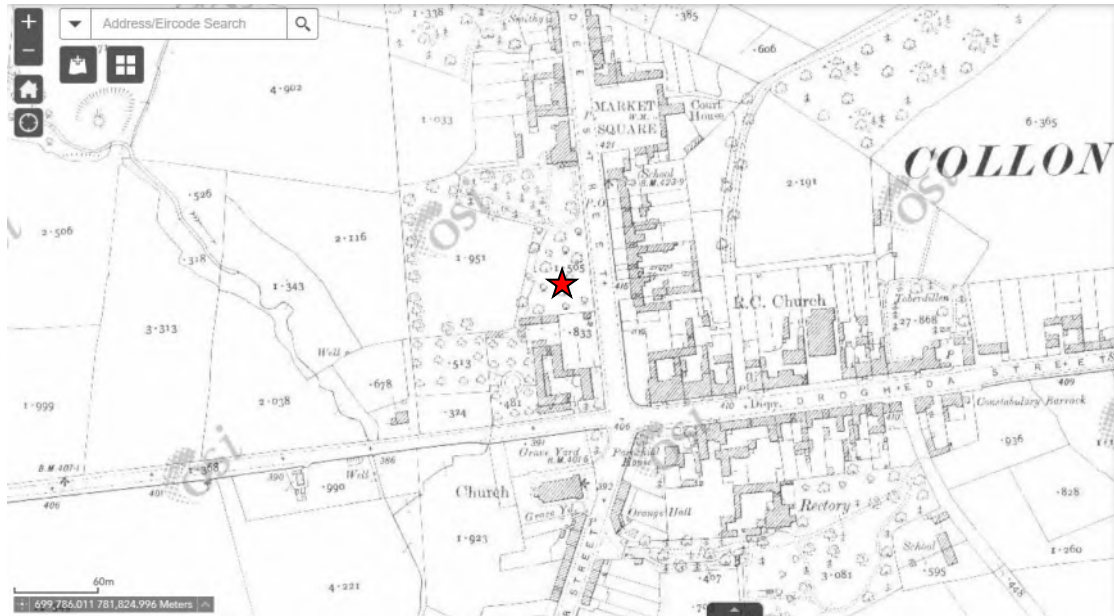
Plate 10. Extract of last Edition of 25-inch historical OS Mapping (note red star indicates the approximate location of the site)

A review of 25-inch historical Ordnance Survey mapping indicates that the site remained as woodland with some slight changes to the landscaped garden towards the northern end of the site. The industrial area to the south of the site also shows little change (see following Plate 10).

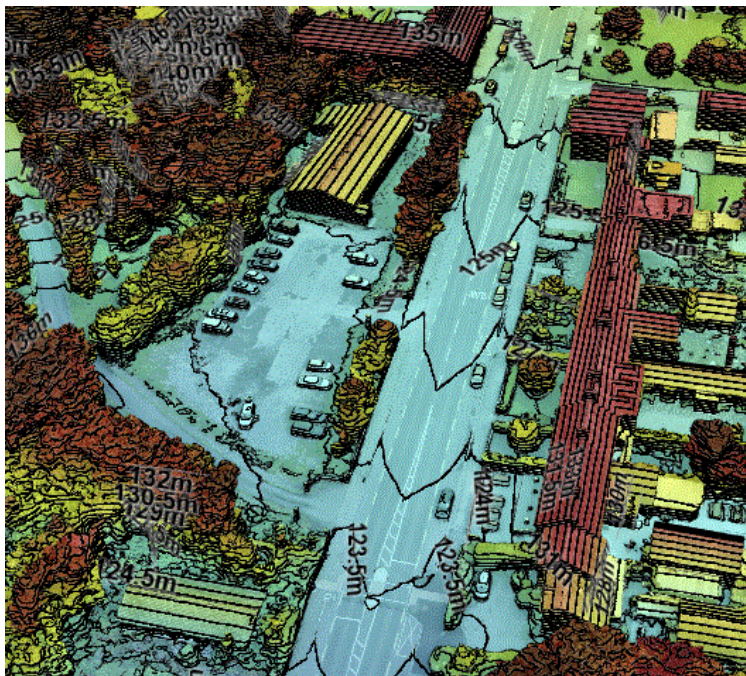
Plate 11. Extract from Dronedeploy 3D Model showing topographic contour lines

The topography of the site slopes evenly from north to south. The highest point of the site is near the northern boundary and is approximately 124.5m AOD. The lowest part of the site is located on the southern end of the site where the elevation is 123.5m AOD (see Plate 11 below).

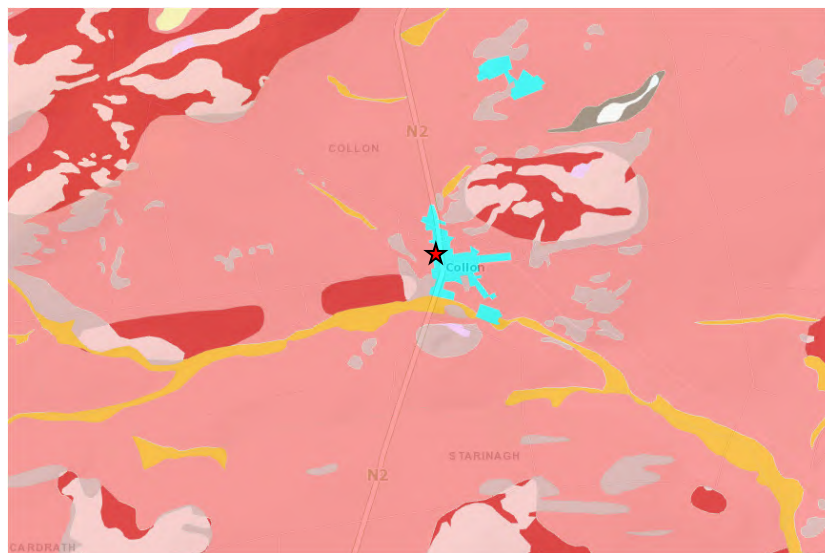
Plate 12. Extract of GSI Mapping showing soil types identified within the vicinity of the site

A National Soil Mapping Project carried out jointly by the EPA and Teagasc have identified a number of soil types within the footprint of the site. Soil type *AminPD - Mineral poorly drained (Mainly acidic)* (which is part of the *Surface water Gleys, Ground water Gleys* soil group) was identified in the area to the north and west of the site (see Plate 12 below). A small area of Soil type *AminSP - Shallow poorly drained mineral (Mainly acidic)* (which is part of the *Surface water Gleys, Ground water Gleys* soil group) is located to the west of the site. A small linear strip of *A - Alluvium* is located running along the route of the surface water body to the west of the site.

Soil type *AminDW - Deep well drained mineral (Mainly acidic)* was identified in the area to the southwest of the site. The footprint of the site is, as expected classed as *URBAN* which is made ground. It is reasonable to infer that there were non-native soils and materials deposited for the purposes of the development of the Collon Parish Hall and carpark. However, it is reasonable to assume that the soil classification is accurate. Based on Mulroy Environmental's local knowledge of the area, the general classification for the area is considered appropriate for the site (see Appendix 1).

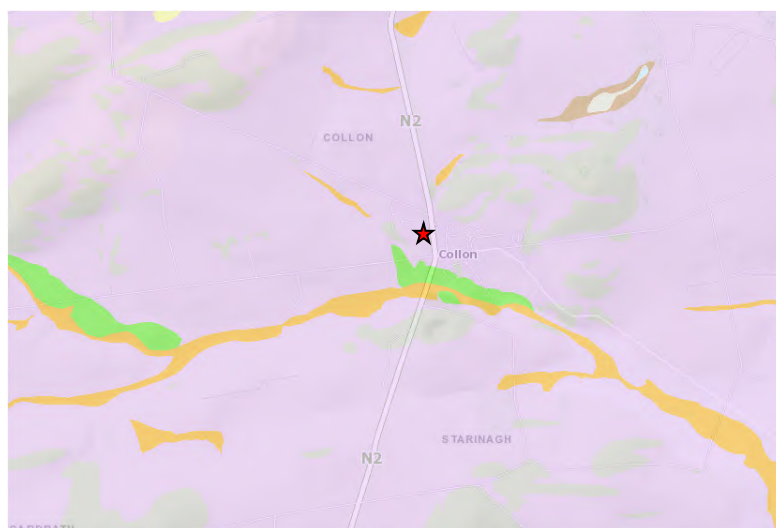
Plate 13. Extract of GSI Mapping showing subsoil types identified within the vicinity of the site

The National Soil Mapping Project carried out jointly by the EPA and Teagasc have identified the main subsoil type on the footprint of the site as *TLPSsS - Till derived from Lower Palaeozoic sandstones and shales* (see Plate 13 below). A small linear strip of subsoil of *A - Alluvium Undifferentiated* was identified in the vicinity of the stream to the east of the site. Shallow bedrock was identified in a small area to the west of the site. *GLPSsS - Gravels derived from Lower Palaeozoic sandstones and shales* are located to the south of the village (see Appendix 1).

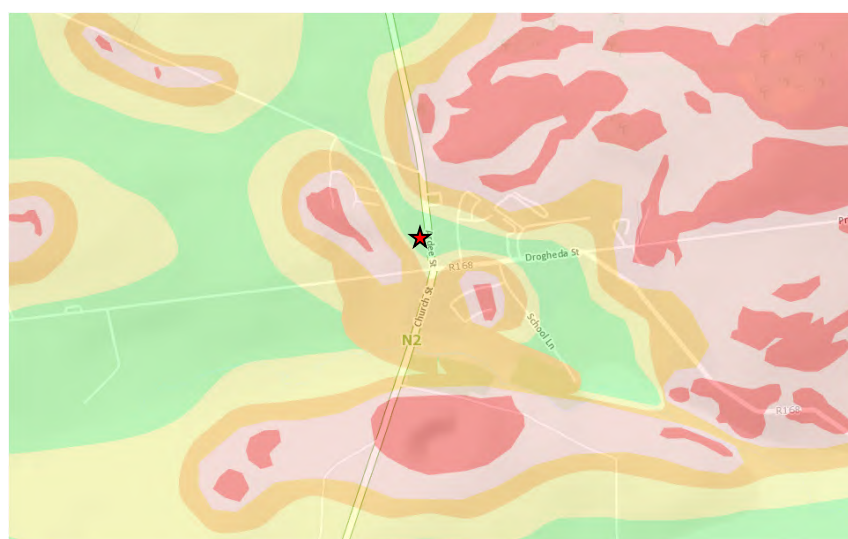
Plate 14. EPA/Teagasc/GSI Aquifer Vulnerability Mapping in proximity of site (note red star is in the centre of the site)

The aquifer vulnerability category rating of *Low (L)* by the GSI is most likely due to the poorly drained and impermeable soils and subsoils identified on site and their depth i.e. in excess of 10m. In addition, average annual recharge rates from rainfall in the vicinity of the site indicate that soil permeabilities are classed as low (see Appendix 1).

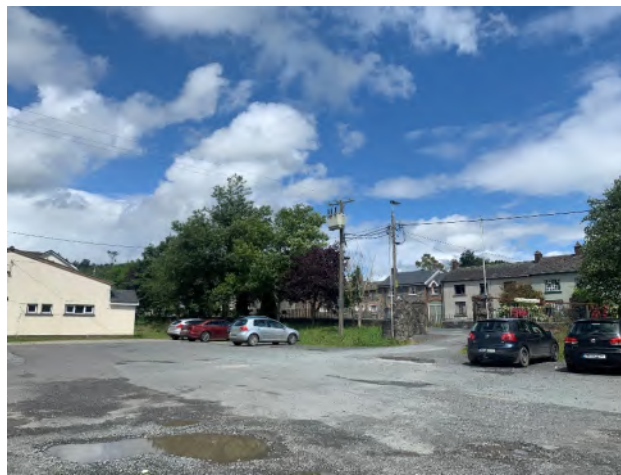
Plate 15. Ground view of site from southwestern corner facing in a northeasterly direction showing the Parish Hall, parking lot (BL3) & the northeastern treeline (WL2)

This category includes all buildings and structures which are composed of artificial structures such as cement, bricks, and tarmac. The Collon Parish hall and the parking lot are included under this habitat description, as they are built with artificial materials, and include less than 50% plant cover. Much of the site is classed under this category (see Plate 15 below and Figure 8).

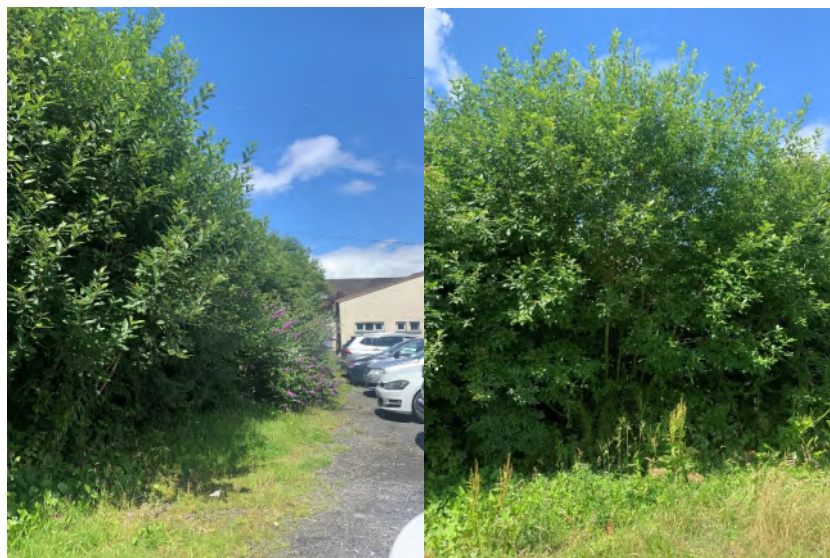
Plate 16. Ground views of Broadleaved Woodland (WD1) in southwestern area of site

This category includes areas of non-native planted woodland or highly modified woodland, which include majority cover (90-100%) broad leaved trees, and no more than 0-25% coniferous land cover (see Figure 8). Woodlands within this category cannot be specified as semi-natural, however the species composition can include both non-native and native trees. The woodland on the western border of the carpark and the Parish Hall can be classified as a broadleaved woodland, as it is a planted non-natural area with majority broadleaf cover (see following plate, Plate 16). This would be specified as a non-mixed woodland as it is not particularly specious. The portion of the woodland to the southwest along the proposed playground site would be more closely identified as a *narrow* woodland, as it is between 10-12 meters wide. However, as this is greater than 4 meters in elevation, it cannot be described as a treeline. The canopy is also greater than 5 meters in height, so this also cannot be classified as scrub, despite the abundance of shrubbery present (see Figure 8).

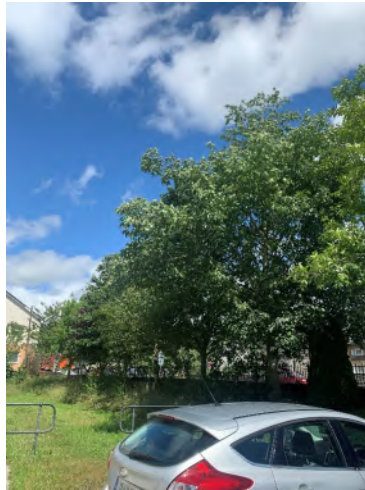
Plate 17. Ground views of the protected treeline (WL2) on the eastern boundary of the Parish Hall.

The treeline located to the northeast of the site is protected under the Louth County Development Plan and may not be modified during construction. The species within this treeline have been listed in Table 6. Native species encountered include cherry plum (*Prunus cerasifera*), sweet cherry (*Prunus avium*), silver birch (*Betula pendula*) and common ash (*Fraxinus excelsior*), while non-native species include Japanese cherry (*Prunus serrulata*), gray alder (*Alnus incana*), red alder (*Alnus rubra*) and Norway maple (*Acer platanoides*). This treeline includes several shrubs at the base, and two small evergreen shrubs frame the access gate along this treeline. There is also a small area of grassland adjacent to it.

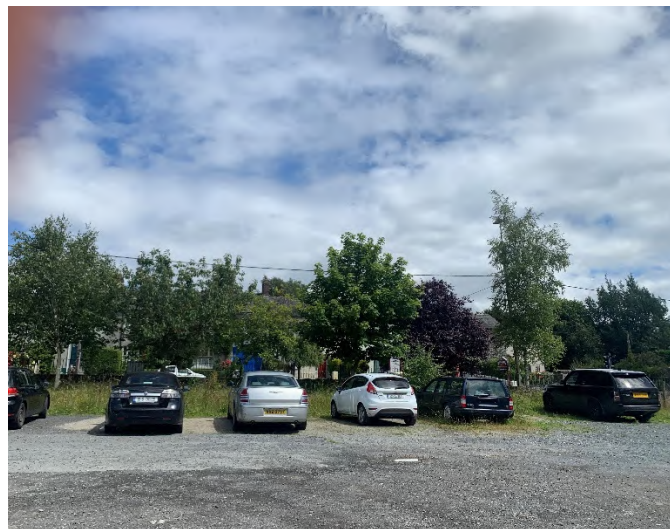
Plate 18. Ground views of the second treeline (WL2) on the southeastern boundary of the site

The treeline which borders the east of the site will be affected by construction works. This includes native species such as silver birch, blackthorn, and cherry plum. Alien species such as Japanese cherry (*P. serrulata*), gray alder (*A. incana*), red alder (*A. rubra*), and Norway maple (*A. platanoides*) were also recorded here. These species have not been categorised as invasive either due to a lack of information or because they pose a low invasive risk to native biota or protected species. The alien species found along the treeline boundary immediately east of the site are not listed as Invasive Alien Species of Union Concern by the European Commission. Therefore, they are not regulated as part of the Alien Invasive Species European Regulation (EU No. 1143/2014).

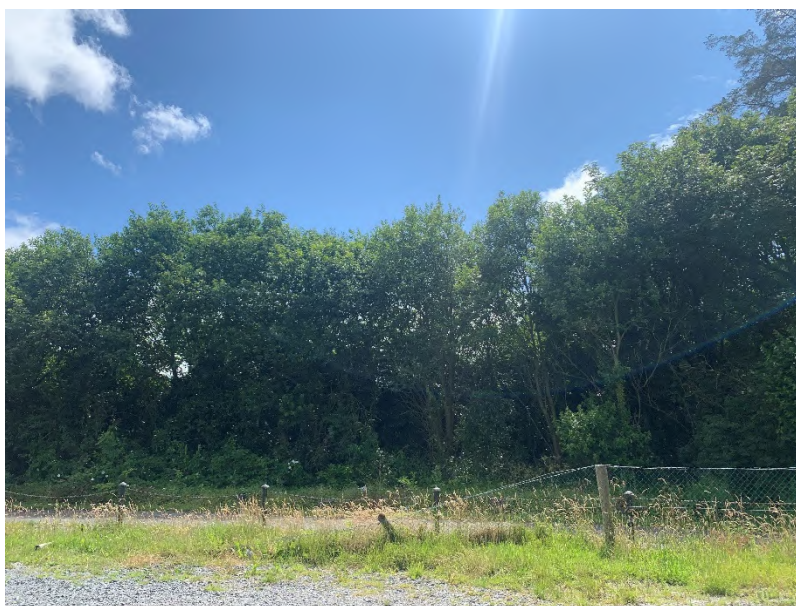
Plate 19. Ground view of Broadleaved Woodland (WD1) to the south of the site

A tarmac-paved access road is located south of the site, leading into the drive of the parochial property. This would also be included under *BL3 Buildings and Artificial Surfaces*. A mature woodland borders the far side of this access road and continues further south (see Figure 8 and Plate 19 below). A general list of accessible species identified alongside this road is outlined in Table 5. This woodland is also classed as a *WD1 Mixed Broadleaved Woodland* based on evidence collected during the field survey and a desk-based study of the drone survey mapping. There were numerous shrub species identified within the undergrowth of this woodland. Additionally, there are 2 derelict buildings which were also visible within this woodland area. Further investigation would be required to identify whether these buildings would be classed as an intact building under *BL3 Buildings and Artificial Surfaces*, or a highly damaged stone derelict building, under the *BL1 Stone Walls and other Stonework* category. Structures under this category would be regarded as of high ecological importance, particularly as potential habitats for bats and bird species. A concrete boundary wall lines this property on the east and south alongside the road.
