LOUTH COUNTY COUNCIL

APPROPRIATE ASSESSMENT SCREENING REPORT

PROPOSED PLAYGROUND,

BALTRAY ROAD, TERMONFECKIN, CO. LOUTH

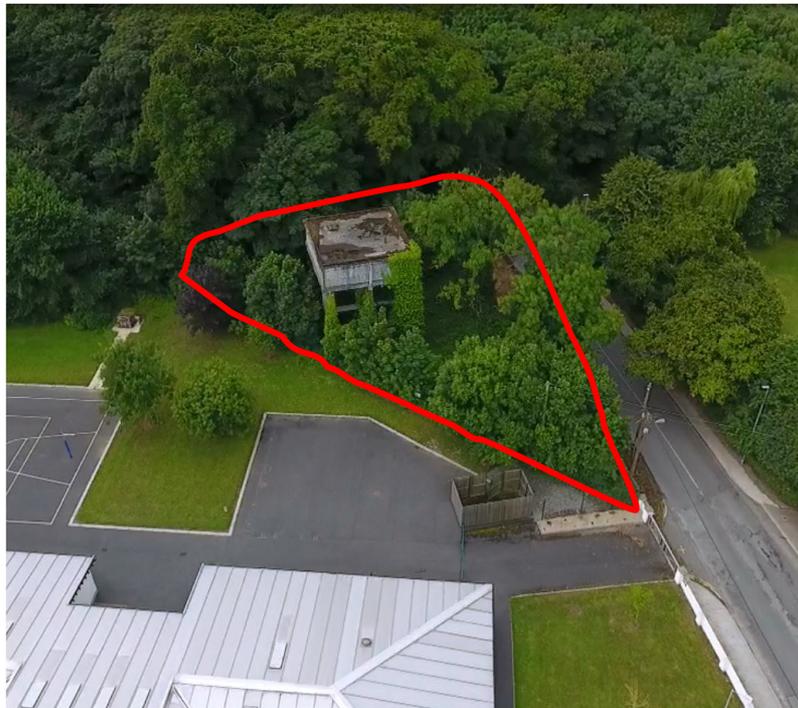
Plate 1. UAV Aerial photograph of site taken at 40m elevation over the school to the north of the site facing in a southerly direction

It is understood that Louth County Council wish to install a new playground on a small site (555m²) located to the southwest of Scoill Naoimh Feichin Primary School, Termonfeckin, County Louth. The site currently has a disused public water abstraction borehole and associated pump system on its northern end and a 11m high disused concrete reservoir tower with a capacity of 160m³ in the middle of the site. Water was pumped from the well and into the 11m high reservoir which was used to store the abstracted groundwater water. Groundwater was then fed via gravity to a water treatment plant located approximately 200m to the north of the site where the water was treated prior to being distributed into the potable water system in Termonfeckin. The site is currently moderately overgrown with vegetation (see Plate 1 below).

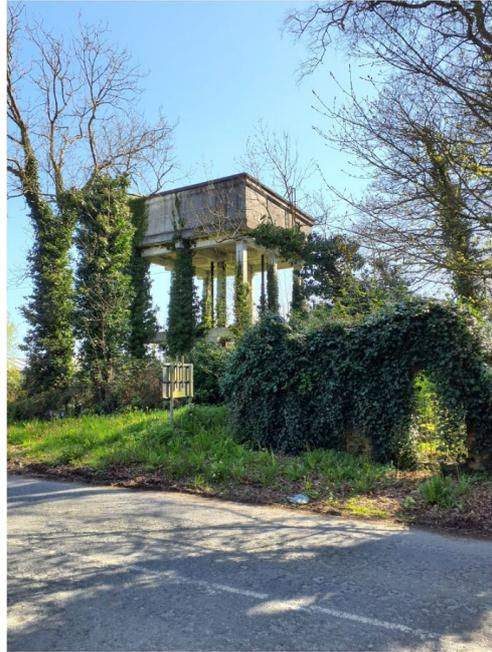
Plate 2. Photograph of site taken from the R167 to the southwest of the site facing in a north-easterly direction (note reservoir to be demolished)

The proposed development, which is approximately 555m², will make use of the full site (see Plate 2 below). It is proposed to demolish the existing concrete reservoir (see Plate 2 following). The site, which is covered by a mixture of gravel and soil, is currently disused (see Figures 6 & 7).

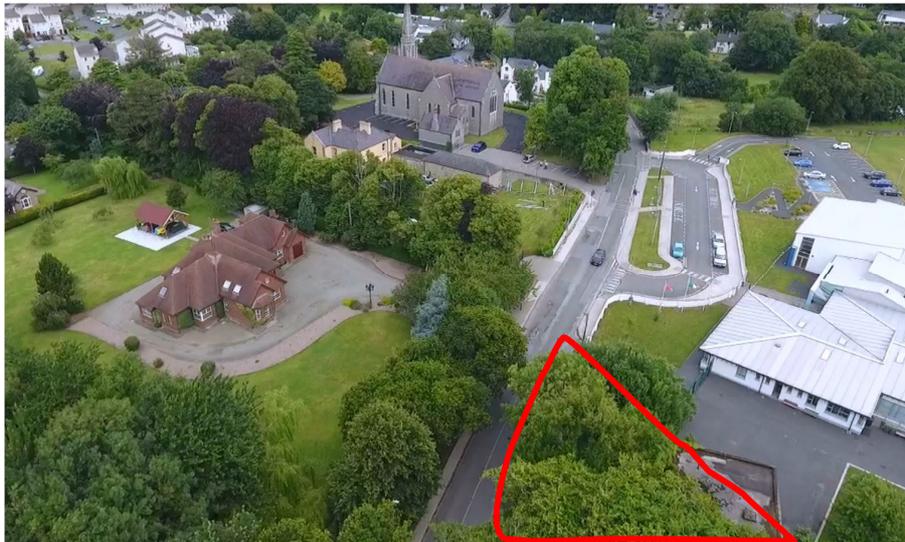
Plate 3. UAV Aerial photograph (50m elevation) at a location to the south of the site over the woodland facing in a northerly direction (note position of the reservoir on the bottom right-hand side shown approximately with red outline)

The R167 Regional Road (known locally as the Baltray Road) is located to the west of the site. To the north and northeast of the site is located the Scoil Naomh Feichin Primary School. A detached residence and its grounds are located to the west of the R167 and 60m to the northwest of the site. A church, The Church of the Immaculate Conception and its Parochial House is located to the north of this residence and 90m to the northwest of the site (see Figures 6 & 7 and following Plate 3).

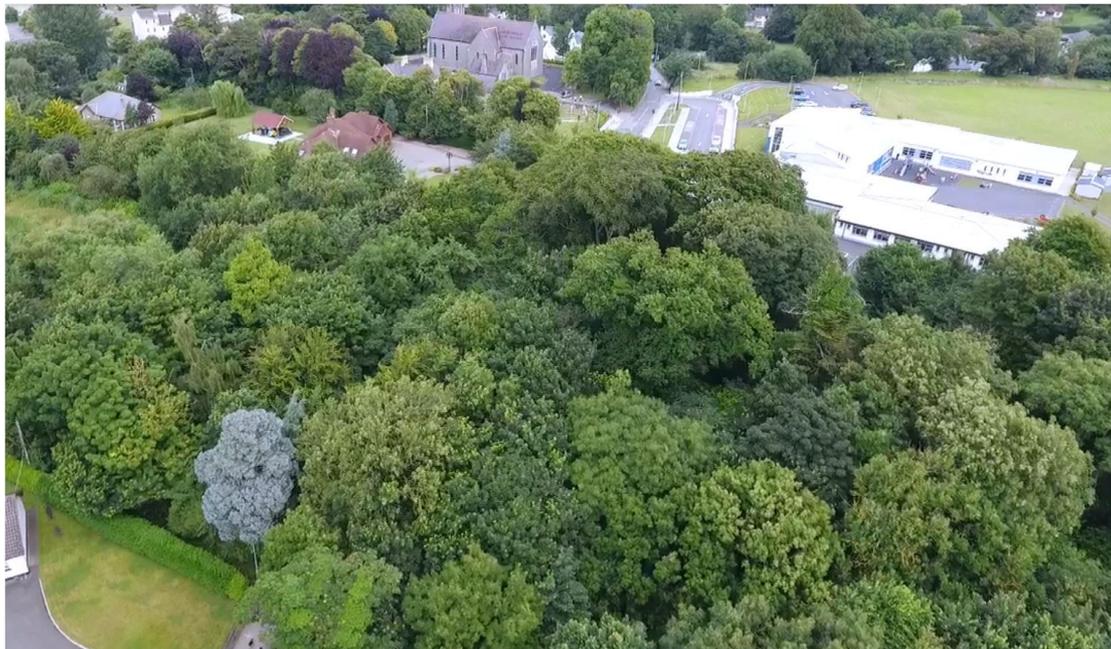
Plate 5. UAV Aerial photograph (50m elevation) at a location approximately 110m to the south of the site over the woodland facing in a northerly direction (note position of reservoir)

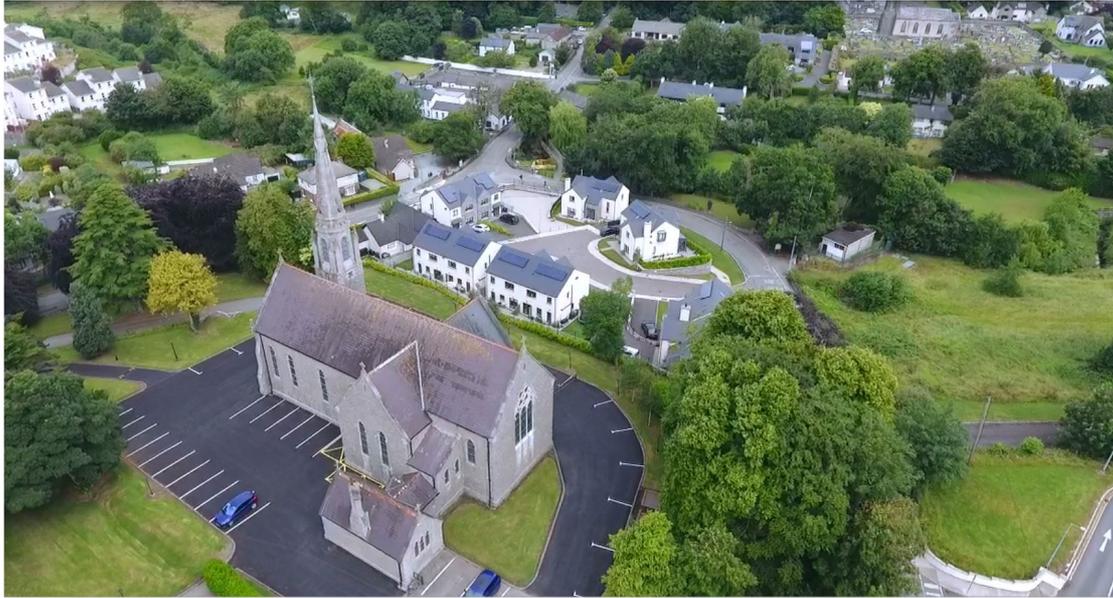
Plate 6. UAV Aerial photograph (50m elevation) at a location over Scoill Naomh Feichin to the north of the site facing in a north-westerly direction showing Church and residential estate (note position of Ballywater River (also referred to as Termonfeckin River by EPA) with vehicular and pedestrian bridges crossing to the northwest of the site)

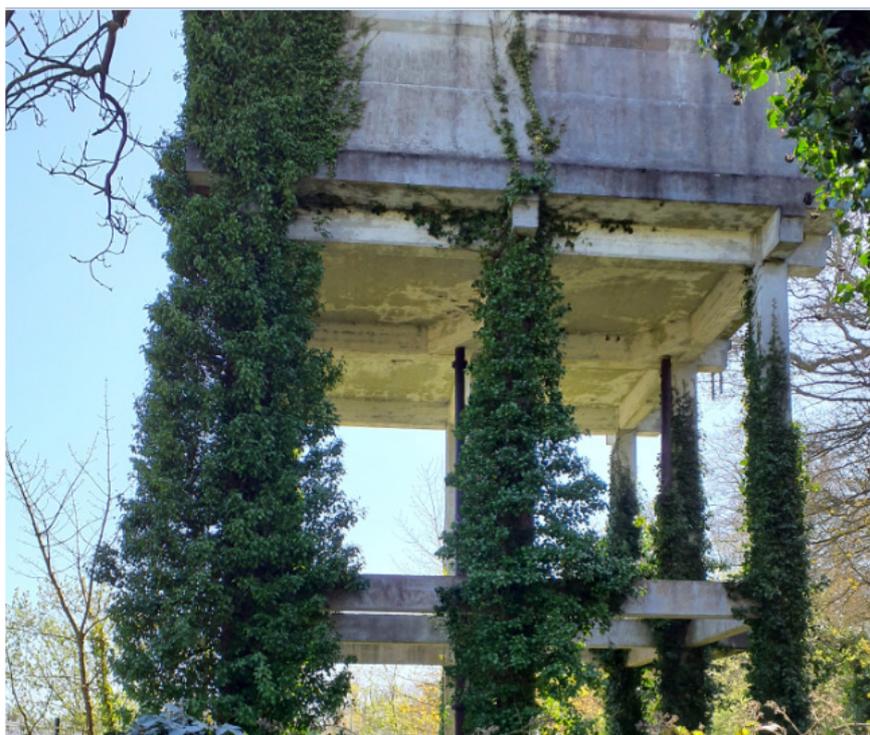
Plate 9. Ground photograph taken during the inspection of the underside and side walls of reservoir for evidence of bats

The reservoir's dimensions are as follows, width 8m, length 8m and height 2.5m (see Plate 9 below). It is estimated to have a volume of approximately 160m³. It is supported by 6 concrete columns. It is understood that the reservoir is now empty and as such, the reservoir presents a suitable bat roost provided suitable openings exist to its interior. A comprehensive inspection was carried out on the on-site water reservoir to identify any apertures or openings where bats could enter. The bottom and side walls of the reservoir were photographed with a zoom camera and the ground directly under the reservoir was inspected to determine if there was any evidence of bats (e.g., bat droppings, urine staining, grease marks (oily secretions from glands present on stonework), bat pupae and claw marks, etc.).

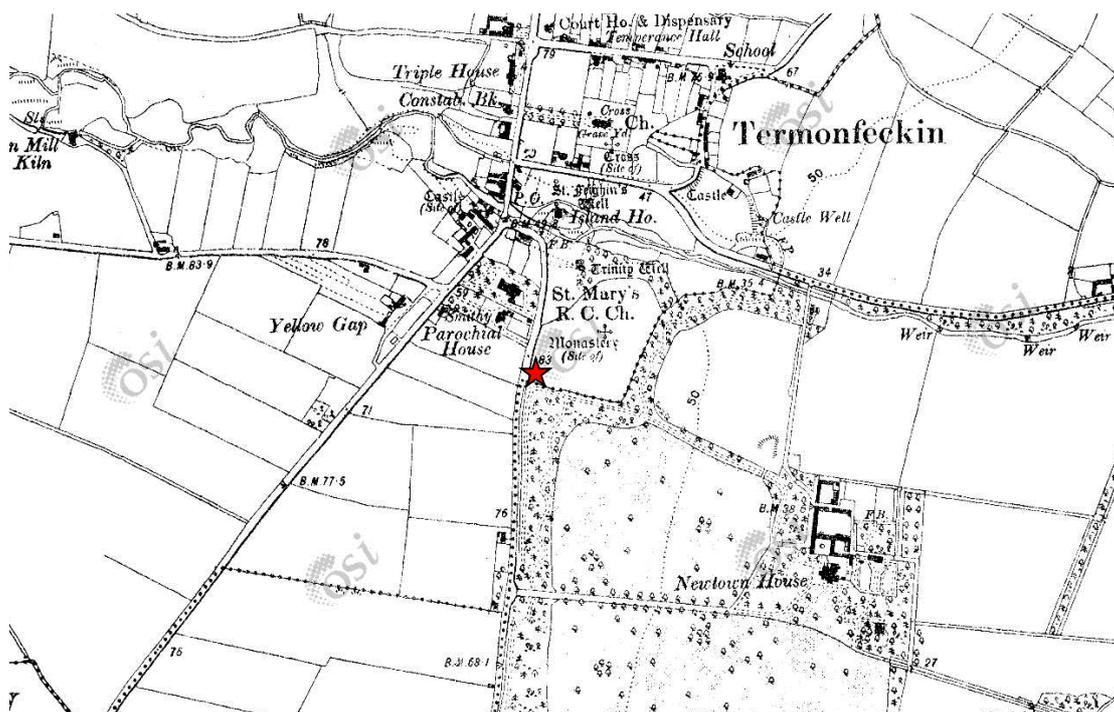
Plate 10. Extract of last Edition of 6-inch historical OS Mapping showing historical brick works to the northwest of the site (note red star indicates the approximate location of the site)

A review of 6-inch historical Ordnance Survey mapping indicates that the site was located on the southwestern corner of an agricultural field which was the site of a former monastery. The present woodland is evident on the mapping and appears to have been part of the Newtown House Demense which was originally constructed around 1780 (see Plate 10 below).

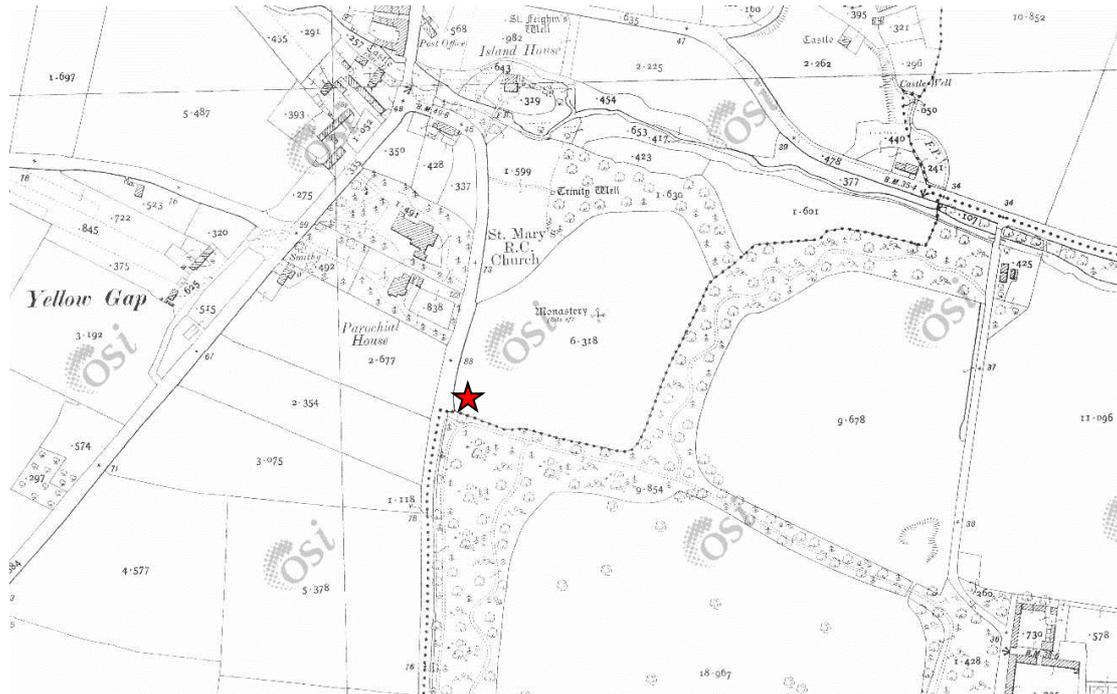
Plate 11. Extract of last Edition of 25-inch historical OS Mapping (note red star indicates the approximate location of the site)

A review of 25-inch historical Ordnance Survey mapping indicates that the site remained unaltered. An inspection of the mapping for the woodland to the south and east of the site indicates the presence of various pathways indicating that it was used by the estate for walking and leisure (see following Plate 11).

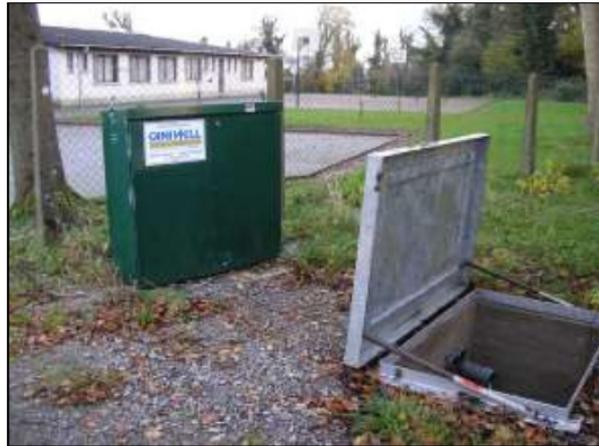
Plate 12. Photograph extract from report, *Groundwater Protection Establishment of Groundwater Source Protection Zones Termonfeckin Water Supply Scheme Termonfeckin Borehole Groundwater Source Protection Zones November 2011 Revision: E*

A disused water abstraction well is located on the northern boundary of the site. The borehole and rising main are located in a 1m², concrete block lined chamber approximately 0.9 m deep (see Plate 12 below and Figure 10). The top of the chamber is flush with ground level and is covered by a securely-fitting and bolted metal cover.

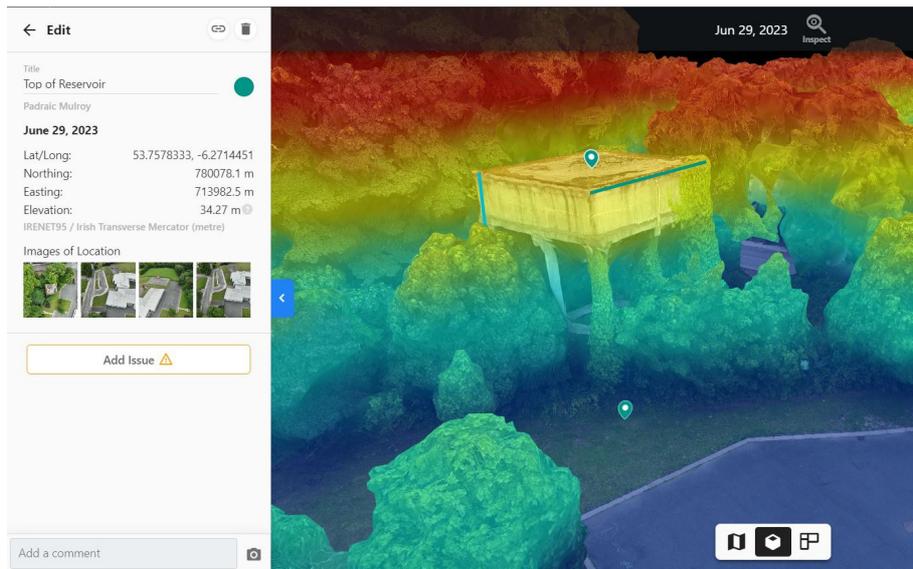
Plate 13. Extract of Dronedeploy 3D Model of Reservoir showing elevation of roof of reservoir

The reservoir’s dimensions appear to be approximately 8m x 8m x 2.5m (i.e., a volume of 160m³). The elevation of the top (i.e., the roof) of the reservoir appears to be approximately 34.27mAOD. The elevation of the ground beneath the reservoir is approximately 23mAOD. Therefore, the reservoir appears to have a height of approximately 11m (see Plate 13 following).

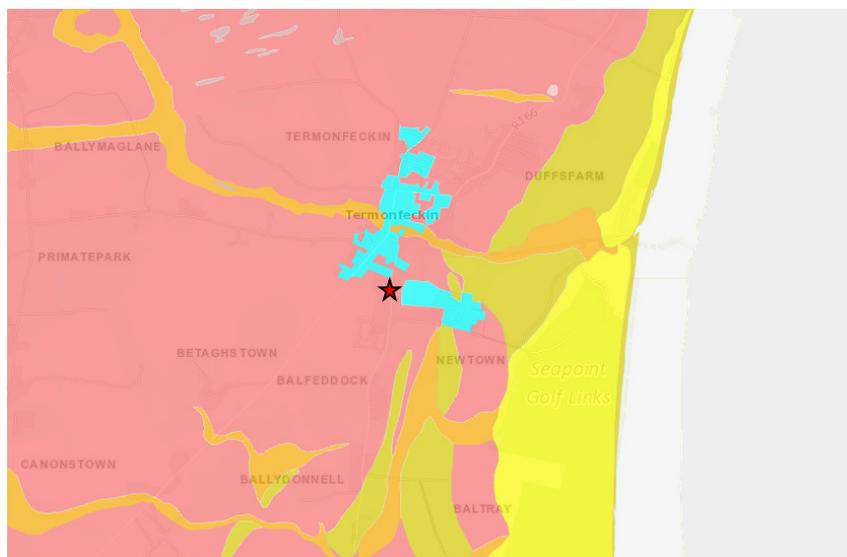
Plate 14. Extract of GSI Mapping showing soil types identified within the vicinity of the site

A National Soil Mapping Project carried out jointly by the EPA and Teagasc have identified a number of soil types within the footprint of the site. Soil type *AminPD - Mineral poorly drained (Mainly acidic)* (which is part of the *Surface water Gleys, Ground water Gleys* soil group) was identified in the under the full footprint of the site (see Plate 14 below). A linear strip of *A – Alluvium* is located running along the route of the Ballywater River to the north of the site.

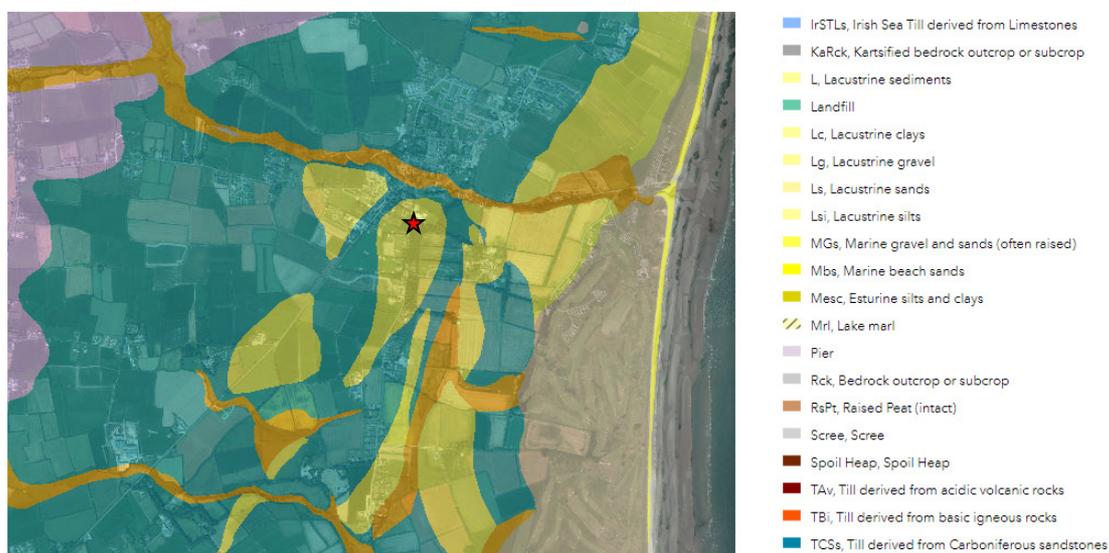
Plate 15. Extract of GSI Mapping showing subsoil types identified within the vicinity of the site

The National Soil Mapping Project carried out jointly by the EPA, GSI and Teagasc have identified several subsoil types in the vicinity of the site. These include *raised beach sands and gravels (MGs)*, *tills (IrSTLPSsS, TLPSsS)*, *alluvium (A)*, *beach sands (Mbs)* and *windblown sands (Ws)*. A significant area of built ground (MADE) also occurs to the north of the source. The main subsoil type on the footprint of the site is *MGs - raised beach sands and gravels* (see Plate 15 below).
