LOUTH COUNTY COUNCIL

APPROPRIATE ASSESSMENT REPORT FOR PROPOSED COASTAL PROTECTION WORKS, BELLURGAN POINT, DUNDALK, CO. LOUTH

VOLUME I. REPORT

9th January 2024

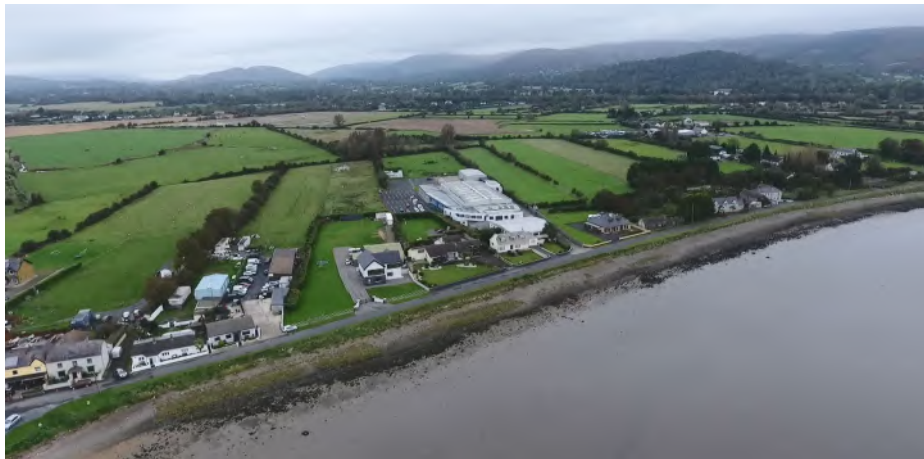
Plate 1. Aerial photograph taken of the proposed work area at 70m elevation facing in a northerly direction.

Louth County Council wishes to carry out coastal protection works at 3 locations along the foreshore to the east of the Quay at Bellurgan Point, Dundalk, County Louth (see Figures 1-6 and Plate 1 below). Damage has occurred at 3 locations along this sea front with soil erosion and boulders displaced by wave action during storm conditions along the upper foreshore. The three site work areas are referred to as Locations A, B and C (see Figures 7, 8, 11 and 12) and are located directly to the south of a coastal road which runs in a southwest to northeast direction and provides access to Bellurgan Point.

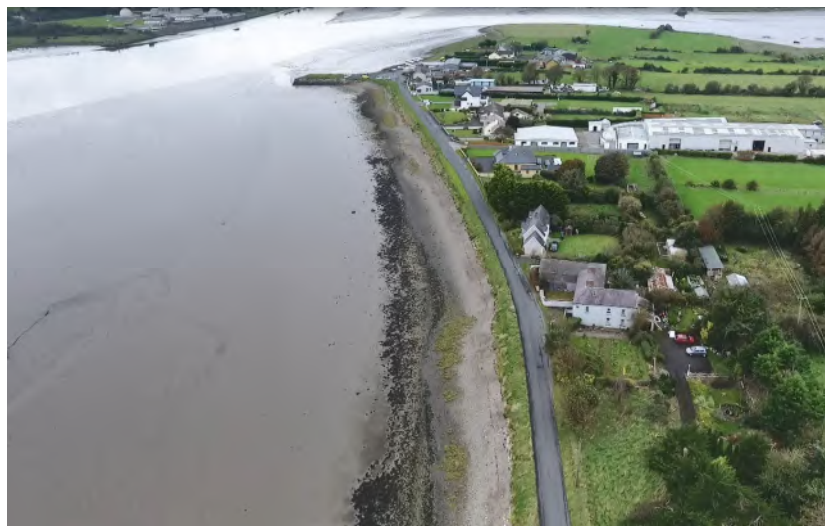
Plate 2. Aerial photograph taken of the proposed works area at 70m elevation taken facing in an westerly direction.

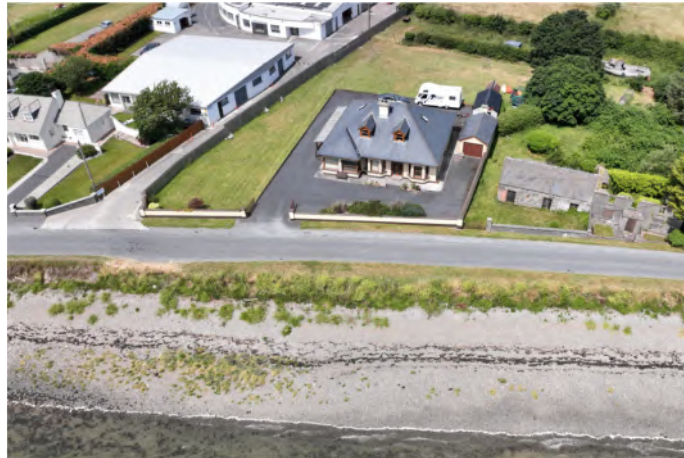
Plate 3. Aerial photograph taken at 40m elevation taken from seaward facing in a northerly direction towards Location A proposed coastal works area

The first location, Location A is located on the western side of the foreshore and is approximately 90m from the eastern side of Bellurgan Point Quay (see Figures 6 and 12 and Plates 3 and 4 below and following). This works area is 60m in length and runs between Chainage 0m and 60m. The area between Chainage 0m to 15m consists of badly damaged stone sea wall which has fallen away with pea gravel fill from an adjacent Telecom Eireann duct visible due to the erosion. A manhole cover for the Telecom Eireann is located on the grass verge at Chainage 12m. It should be noted that no existing coastal protection structure exists between Chainage 15m to 60m at Location A works area. This area shows evidence of soil collapse. To the west of Location A, is located approximately 20m existing stone sea wall which is largely intact.

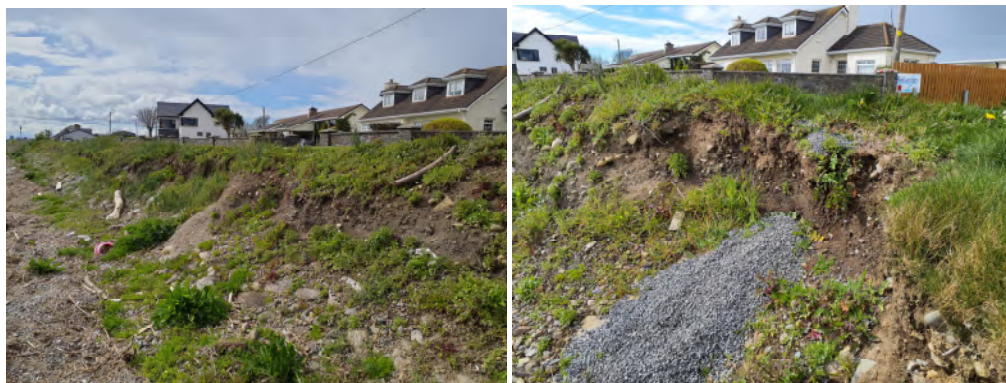
Plate 4. Two ground photographs taken on the 17th April, 2023 at Chainage 30m facing in a north-westerly direction towards Location A proposed coastal works area showing damaged stone sea wall on the western side and soil collapse in the middle of Location A Works Area

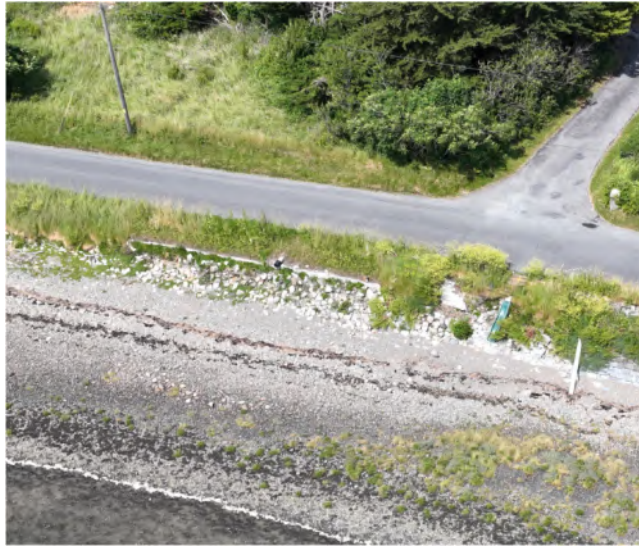
Plate 5. Aerial photograph taken at 40m elevation taken from seaward facing in a northerly direction towards Location B proposed coastal works area

The 2nd location, Location B is located towards the eastern side of the foreshore, is approximately 15m in length and runs between Chainage 205m and 220m (see Plates 5 and 6 below). This area is characterised by a concrete footing within the road verge that was constructed in 2022 as emergency protection works following a storm event which caused undermining of the local road. However, there are areas under and above this concrete footing which show evidence of collapse (see Figure 13).

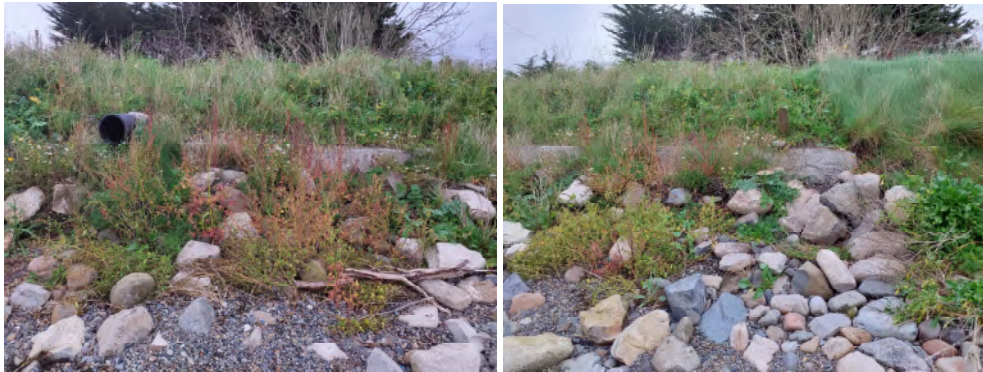
Plate 6. Two ground photographs taken on the 7th October, 2023 at Chainage 205m to 220m facing in a north-westerly direction towards Location B proposed coastal works area showing concrete footing with collapsed stone sea wall beneath

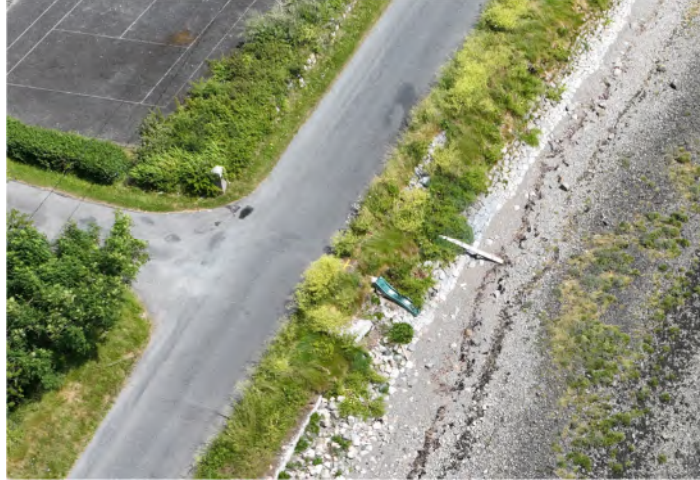
Plate 7. Aerial photograph taken at 40m elevation taken over Location B facing in a north-easterly direction towards Location C proposed coastal works area

The 3rd location, Location C is located on the eastern side end of the foreshore, is approximately 25m in length and is between Chainage 220m and 245m (see Figure 13 and Plates 7 and 8 below). This area is directly to the east of Location B Proposed Coastal Works area. Location C Works Area requires repair

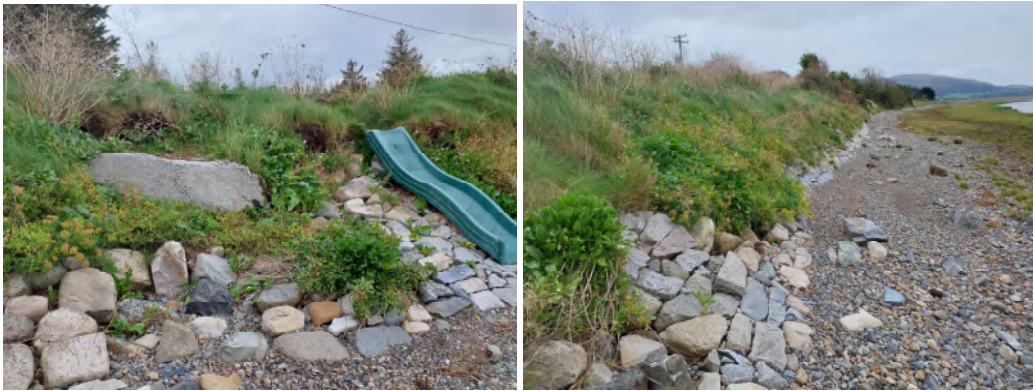
Plate 8. Two ground photographs taken on the 7th October, 2023 at Chainage 220m facing in northerly and easterly directions towards Location C proposed coastal works area showing damaged stone sea wall

to the existing stone sea wall which shows evidence of erosion with collapsing and boulders detaching from the sea wall. A manhole cover for the Telecom Eireann is located on the grass verge at Chainage 225m. The original sea wall extends from Chainage 170m for approximately 200m to the east (see Figure 11).

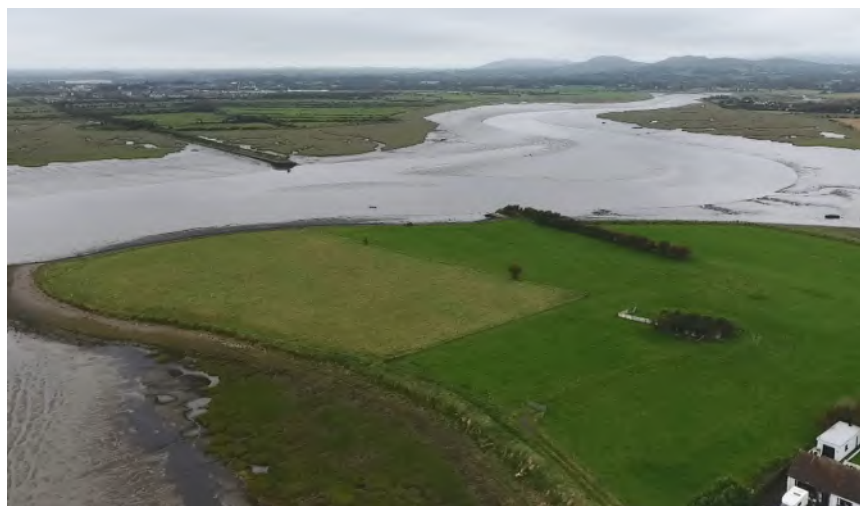
Plate 13. Aerial photograph taken at 70m elevation at Bellurgan Quay facing in a north-westerly direction showing the abutments for the former Dundalk to Greenore Railway Bridge

A review of 25-inch historical Ordnance Survey mapping indicates the existence of the current road, some of the current residences and the quay to the south of the village approximately 100 years ago (see following Plate 12). A prominent feature in Bellurgan at that time was the Dundalk to Greenore railway line which ran in a west to east direction and was located to the north and rear of the roadside residences. A number of level crossings are visible on the 25-inch mapping. Evidence of the route of the railway line are clearly visible in current aerial photography e.g., former railway bridge over Flurry River (see Plate 13 below).

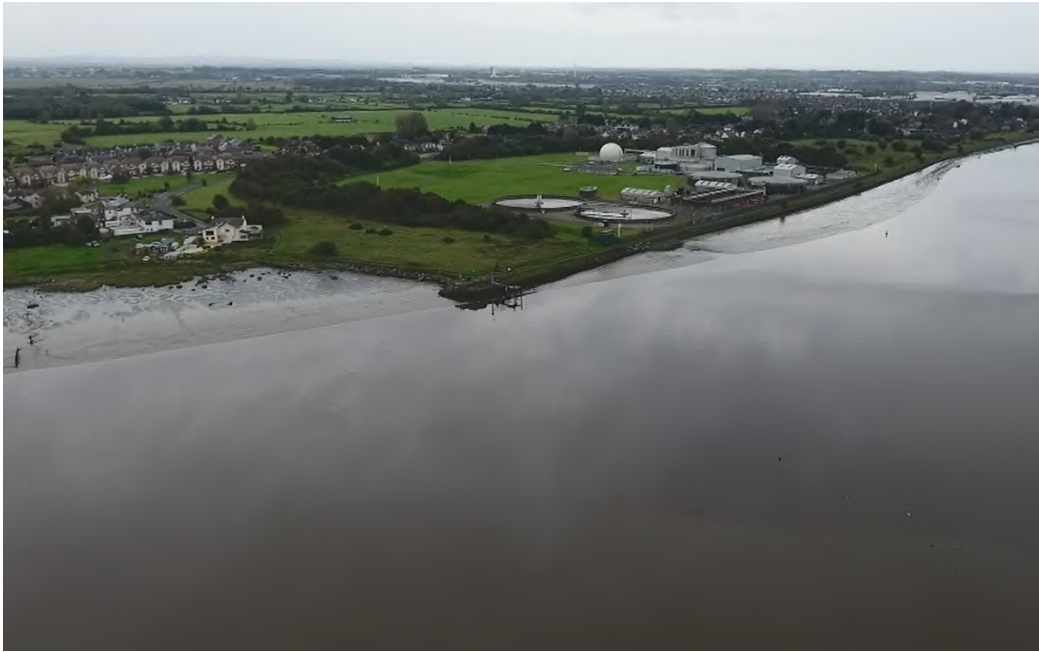
Plate 16. Aerial photograph taken at Bellurgan Point Quay at 70m elevation facing in a south-westerly direction towards Soldier's Point Wastewater Treatment Plant

The wastewater treatment plant for Dundalk is located at Soldier's Point approximately 550m to the southwest of the site across the Castletown Estuary. The discharge from this Wastewater Plant is located at its north-eastern corner which is approximately 480m to the southeast of the proposed coastal protection works.

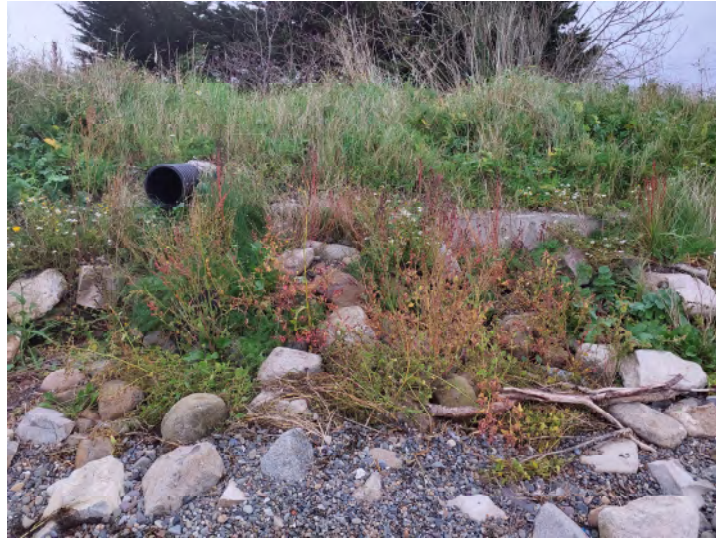
Plate 17. Ground photograph taken on the 7th October, 2023 at Chainage 212m facing in a northerly direction towards Location B Coastal Works Area showing land drainage pipe

There are no surface water bodies or land drains within the site or along the perimeter of the 3 works areas. A 10-inch land drainage pipe is located at the Location B Coastal Works area (see Plate 17 below). This pipe accepts surface water runoff from the public road and most likely only discharges onto the foreshore following extensive rainfall during the winter period. There was no evidence of soil erosion and/or channelling beneath the pipe outfall.

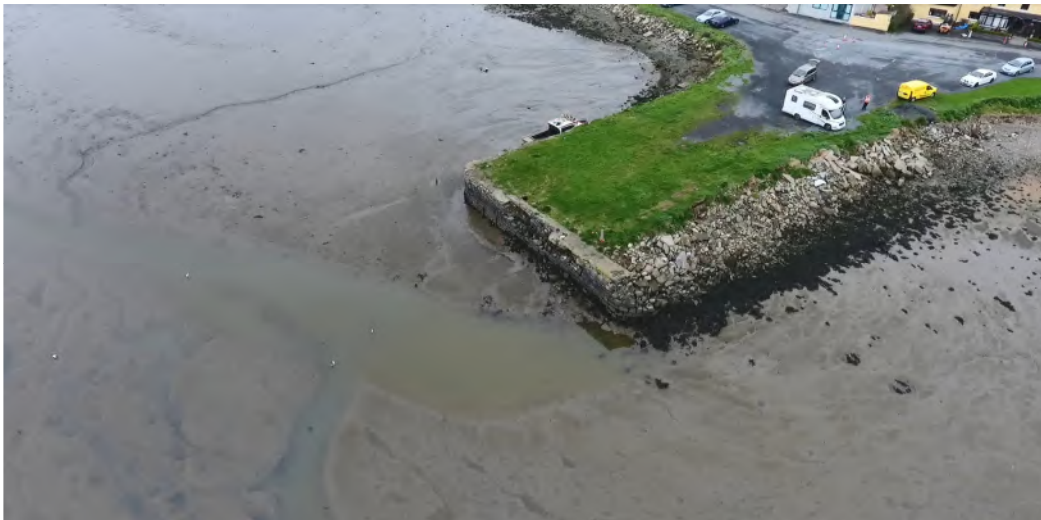
Plate 18. Aerial photograph taken at 30m elevation to the southeast of Bellurgan Quay facing in a north-westerly direction showing ponded stormwater from the stormwater outfall

A stormwater pipe is located on the south-eastern corner of Bellurgan Point Quay outside of the proposed works areas (see Figure 4 and Plate 18 below and Plate 19 following).

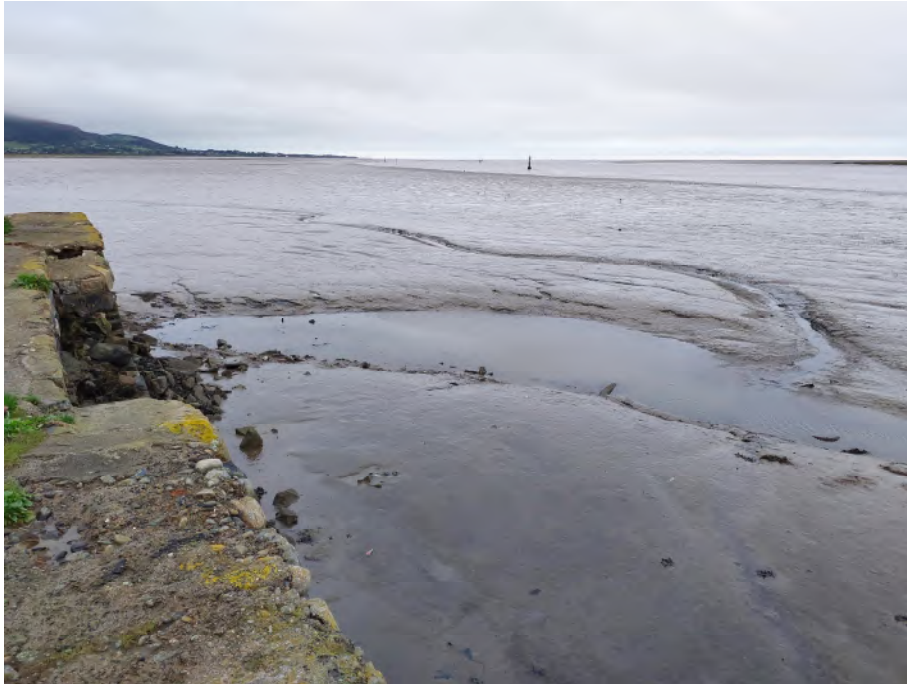
Plate 19. Ground photograph taken on the 6th October, 2023 at southern edge of Bellurgan Quay facing in an easterly direction showing stormwater outfall to southeast of quay

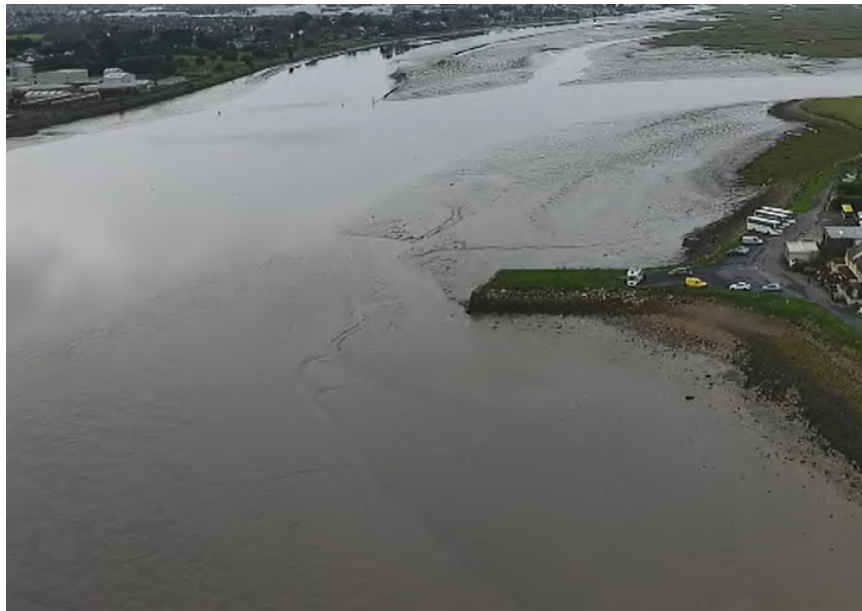
Plate 21. Aerial photograph taken at 70m elevation to the east of Bellurgan Quay facing in a westerly direction showing freshwater channel from the stormwater outfall to main Castletown river channel

As stated previously, there are no surface water bodies or land drains within the works site or along the perimeter of the site. However, there is a stormwater pipe located on the south-eastern corner of Bellurgan Point Quay discharging freshwater onto the foreshore to the south of the quay (see Figure 4 and previous Plates 18 and 19 and Plate 21 below). The freshwater channel from this outfall, which also receives freshwater from a channel flowing from the east, is visible during low tide (see Plate 21 below).

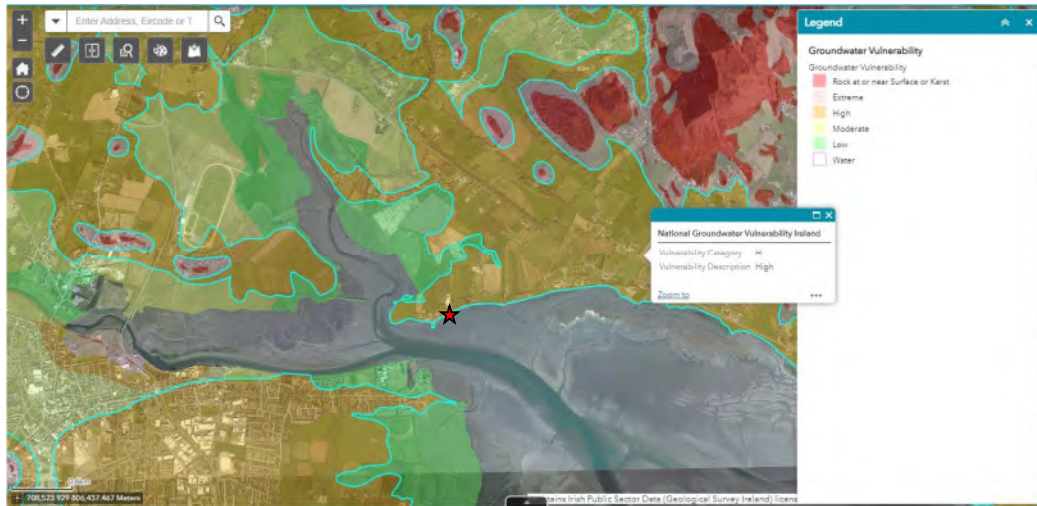
Plate 23. Groundwater vulnerability mapping for the Bellurgen Area (note red star is in the centre of the site and site’s vulnerability is ‘High’)

The site has been given an aquifer vulnerability category rating of High (H) by the GSI (see Plate 23 below and Appendix 1).

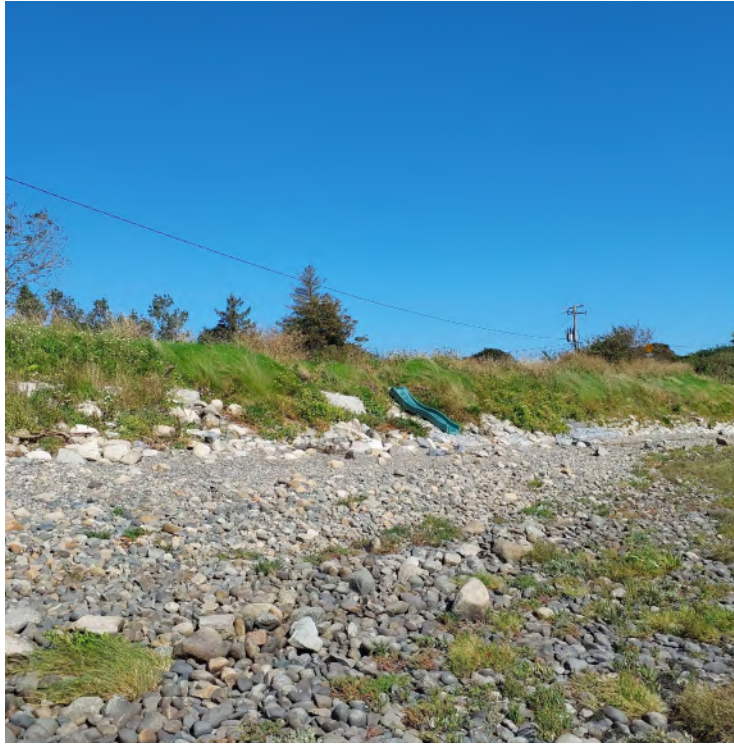
Plate 24. Ground photograph taken to the south of Location B works area facing in a north-easterly direction showing stone sea wall along Locations B and C work areas (i.e., *Sea Walls, Piers, and Jetties (CCI) habitat*)

The proposed works include replacing existing structures at Locations A and B with rock armour and repairing the existing stone sea wall at Location C works area. Varying patches of vegetation can be seen along the existing sea wall structures throughout all 3 locations. The species found along this CC1 habitat are listed in Table 3. It should be noted that an earthen sea wall exists between Chainage 20m and 60m at Location A.

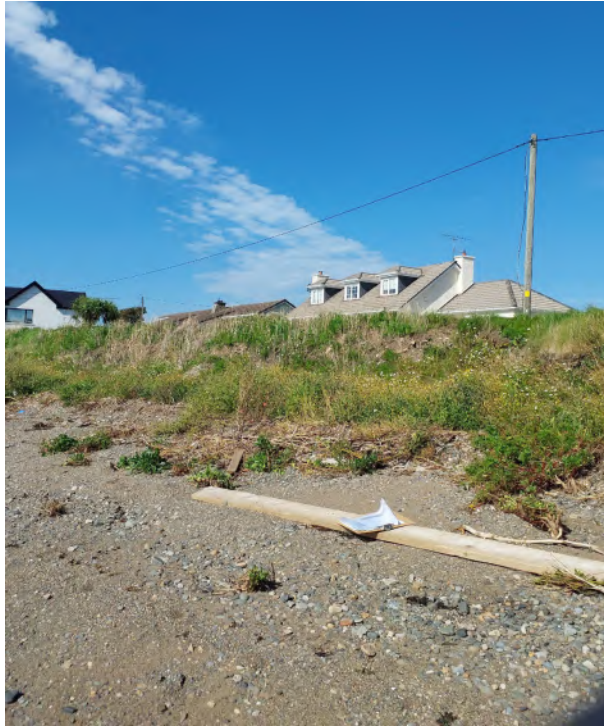
Plate 25. Annex I (Habitats Directive) habitat ‘[1220] Perennial vegetation of stony banks’ located along the upper stretch of the shore between Chainage 20m and 40m within proposed Location A Works Area

(*Raphanus raphanistrum*) and sea mayweed (*Tripleurospermum maritimum*) (see Table 4). The stretch of vegetation between approximately Chainage 20m and 160m (i.e., from within Location A to c. 40m from the southwest of Location B) includes plant species growing within stony banks along the upper shore above the high tide mark. These species conform to the Annex I (Habitats Directive) habitat '[1220] **Perennial vegetation of stony banks**', with the presence of sea sandwort (*Honckenya peploides*), curled dock (*Rumex crispus*), sea beet (*Beta vulgaris* ssp. *maritima*), sea mayweed (*Tripleurospermum maritimum*), sea radish (*Raphanus raphanistrum* ssp. *maritimus*) and lyme grass (*Leymus arenarius*) (see Plates 25 and 26 following). The width of this habitat varies along the shore. This habitat also occurs to the southwest of Location A site works. This Annex I habitat type has been listed as a designated priority habitats within the conservation objectives for Dundalk Bay SAC [000455]. Plant species found within the LS1 shore have been listed in Table 4. Coastal dry grassy verges (GS2) and improved amenity grassland (GA2) occur above this habitat along the road. A portion of this habitat, between Chainage 20m and 60m, will require removal to facilitate the construction of the rock armour at Location A. The construction of a Temporary Engineered Haul Road along Location A, and the marking out of a second Temporary Haul Road (i.e., on construction materials required) between 3-5m wide along Locations B & C will be required between the site work's southern boundaries and the High-Water Mark (HMW). Two access ramps will also be required to the immediate west of Locations A and B. These temporary works will be constructed along the *LS1-Shingle and Gravel Shore* habitat, largely in areas of unvegetated shingle. To protect areas of '[1220] **Perennial vegetation of stony banks**' along Location A, a Temporary Engineered Haul Road is required which involves the placing of a layer of pea gravel, terram, aggregate and a top layer of gravel (see Figure 12). This will aim to prevent habitat loss and offer protection from compaction caused by large machinery. This Temporary Engineered Haul Road will require carefully removal on completion of the project. Due to the lack of vegetation along Locations B and C, this second temporary haul road will not require the construction of a protective overlay.

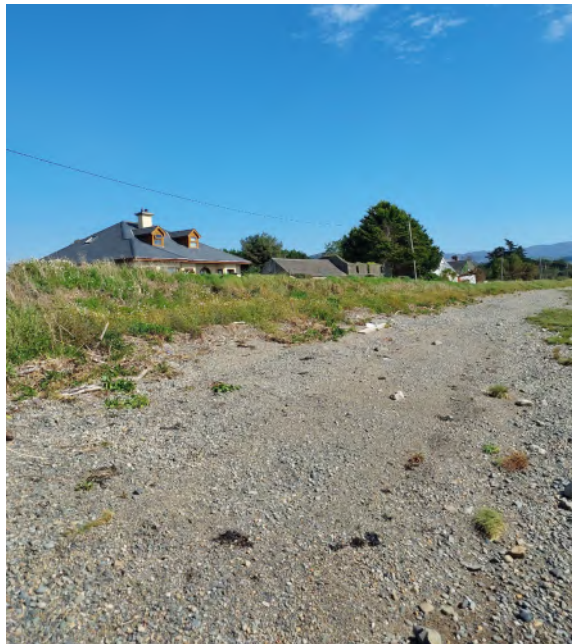
Plate 26. Annex I (Habitats Directive) habitat ‘[1220] Perennial vegetation of stony banks’ located along the upper stretch of the shore between Chainage 40m and 70m marks within and to the northeast of Location A Works Area

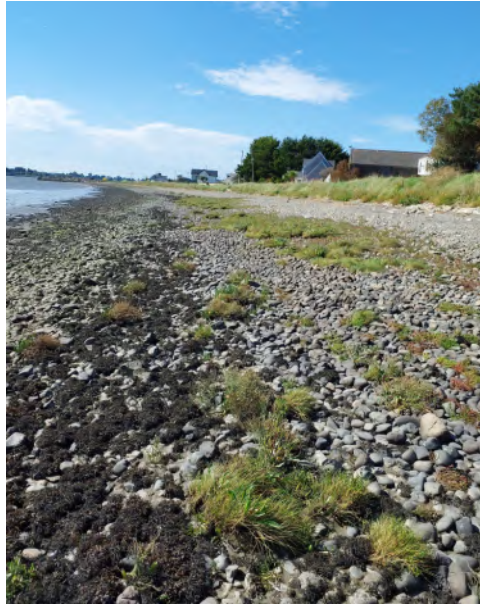
Plate 26. Ground photograph taken to the south of Location C Works Area facing in an easterly direction showing Lower salt marsh (CMI) Annex I habitat (Habitats Directive) ‘[I330] Atlantic salt meadows’ across the middle of the shingle (LS1) shore in fragmented patches.

Lower salt marsh consists of dense strands of halophytes, which are subject to more prolonged submersion by seawater in comparison to upper salt marsh. The salt marsh at Bellurgan Point is located across the middle of the shingle (LS1) shore in fragmented patches which widens to the southeast of the Location C works area to a more continuous, extensive distribution (see Figures 9 to 11 and Plates 27 & 28). The species composition across each area is identical, with laterally varying abundances of individual species. Saltmarsh habitats can be categorised by distinct zones of vegetation, which is apparent in Bellurgan Point, particularly to the eastern area of the shore. The vegetation in this habitat is comprised of both annual and perennial species such as sea lavender (*Limonium humile*), sea plantain (*Plantago maritima*), sea purslane (*Atriplex portulacoides*) and seashore aster (*Tripolium pannonicum*). These species listed are typically found between the mid shore and areas further inland. Sea lavender (*Limonium humile*), sea purslane (*Atriplex portulacoides*) and seashore aster (*Tripolium pannonicum*) are particularly abundant across all areas. Coastal salt marsh grass species recorded included red fescue (*Festuca rubra*), European beach grass (*Ammophila arenaria*) and sea arrowgrass (*Triglochin maritima*). The species found within this habitat have been listed in Table 7. Red fescue (*F. rubra*) is particularly abundant towards the upper half of the marsh in most areas. Quantities of annual seablite (*Suaeda maritima*) and glassworts (*Salicornia* spp.) are common throughout the saltmarsh but appear more conspicuous to the extremes; either further inland or lower towards the seaward region. The wider area of saltmarsh to the southeast of Location C is dominated by monocultural swards of common cordgrass (*Spartina anglica*) at the seaward edge between the shingle and mud shores (see Plate 27). This habitat continues East along the coast over a substantial area.

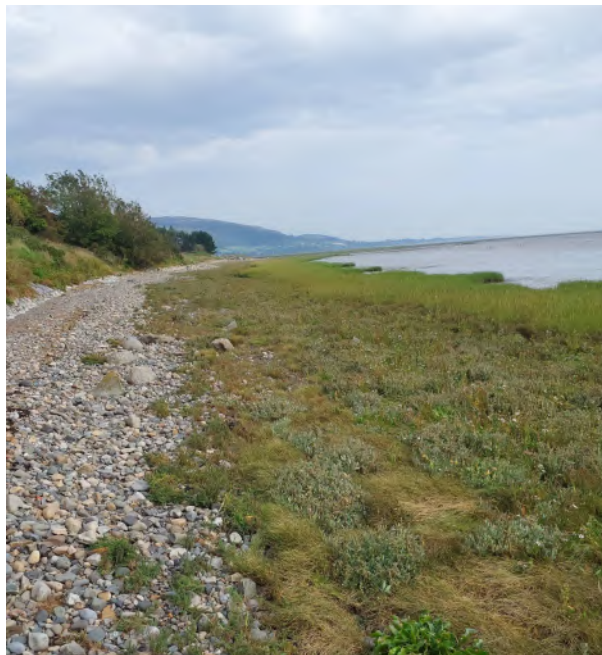
Plate 27. Ground photograph taken to the south of Location C Works Area facing in an easterly direction showing the Lower salt marsh (CM1) Annex I habitat (Habitats Directive) '*[1330] Atlantic salt meadows*' to the east of Location C Works Area

The lower saltmarsh habitat in Bellurgan Point is consistent with the Annex I habitat (Habitats Directive) '*[1330] Atlantic salt meadows*'. This habitat can be classified by distinct zones which relate to elevation and submergence factors. The seaward edge of this habitat is categorised with the presence of glassworts (*Salicornia* spp.), annual seablite (*Suaeda maritima*), lax-flowered sea-lavender (*Limonium humile*) and the invasive common cordgrass (*Spartina anglica*). The mid-marsh areas generally host species such as thrift (*Armeria maritima*) and/or sea plantain (*Plantago maritima*). This zone is generally transitional to an upper marsh herbaceous community with red fescue (*Festuca rubra*). This description corresponds with the Bellurgan Point saltmarsh areas (see Plate 27). This Annex I habitat type has been listed as a designated priority habitat within the conservation objectives for Dundalk Bay SAC [000455]. This habitat is not located within the site location and should not be directly impacted by site works, although a sufficient buffer should be put in place to protect these areas during construction. The Temporary Engineered Haul Road along location A and the Temporary Haul Road along Locations B and C on the *LSI-Shingle and Gravel Shore* has not been predicted to impact valuable lower salt marsh '*[1330] Atlantic salt meadows*' habitat. Areas of this habitat will be carefully demarcated and fenced off prior to construction, and care will be taken to avoid vegetated areas to prevent habitat loss or damage.

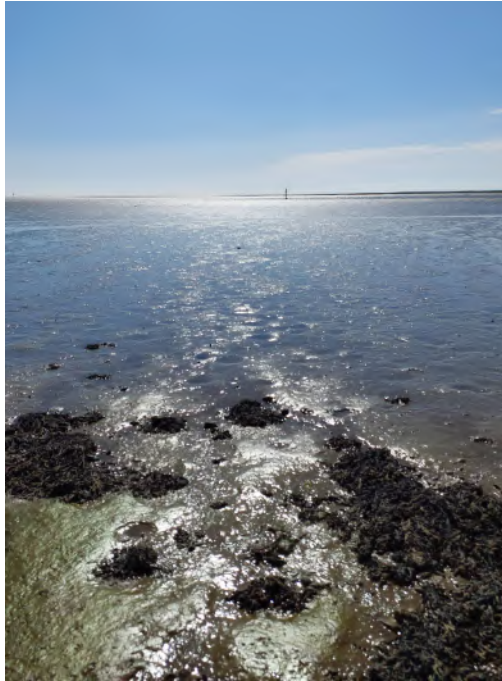
Plate 28. Ground photo of mud shore (LS4) located southeast of the site location along the lower shore which is continuous with the Annex I habitat '*[1140] Tidal Mudflats Not Covered by Seawater at Low Tide*'.

The mud shores are continuous with the Annex I habitat (Habitats Directive) '**[1140] Tidal Mudflats and Sandflats Not Covered by Seawater at Low Tide**'. The mudflats at Bellurgan Point are finely packed fine sediments enabling anoxic conditions in underlying sediments (see Plates 28 and 29). These habitats are typically devoid of vascular plants; but they support algal communities and beds of *Zostera* spp. They are of particular importance as feeding grounds for wildfowl and waders. No *Zostera*

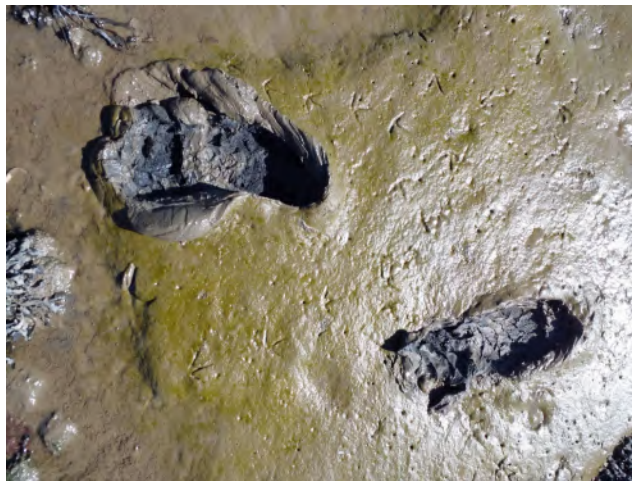
Plate 29. The composition of the mud shore (LS4) located southeast of the site location along the lower shore, with underlying anaerobic conditions (note bird tracks and possible worm holes)

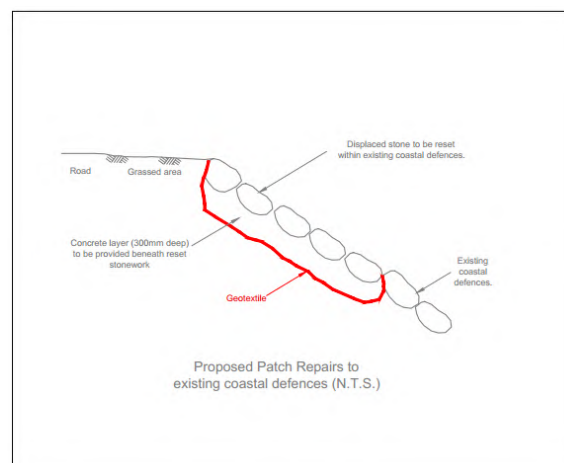
Plate 31. Extract of civil engineering drawings for proposed Coastal Works at Bellurgan showing section through proposed stone sea wall for Locations C Work Area

To repair the stone sea wall at Location C works area, it is proposed to initially remove the displaced stonework over an area of approximately 100m². Following this, a geotextile membrane will be placed in the excavation and spread on side walls of the excavation. Then a 300mm layer of concrete will be put in place with the original stone then set into the concrete and allowed to set (see Plate 31 following).
