LOUTH COUNTY COUNCIL

NATURA IMPACT STATEMENT

PROPOSED COASTAL PROTECTION WORKS,

DRUMMULLAGH, OMEATH, CO. LOUTH

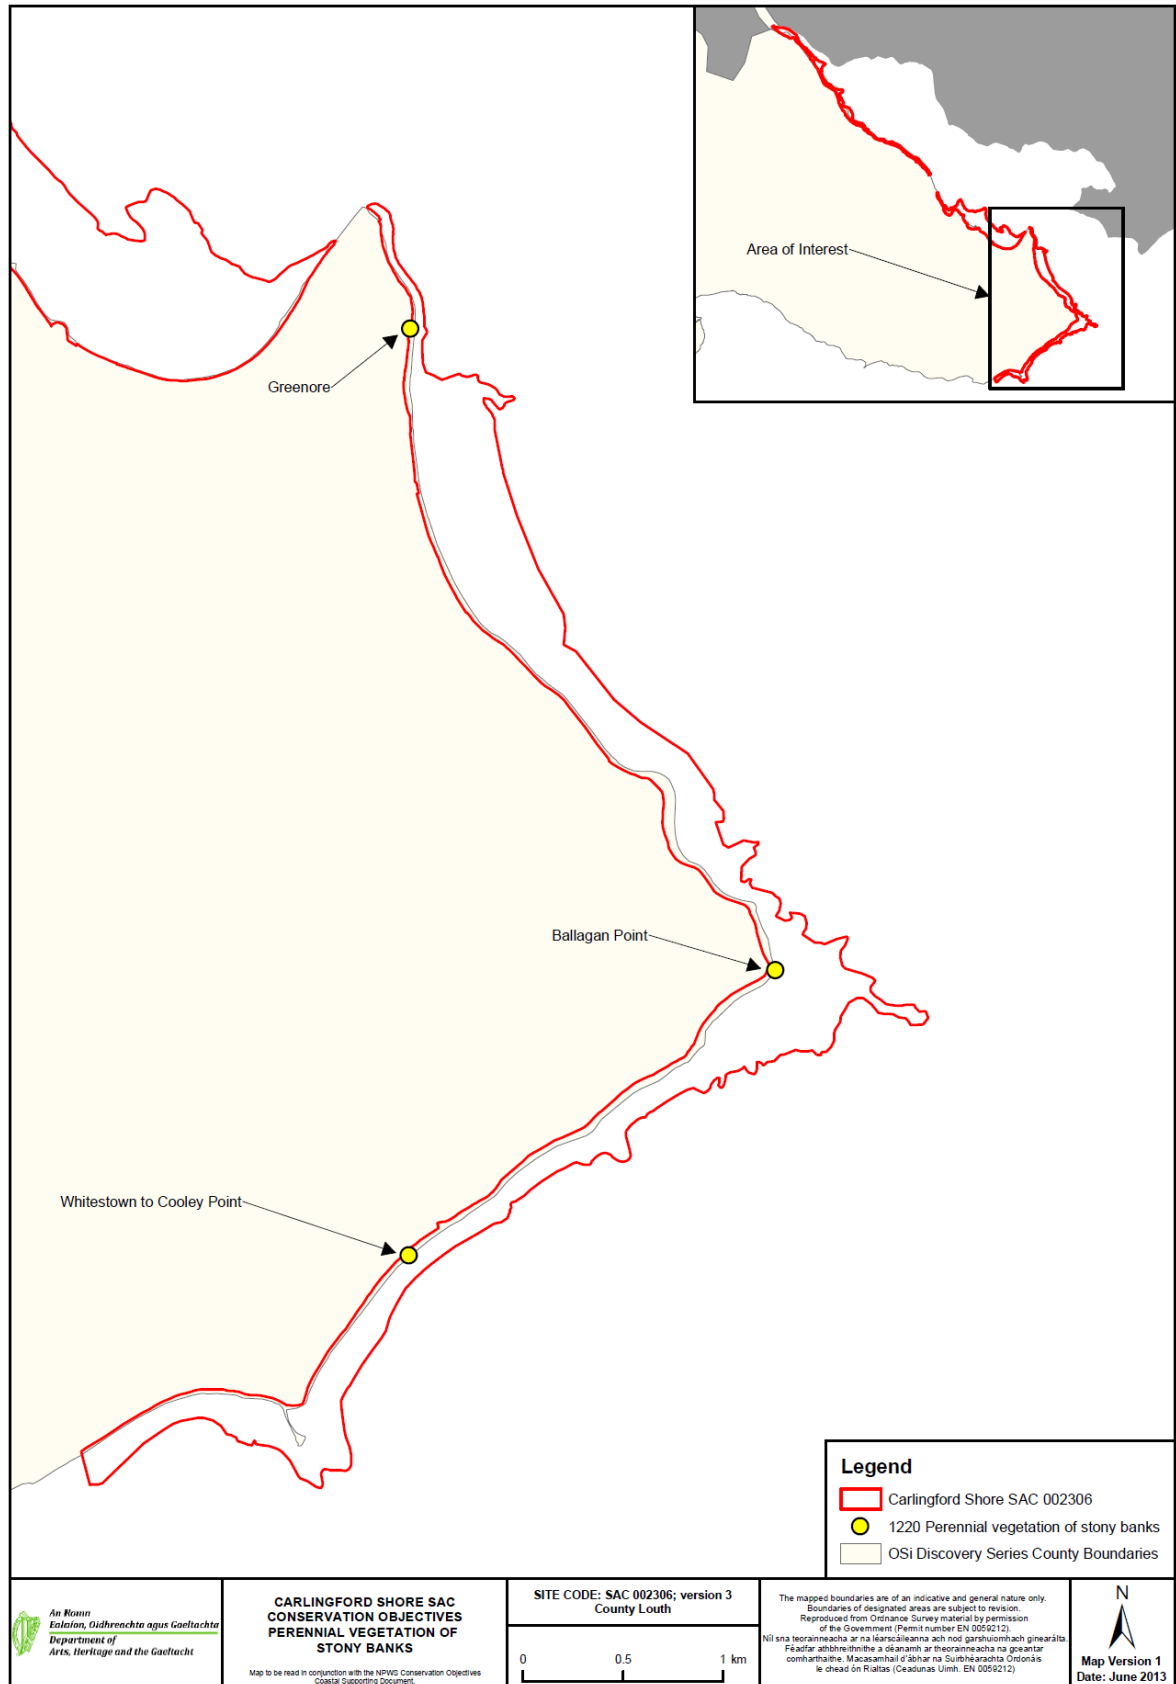
Appendix I: Distribution map of known shingle sites within Carlingford Shore SAC, as identified during the National Shingle Beach Survey (Moore & Wilson, 1999)
