LOUTH COUNTY COUNCIL

NATURA IMPACT STATEMENT

PROPOSED COASTAL PROTECTION WORKS, BALLYNAMONY (MURPHY), BALLAGAN, GREENORE, Co. LOUTH

VOLUME I. REPORT

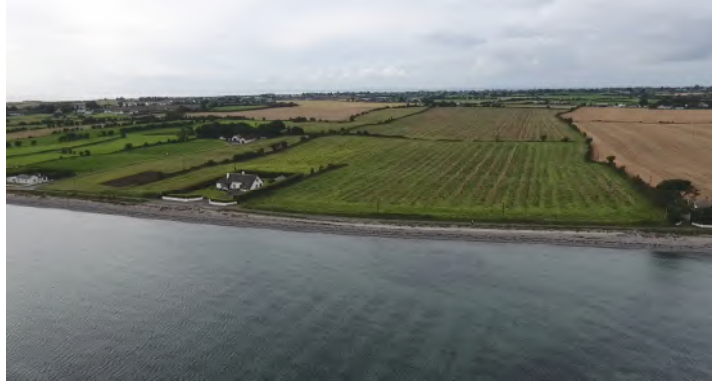
Plate 1. Aerial photograph taken at 50m elevation taken from seaward facing in an easterly direction towards proposed coastal works protection area which is approximately 245m in length

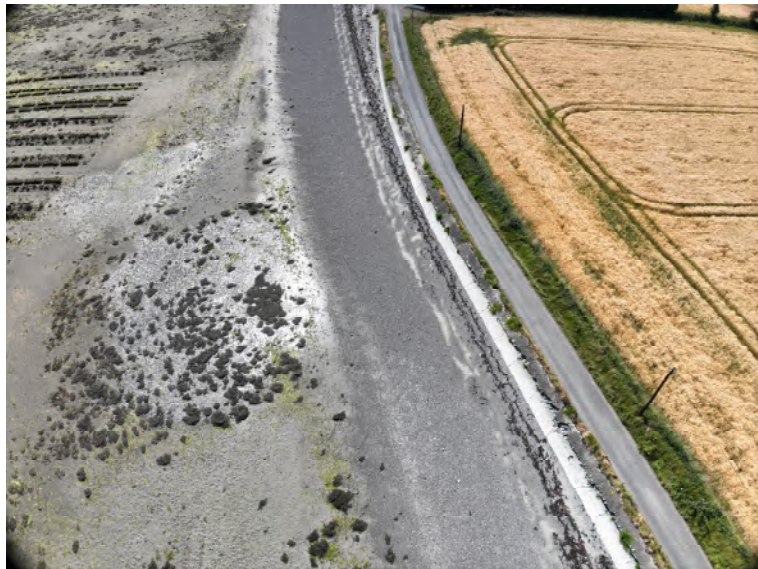
Plate 2. 4K Aerial photograph taken at 40m elevation over foreshore facing in a southerly direction showing the northern end of the damaged seawall with collapsed concrete capping

It is understood that the current coastal protection infrastructure was constructed at Ballynamony (Murphy), Ballagan some time ago. This consists of a wall of concrete approximately 1.2m to 1.3m high that appears to have been constructed against a rock armour consisting of various sizes of rounded and subrounded marine boulders which were collected from the shore (see Plate 2 below).

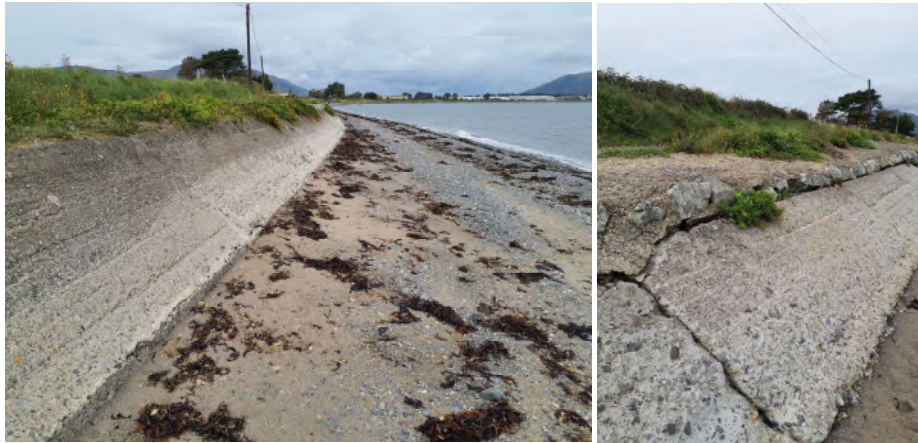
Plate 3. Ground photographs of seawall with crack caused by sea erosion

This wall has been damaged in places with wave action undermining its foundation or seawater penetrating through cracks/breaks and washing out the gravel and boulders behind the wall (see Plate 3 below).

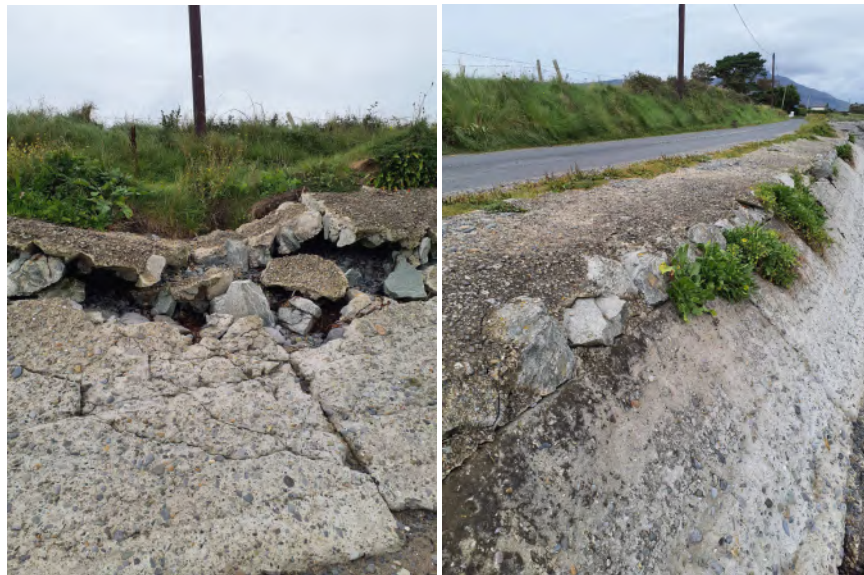
Plate 4. Concrete cap along seawall showing evidence of erosion at the cap seawall interface at the top and where the cap and seawall have collapsed exposing the gravel and boulder foundations to erosion

At certain sections of the seawall a concrete cap was placed on top. This cap runs to the edge of the roadway. The cap has collapsed downwards at a number of locations with the seawall then collapsing towards the roadway and exposing the boulders and gravel behind the seawall to wave action and subsequent erosion (see Plate 4 below and following Plate 5).

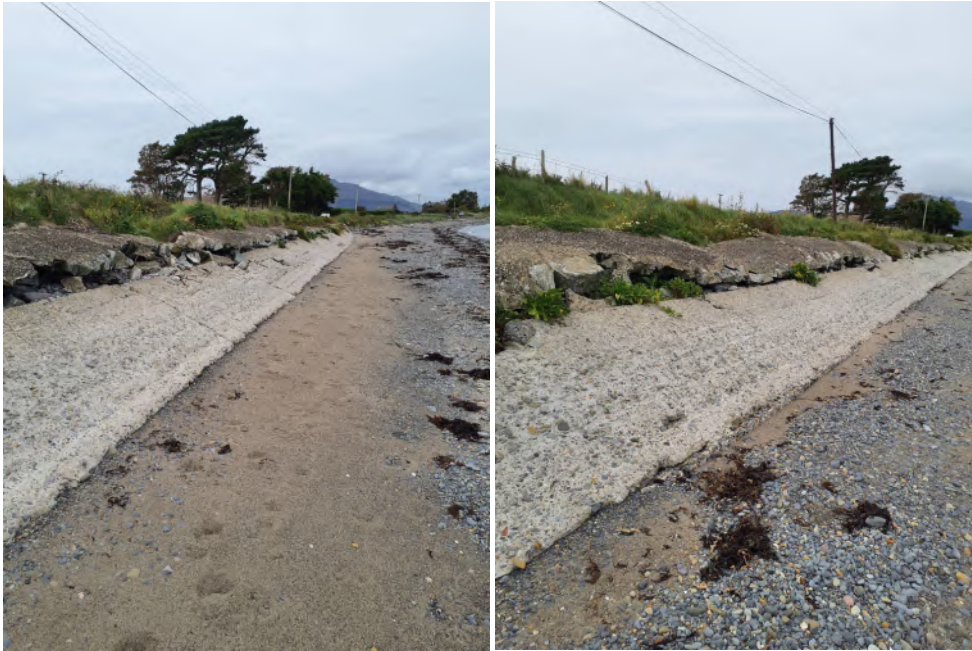
Plate 5. Areas along seawall where concrete cap has completely collapsed and buckled inwards

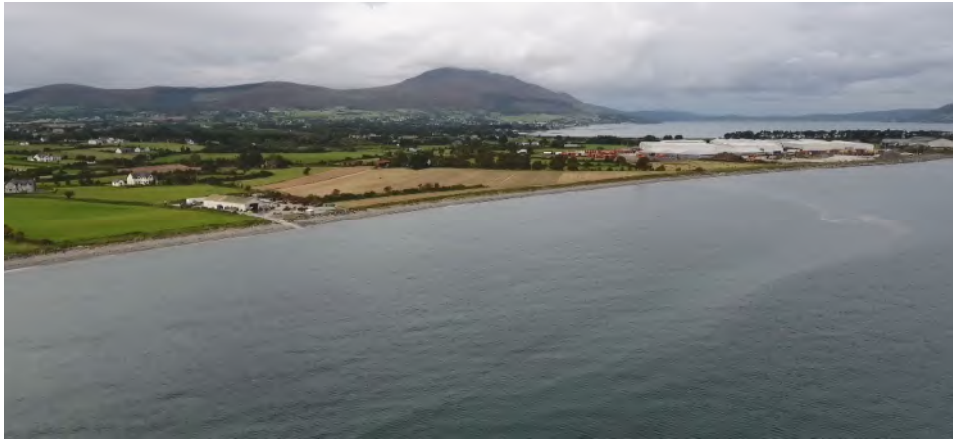
Plate 6. Aerial photograph taken at 50m elevation to the east of the site facing in a north-westerly direction towards Greenore Port (note Hanlon's Transport yard on the right and Cooley Oyster farm with slipway on left)

The proposed coastal protection works site at Ballynamony (Murphy), Ballagan is approximately 245m by 3m in footprint and is located on the eastern edge of a country road which runs in a north to south direction. The site is approximately 2km to the southeast of Greenore Port (see Plates 6 and 7 below). The foreshore to the northeast and east of the site is populated with oyster beds that are farmed by Cooley Oysters Ltd. whose facility is located approximately 520m to the north of the site (see Figure 4 and following Plates 8 and 9 following).

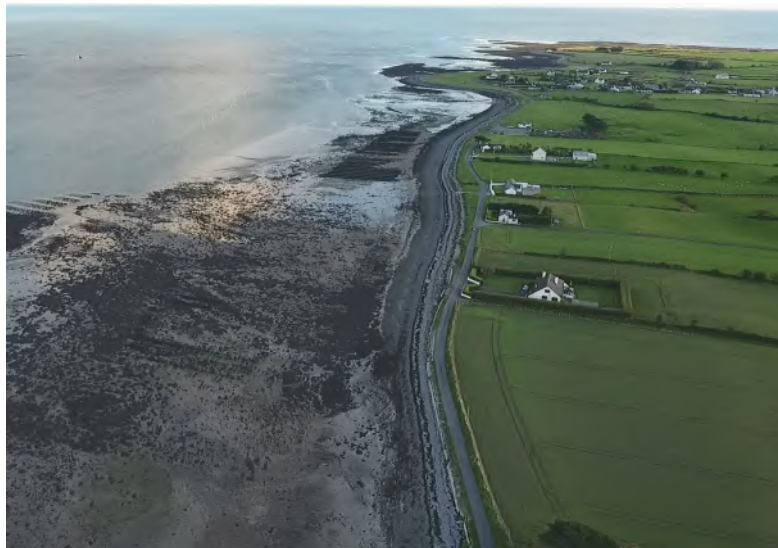
Plate 7. Aerial photograph taken at 50m elevation to the north of the site facing in a southerly direction at low tide (note oyster beds on foreshore to the east and southeast of the proposed coastal protection works area)

This habitat category includes aquacultural areas such as commercial fish and shellfish farms that can occur in coastal waters or freshwater habitats and lagoons at varying distances from the shore. Oyster beds comprised of shellfish rafts are farmed by Cooley Oysters Ltd and are located in the open water to the northeast and east of the site (see previous Plate 7).

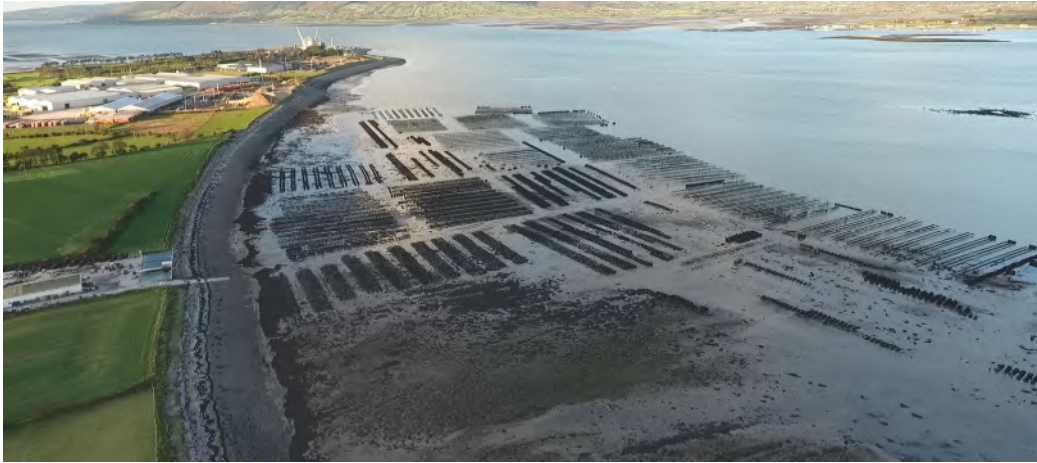
Plate 8. Aerial photograph taken at 50m elevation to the north of the site facing in a northerly direction at low tide towards beds farmed by Cooley Oysters along foreshore (note tractors working on oyster beds to the right)

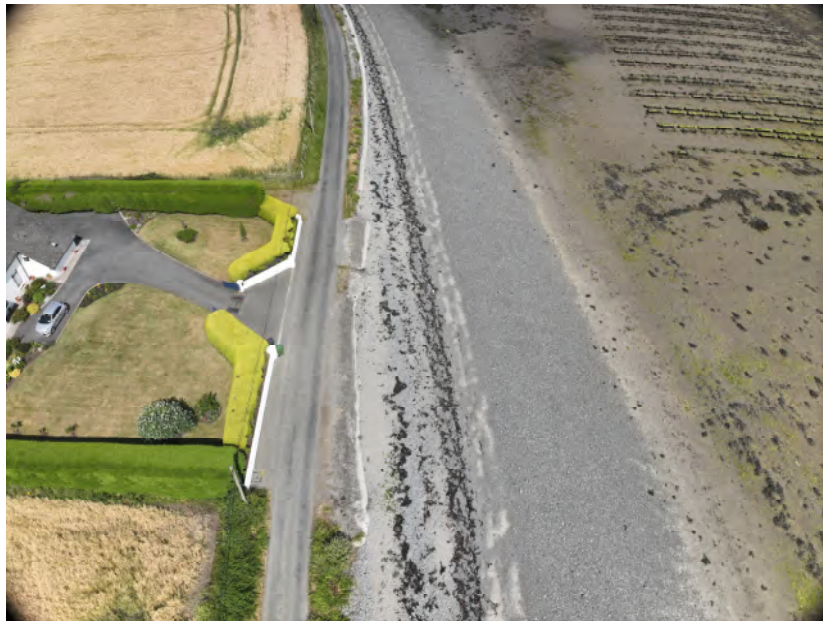
Plate 9. Aerial photograph taken at 40m elevation at the southern end of the proposed coastal protection works area facing in a northerly direction (note oyster bed to the right i.e., the east)

There are 5 residences within 100m of the edge of the proposed coast protection works with 1 residence directly to the west of the proposed coastal protection works (see Figures 7 and 8 and Plate 9 below).

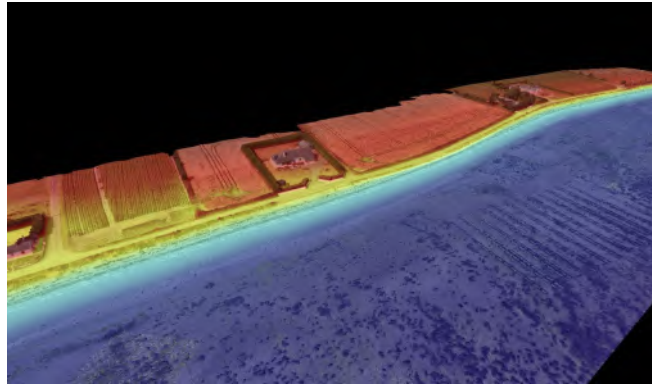
Plate 11. Extract of Dronedeploy 3D Elevation Model

The agricultural land to the west of the road is relatively flat with the exception of 2 isolated low-lying depressions to the south of the site where groundwater springs may exist. The overall regional topography of the area is characterised by the land closest to the site sloping gently from west to east towards the foreshore (see Plate 11 following).

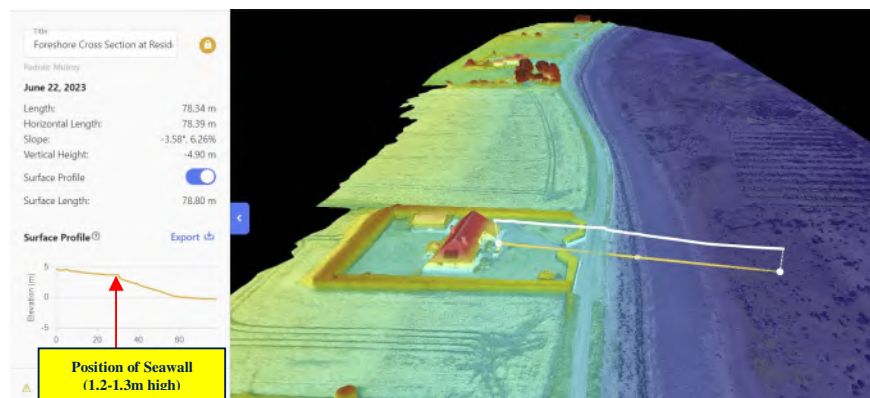
Plate 12. Cross-section through residence, road, seawall and foreshore prepared using Dronedeploy 3D Elevation Model

The northeastern edge of the road adjacent to the works area has an elevation of 3.696m AOD at Chainage 0 (see proposed works layout in Figures 11 to 14). The elevation increases to 3.814m AOD at Chainage 60 and then decreases to 3.627m AOD at Chainage 120. The elevation then remains at approximately 3.62m AOD until the end of the works area at Chainage 229. The following plate, Plate 12 shows a section through the adjacent residence's front garden, the adjacent road, the seawall and down onto the foreshore. As can be seen from the section to the left of Plate 12, the elevation varies from approximately 4.65m AOD to 0m AOD (i.e., sea level) approximately 80m to the east on the foreshore. This consists of a wall of concrete approximately 1.2m to 1.3m high that appears to have been constructed against a rock armour consisting of various sizes of rounded and subrounded marine boulders which were collected from the shore (see Plate 12 below).

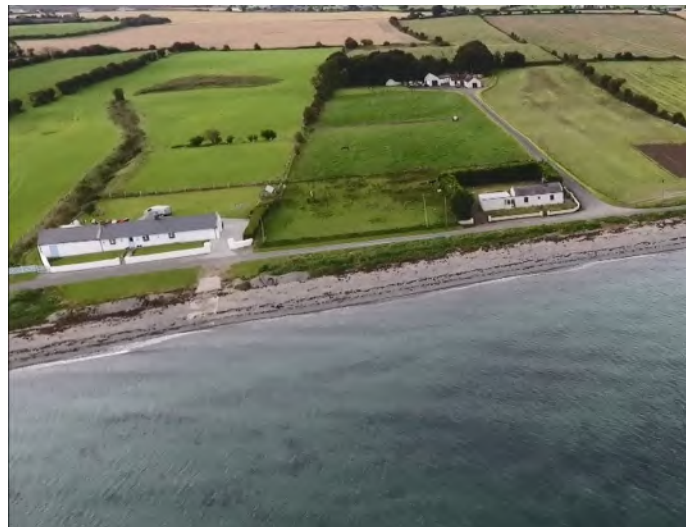
Plate 14. Aerial photograph taken at 40m elevation to the southwest of the proposed coastal protection works area facing in a westerly direction (note position of licensed slipway)

The foreshore to the east of the proposed coastal works area is also farmed under licence for oysters (see Figures 7 & 8 and Plate 14 below). This area is currently accessed by a licensed slipway and haul road which runs along the foreshore to provide access to the various licensed areas (see Plate 14 below).

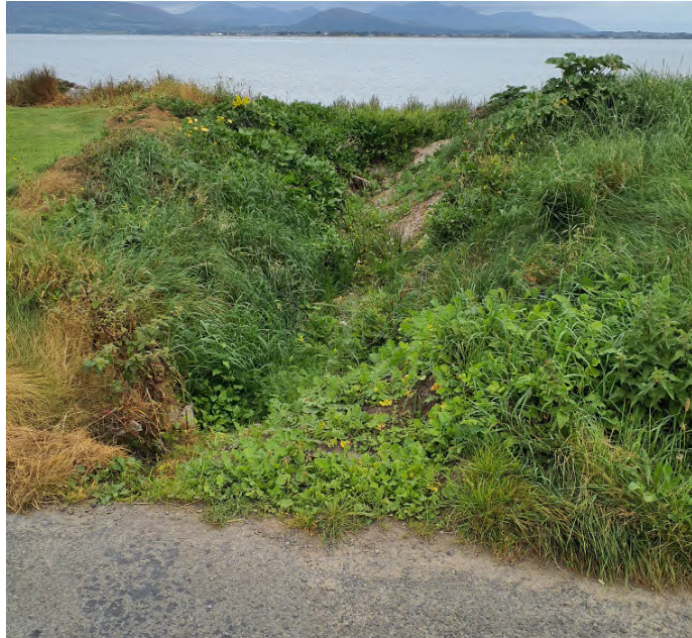
Plate 15. Ground photograph of land drain 135m to the southeast of the site facing in a northerly direction before its discharge on to the foreshore (note land drain was dry during the inspection)

As stated previously, there are no surface water bodies or land drains within the works site or along the perimeter of the site. However, there is a land drain located approximately 150m to the southeast of the site which flows in a southwest to northeast direction and which is culverted under the country road and discharges on to the foreshore. During the site inspection no water was observed in this land drain. The source of water for this land drain is most likely 2 small ponds/waterlogged areas located approximately 320m to the southeast and 430m to the east of the proposed coastal protection works (see Figure 3 and Plate XX below).

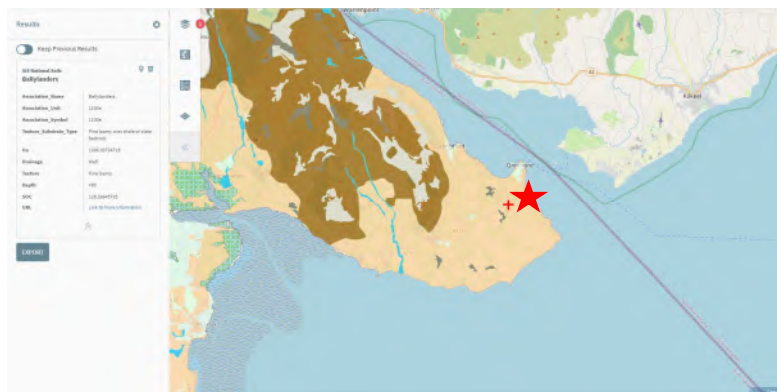
Plate 16. Topsoil mapping for site showing Soil Associations such as Ballylanders (note red star indicates the location of the subject site) (from EPA/Teagasc database)

The formation of topsoil is known as the '*pedogenic*' process. The General Soil Map of Ireland, published by An Foras Talúntais (1980) indicates that the predominant or principal soil type in the Greenore area is Soil Association No. 14 with the Principal Soil identified as *Acid Brown Earths* (75%) with associated '*Secondary*' soils *gleys* (15%) and brown *podzolics* (10%). A National Soil Mapping Project carried out jointly by the EPA and Teagasc has identified the footprint of the site as soil type *AminDW, well drained mineral material*. Reference to the National Soil Map of Ireland (SIS National Soils) published recently and jointly by the EPA and Teagasc indicates that the predominant or principal soil type in the Greenore Area is Soil Association '*1110e Ballylanders – Fine loamy over shale and slate bedrock*' (see Plate 16 below). Approximately 310m southwest of the site another soil type found in the Greenore area is that of *Clonroche* soil types. This soil is described as *fine loamy drift with siliceous stones*, it has a fine loamy texture and has good drainage capabilities. About 400m to the southwest of the site, an area of *Peat* is located. This has not been assigned to any soil association. It should be noted that to the west of the site, the soil type present is '*Carrigvahanagh- Peat over lithoskeletal acid, igneous rock*'. This soil has a peaty texture with imperfect drainage capabilities. The locations of these soil types are indicated on extracts from the EPA maps which can be seen in the Appendix 1. Based on Mulroy Environmental's site-specific observations during the inspection of the foreshore, the general classification for the area is considered appropriate for the site.

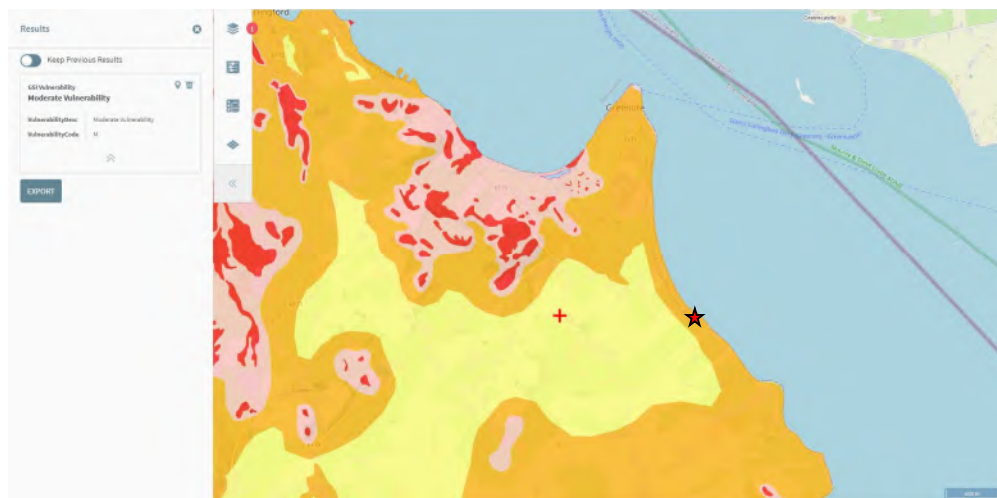
Plate 18. Groundwater vulnerability mapping for the North-Eastern end of the Cooley Peninsula (note red star is in the centre of the site and site's vulnerability is 'High')

The site has been given an aquifer vulnerability category rating of High (H) by the GSI (see Plate 18 below and Appendix 1).

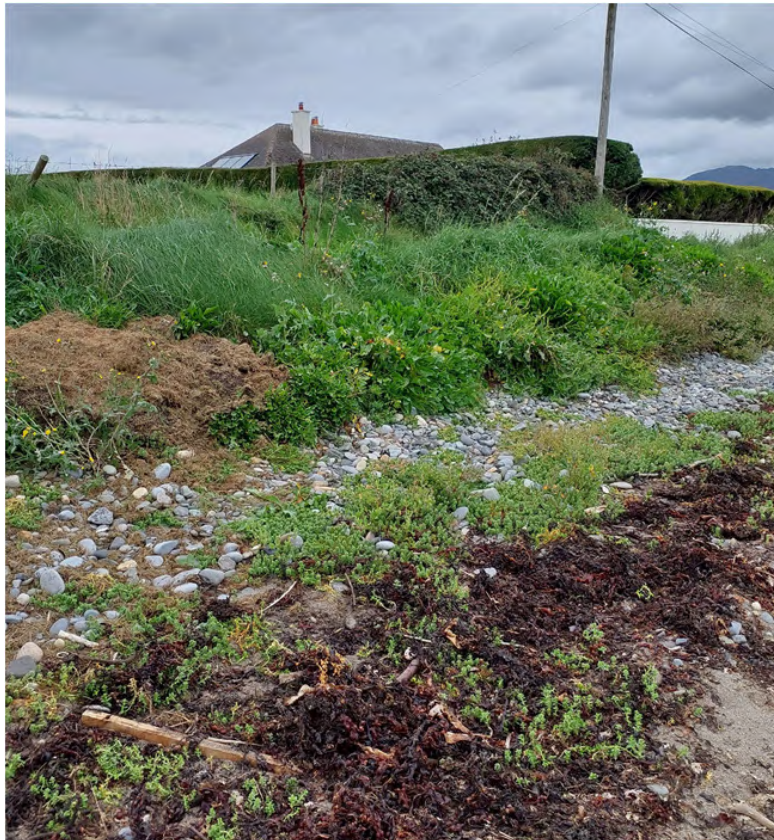
Plate 19. Annex I (Habitats Directive) habitat '*Annual Vegetation of Drift Lines 1210*' and '*Perennial vegetation of stony banks 1220*' located between the c. 189-metre and 220-metre mark within the site (note cut lawn grass dumped on top of the vegetation)

Accumulations of shingle and gravel (i.e., mostly 4-256mm in diameter) were noted along the semi-exposed shoreline along with occasional shell fragments (see Figures 9 & 10). This band of shingle and gravel is itself divided between an upper stretch above the high-water mark, which is vegetated, and a lower stretch which is composed of bare stones, cobble etc (see following Plate 19). This shingle and gravel shore habitat is located along the existing coastal protection structures throughout the site location. A strandline runs along the entirety of the upper shore above the high tide mark, comprised of predominantly dead and dried out brown and red seaweed species. Beach fleas and sand hoppers were noted along the decaying seaweed. Some sparse bouts of sea sandwort (*Honckenya peploides*) occur along the driftline from the 180-metre mark along the southeast within the site location, which loosely resembles the Annex I (Habitats Directive) habitat 'Annual Vegetation of Drift Lines 1210' (see Table 4). This occurs occasionally further outside of the site boundary to the southeast and the northwest. Occasional frequencies of other accompanying annual plant species along the driftline, including narrow-leaved saltbush (*Atriplex littoralis*), triangle orache (*Atriplex prostrata*), sun spurge (*Euphorbia helioscopia*) and knotgrass (*Polygonum aviculare*), signals the presence of small, typically fragmented areas of the Annex I habitat 'Annual Vegetation of Drift Lines 1210' along the upper stretch of the shore outside the site location, southeast past the 240-metre mark (see Plate 19).

The stretch of vegetation that follows the sea wall between the 189-metre mark and the 240-metre mark to the southeast of the site includes plant species growing within stony banks along the upper shore

above the high tide mark. These species conform to the Annex I (Habitats Directive) habitat '*Perennial vegetation of stony banks 1220*', with the presence of sea sandwort (*Honckenya peploides*), curled dock (*Rumex crispus*), sea beet (*Beta vulgaris* ssp. *maritima*), sea mayweed (*Tripleurospermum maritimum*), sea radish (*Raphanus raphanistrum* ssp. *maritimus*) and lyme grass (*Leymus arenarius*) (see Plate 19 below). Vegetated stony banks are thought to occur in a mosaic with annual vegetation of drift lines, which is apparent in Ballynamony (Murphy), Ballagan shore. Further southwest beyond the site boundary, plant species within these habitats have experienced disturbance caused by sediment and cut lawn grass dumping, littering, and fragmentation caused by the construction of a concrete slipway (see following Plates 20 and 21). Both of the above Annex I habitat types have been listed as designated priority habitats within the conservation objectives for Carlingford Shore SAC (002306). Plant species found within the LS1 shore have been listed in Table 4. Coastal dry grassy verges occur in tangent with these habitats further up shore closer to the Ballytrasna road along the stony bank vegetation. This habitat widens further southwest beyond the site boundary.

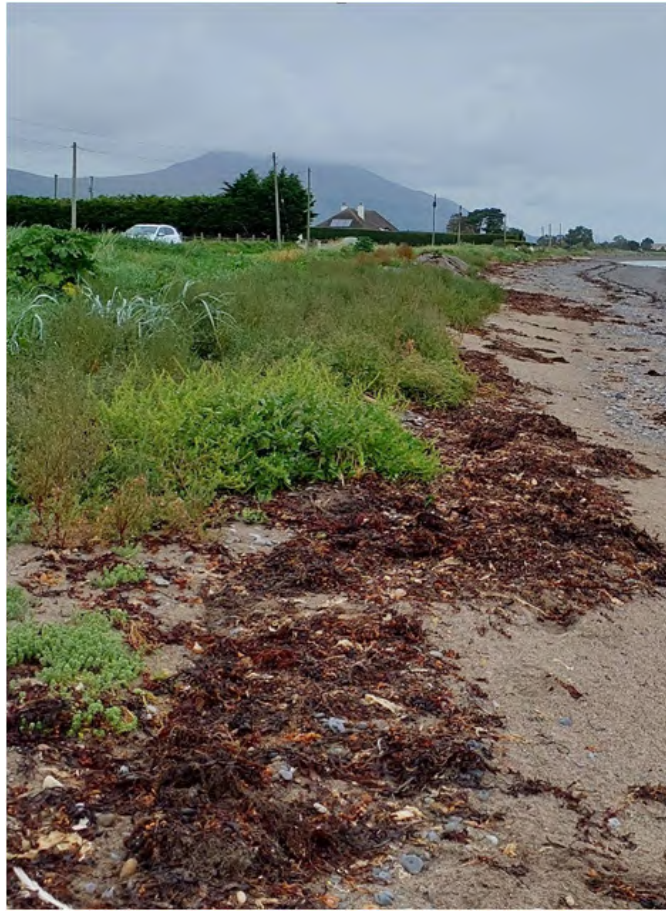
Plate 20. Annex I (Habitats Directive) habitat ‘Annual Vegetation of Drift Lines 1210’ and ‘Perennial vegetation of stony banks 1220’ located along the upper stretch of the shore outside the site location, southeast past the 240-metre mark.

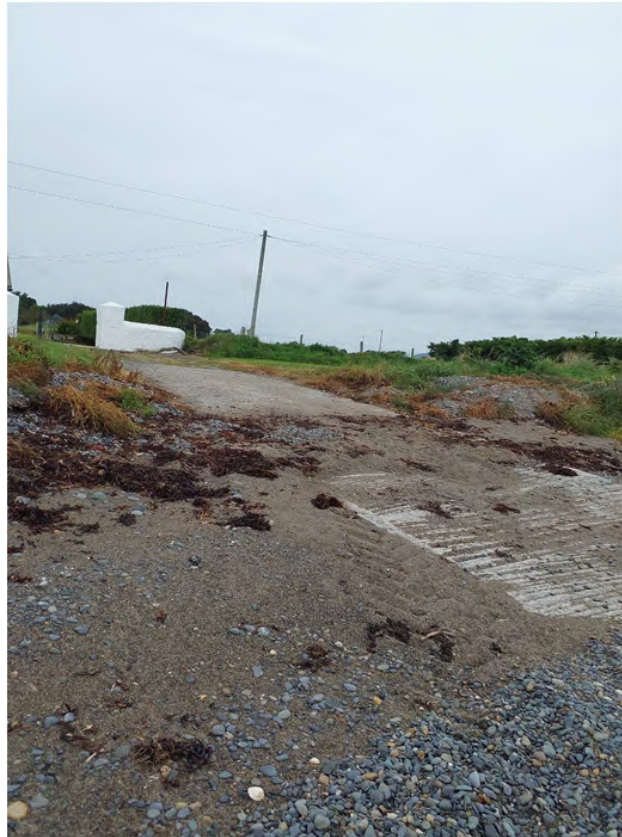
Plate 21. The concrete slipway and sediment dumping accumulations on top of vegetation to the southwest of the site boundary.

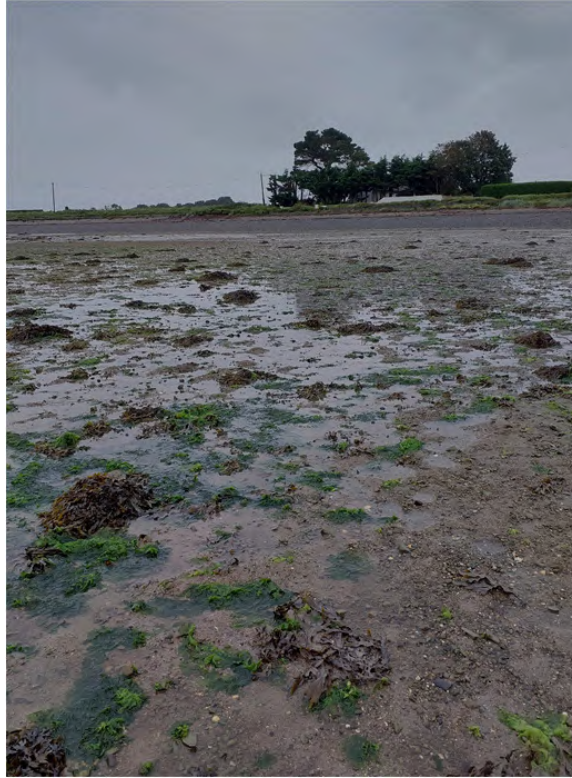
Plate 22. Mixed substrata shore with heavy accumulations of ephemeral green seaweeds (*Ulva* and *Cladophora* spp.).

A mixed substrata shore comprises of rock and sediment, of which includes gravel, sand, or mud (see Figures 9 & 10). Ballynamony (Murphy), Ballagan shore is moderately exposed, and the lower littoral area can be classed as predominantly a mixed substrata shore, although sandy shore areas occur, mostly across the northwest area of the shore. Within the mixed substrata shoreline, there is a large proportion of stone, gravel and sand (see Plate 22). Shell fragments and scattered rocks occur across the shore surface. The furoid seaweed communities are similar to rocky shore habitats, although they occur more sporadically with less percentage cover. The upper to mid-shore is typically dominated by bladder wrack (*Fucus vesiculosus*) and spiralled wrack (*Fucus spiralis*), with frequent occurrences of serrated wrack (*Fucus serratus*). The abundance of serrated wrack and egg wrack (*Ascophyllum nodosum*) cover increased further down along the lower shore. Heavy accumulations of ephemeral green seaweeds (*Ulva* and *Cladophora* spp.) and occurrences of ephemeral red seaweeds (*Porphyra* spp.) were evident across this shore (see following Plate 22). A list of seaweed species encountered can be seen in Table 6. Epifaunal cover increased towards the lower shore with increased rock cover, with barnacles and evidence of common mussel (*Mytilus edulis*) and limpets (*Patella* spp.).

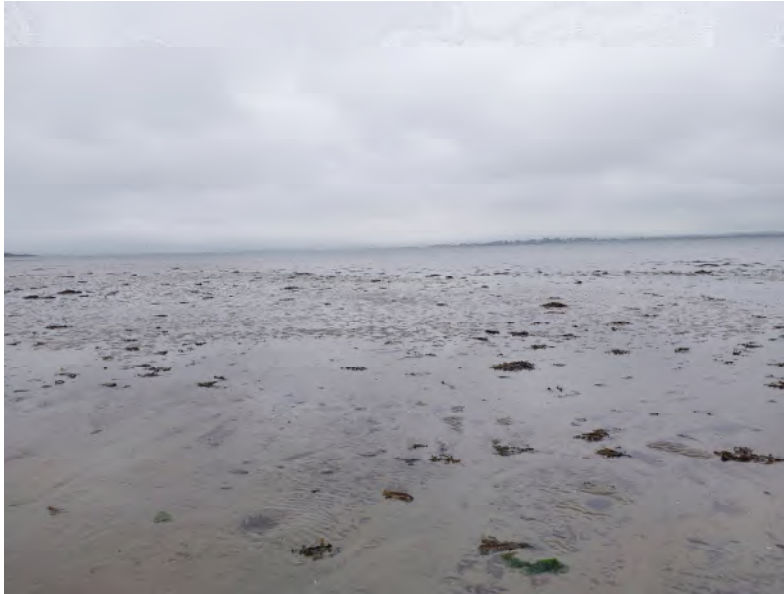
Plate 23. Sandy shore (LS2) located northwest of the site location along the lower shore

Sand shores can be sheltered to exposed shores of coarse, medium or fine-grained sand, typically with a very small proportion of gravel and mud (<10%). Sediment particles range from 0.063-4 mm in diameter. A stretch of sandy shore can be seen along the lower shore to the northwest of the 0-60 metre mark of the site location and along other patches to the northeast (see following Plate 23 and Figures 9 & 10). This area is flat and typically supports scarce occurrences of seaweed, of which the species composition is akin to mixed substrata areas (see Table 6). Lugworm (*Arenicola marina*) casts and holes were frequent throughout the habitat. Lower sand shores may also support communities of amphipod (*Pontocrates* spp., *Bathyporeia* spp., *Haustorius arenarius*) and isopod (*Eurydice pulchra*) crustaceans, along with some polychaete worms (*Scolelepis squamata*, *Nephtys cirrosa*, *Lanice conchilega*).
