# LOUTH COUNTY COUNCIL

## NATURA IMPACT STATEMENT

## PROPOSED COASTAL PROTECTION WORKS, DRUMMULLAGH, OMEATH, CO. LOUTH

### VOLUME I. REPORT

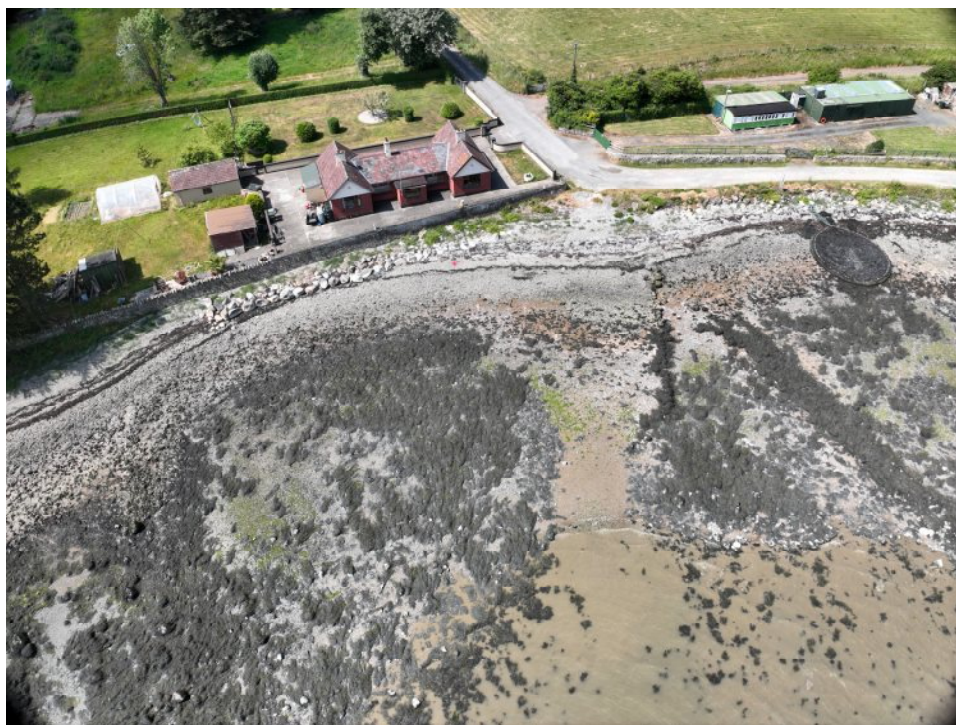
**Plate 1. 4K Aerial photograph taken at an elevation of 40m above ground level approximately 100m to the east of the site facing in a westerly direction towards the location for the proposed coastal protection works located to the east of the residence**

Louth County Council wishes to carry out coastal protection works at a site located at Drummullagh, Omeath, County Louth (see Figures 1-5 and Plate 1 below). It is understood that rock armour was constructed at Drummullagh at some point in the past along the foreshore which extends from the southeastern corner of the existing residence to a location approximately 150m to the north of the site. A section of this rock armour adjacent to a residence has been damaged in recent years with boulders moved by wave action during storm conditions away from their original location adjacent to the eastern boundary wall of the residence. Louth County Council proposes to provide additional coastal protection at this location in order to improve and augment the existing rock armour. The proposed works are intended to have a lifespan in excess of 50 years, thereby providing long term protection to the existing residence. Subject to planning approval, the proposed works are likely to take 2 – 4 weeks to construct.

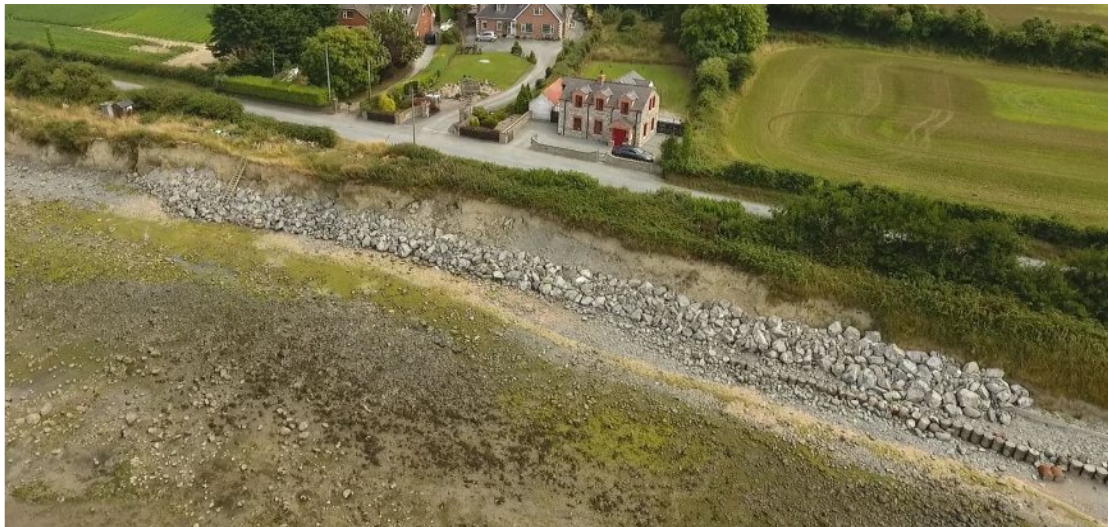
**Plate 2. Aerial photograph of rock armour constructed to prevent coastal erosion at Salterstown, Annagassan, County Louth.**

The following plate, Plate 2 shows a photograph of previous rock armour works carried out by Louth County Council at Salterstown, Annagassan, County Louth. The works carried out in Salterstown were very similar to those works proposed for Drummullagh.

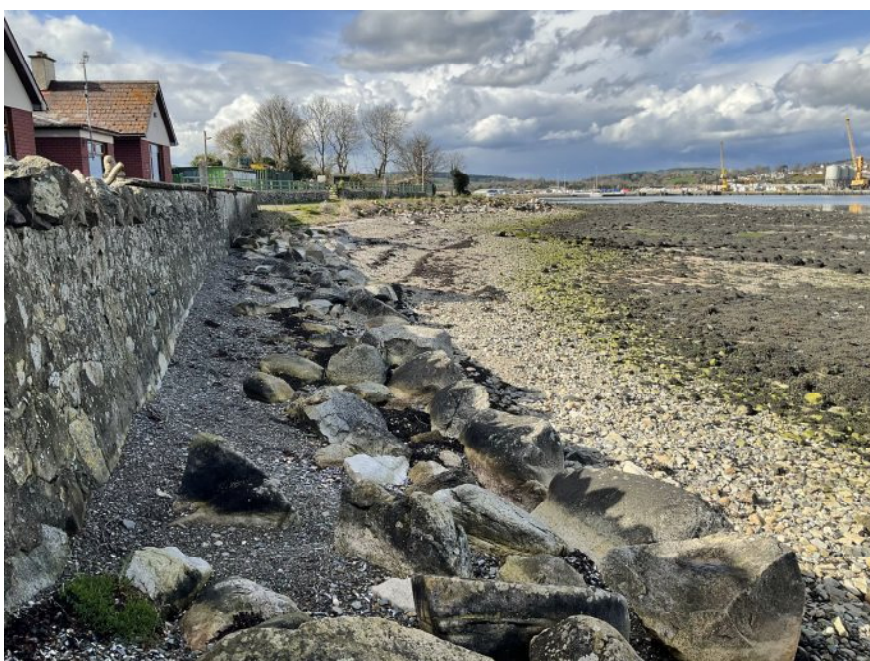
**Plate 3. Ground photograph taken at southeastern corner of existing rock armour to the east of the eastern boundary of the existing residence facing in a northerly direction**

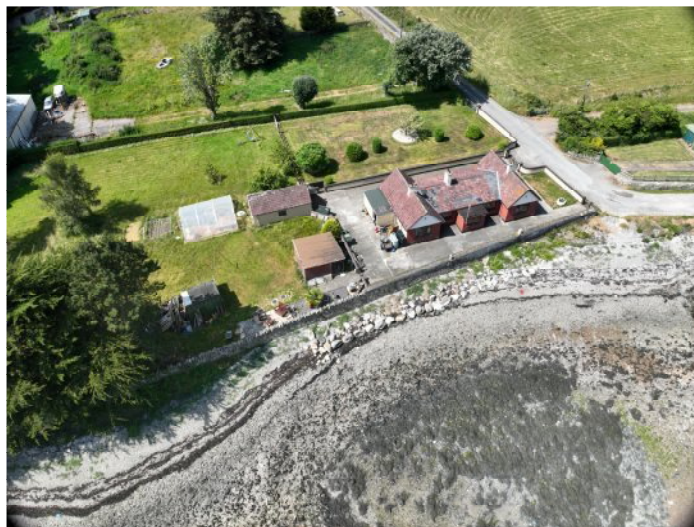
**Plate 5. Aerial photograph taken at 40m elevation from 50m to the southeast of the site facing in a north-westerly direction towards the location of the proposed coastal works immediately to the east of the eastern boundary wall of the residence**

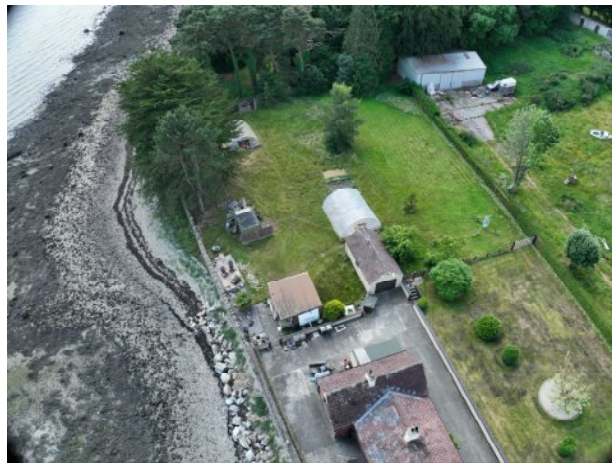
**Plate 7. Aerial photograph taken over the works site at 40m elevation facing in a southerly direction showing the property to the south of the site and adjacent mixed broadleaf/conifer woodland which is the northern boundary of Omra Park**

Figures 6 and 7 have been prepared which shows all residential and commercial property within 100m of the site's planning boundary. As can be seen from Figure 7, there are 2 residences within 100m of the site boundary. As stated previously, the works site is bordered by a residential property to the west (see Figures 6 & 7). The south of the site is bordered by a mixed broadleaf/conifer woodland (see Habitat Maps in Figures 8 & 9 and Plate 7 below).

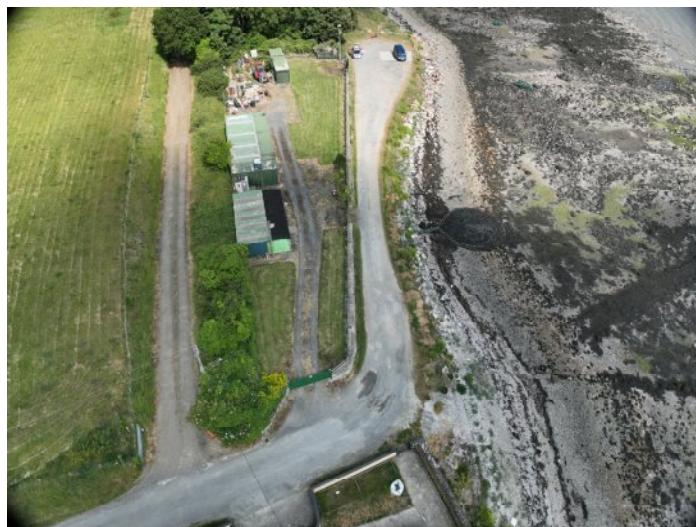
**Plate 8. Aerial photograph taken over the adjacent residence at 40m elevation facing in a northerly direction showing the commercial enterprise to the north of the site.**

A commercial enterprise consisting of a number of truck containers is located to the north of the site immediately to the west of the cul-de-sac (see Figure 7 and Plate 8 below). A seaweed farming business is also operated on the foreshore of the site with a number of seaweed nets tethered to points along the foreshore to the east of the cul-de-sac (see Plate 8 following).

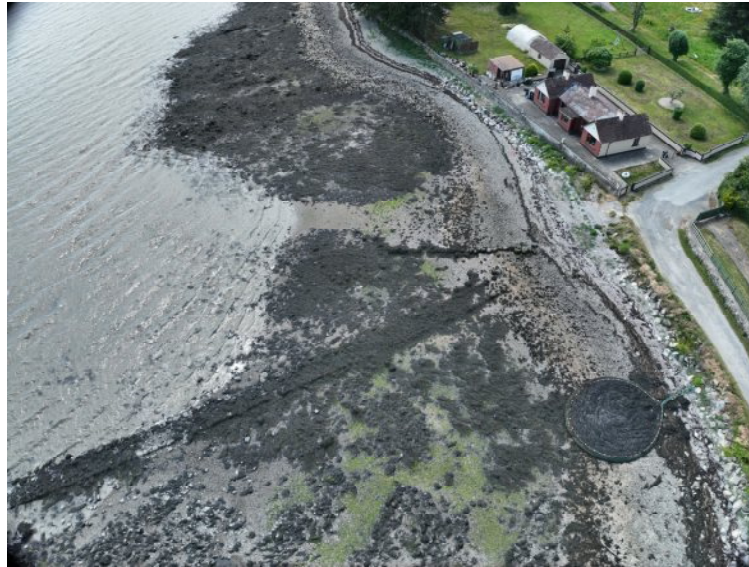
**Plate 9. Aerial photograph taken at a location to the northeast of the works site 40m elevation facing in a southerly direction showing the pipe running along the foreshore**

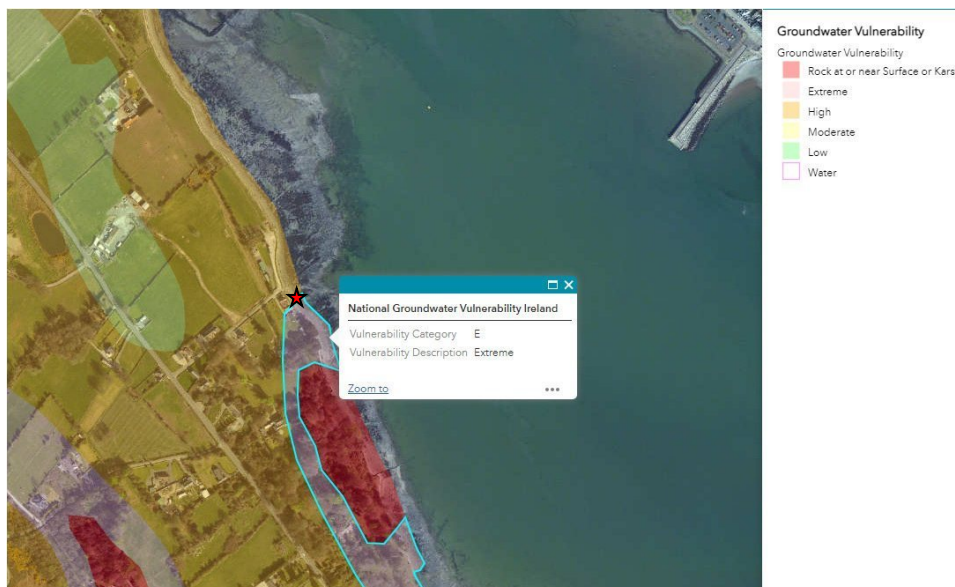
**Plate 11. EPA/Teagasc/GSI Aquifer Vulnerability Mapping in proximity of site (note red star is in the centre of the site)**

The southern half of the site has been given an aquifer vulnerability category rating of Extreme (E) by the GSI, with the northern half of the site classified as High (E) (see Plate 11 below and Appendix 2).
