Project: Coastal Erosion - Ballynamony (Murphy), Ballagan, County Louth  
 Drawing Title: Proposed Coastal Protection Works  
 Designed: SOH/JPS Checked: PC  
 Drawn: SOH/JPS Approved:

© Ordnance Survey Ireland. All rights reserved.  
 OSI Licence Number: 2011/30/CCMA/Louth County Council  
 Date: October 2023 Dwg. No.: CE-2021-02-01  
 Scale: As Shown (A1)

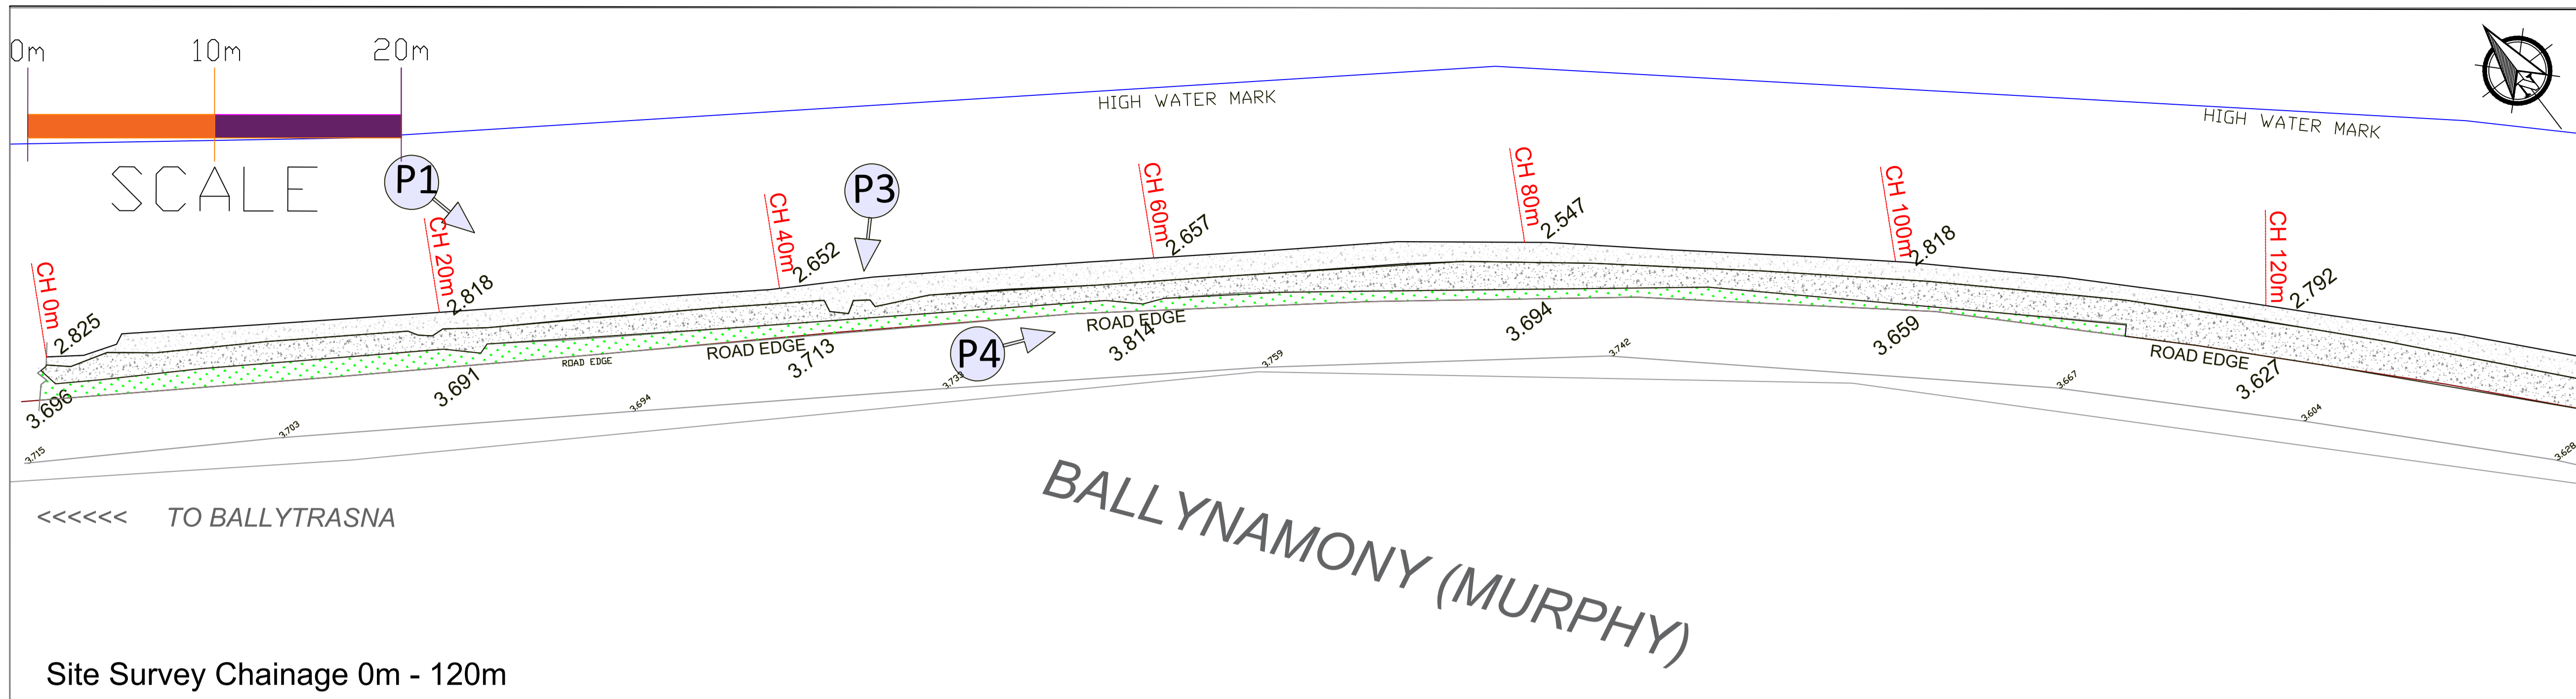
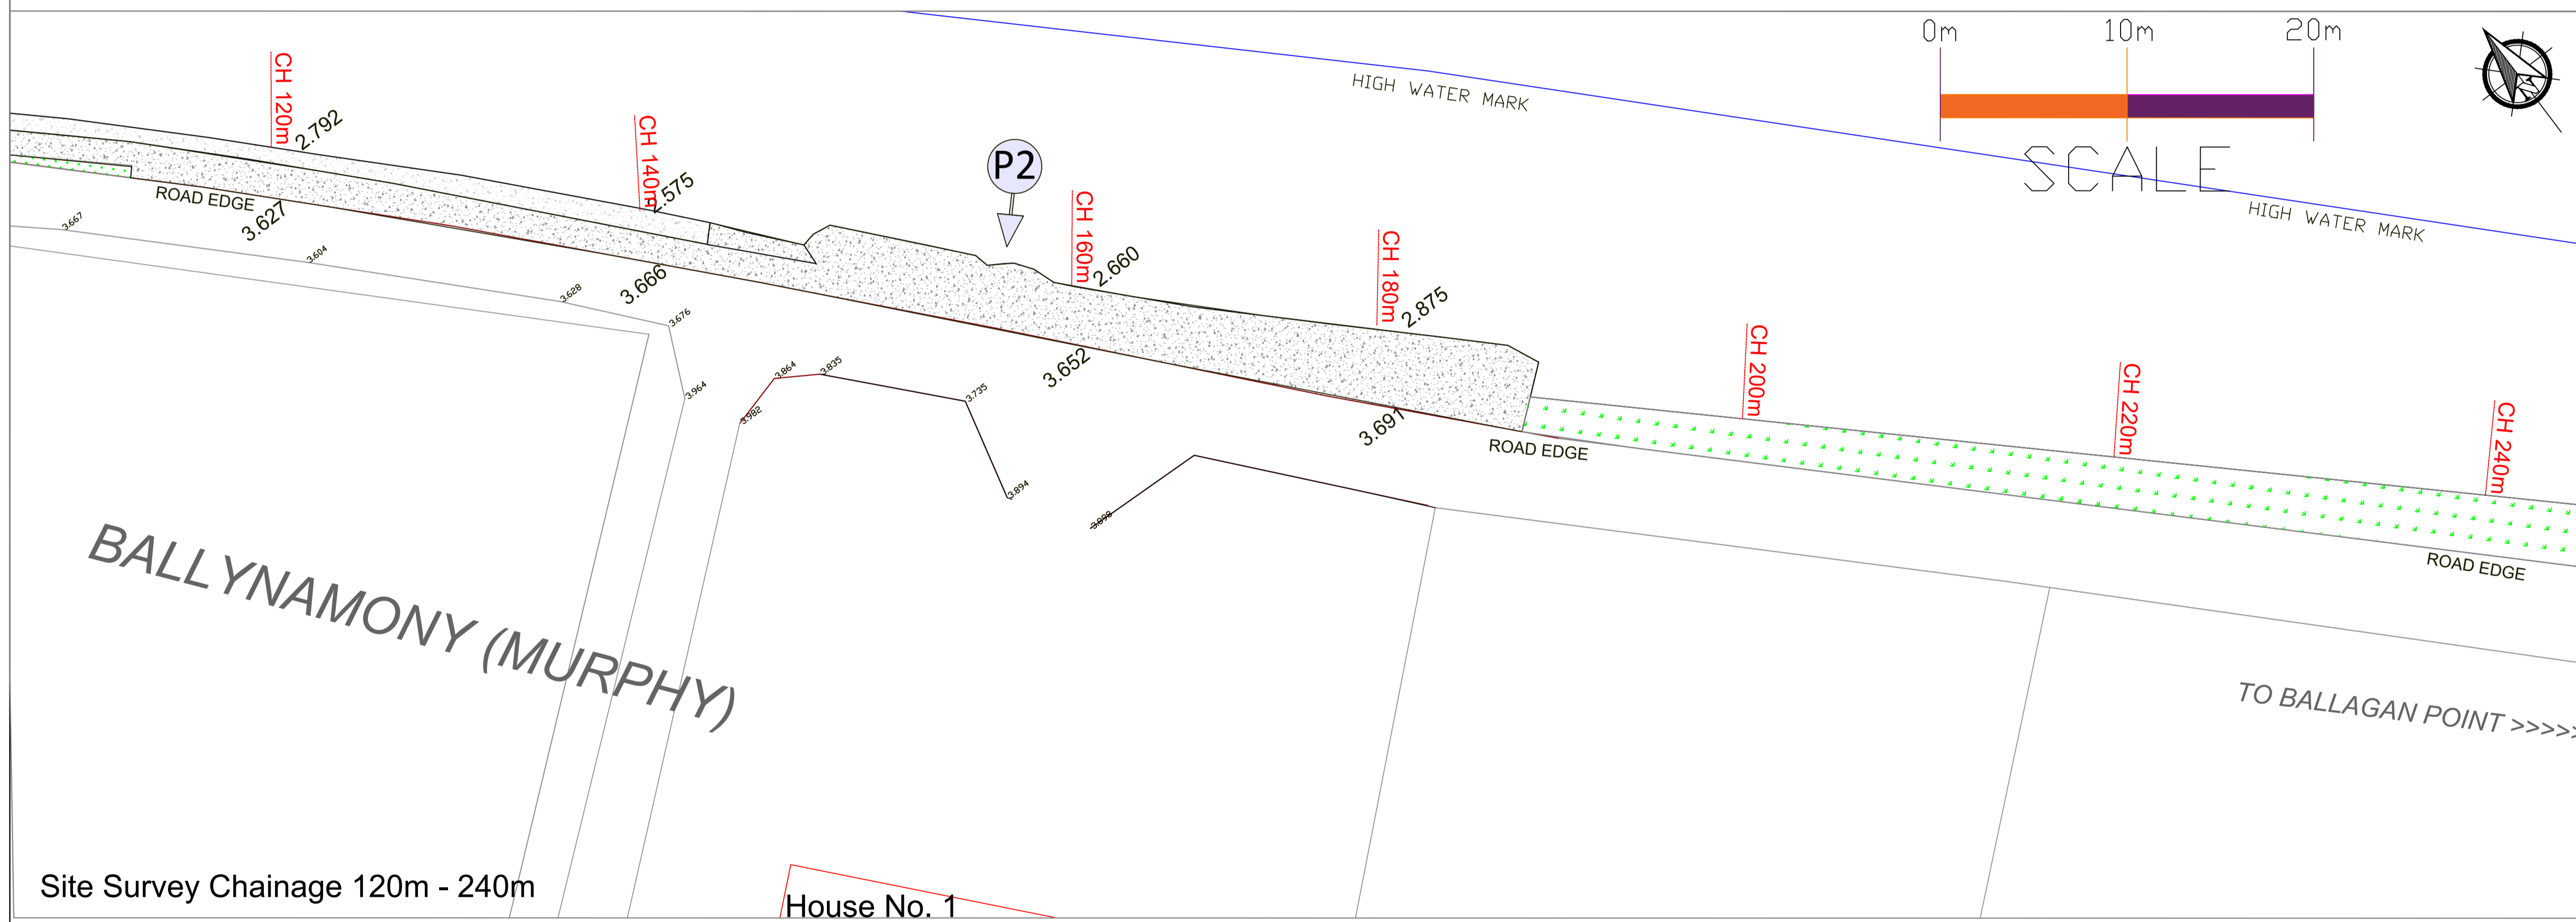
Chainage	Work Required
0m to 4m	Repointing - Stonework
4m to 15m	Concrete Crack Repair
15m to 35m	In situ concrete infill to voids of Existing Sea Wall
35m to 75m	Break up damaged section of existing Sea Defense wall and compact down. Replace with composite concrete and boulder
75m to 100m	In situ concrete infill to voids of Existing Sea Wall
100m to 144m	Concrete Crack Repair
144m to 150m	Repointing - Stonework
150m	In situ concrete infill to voids of Existing Sea Wall
150m to 159m	No Works
159m to 164m	In situ concrete infill to voids of Existing Sea Wall
189m to 229m	Install Rock Armour

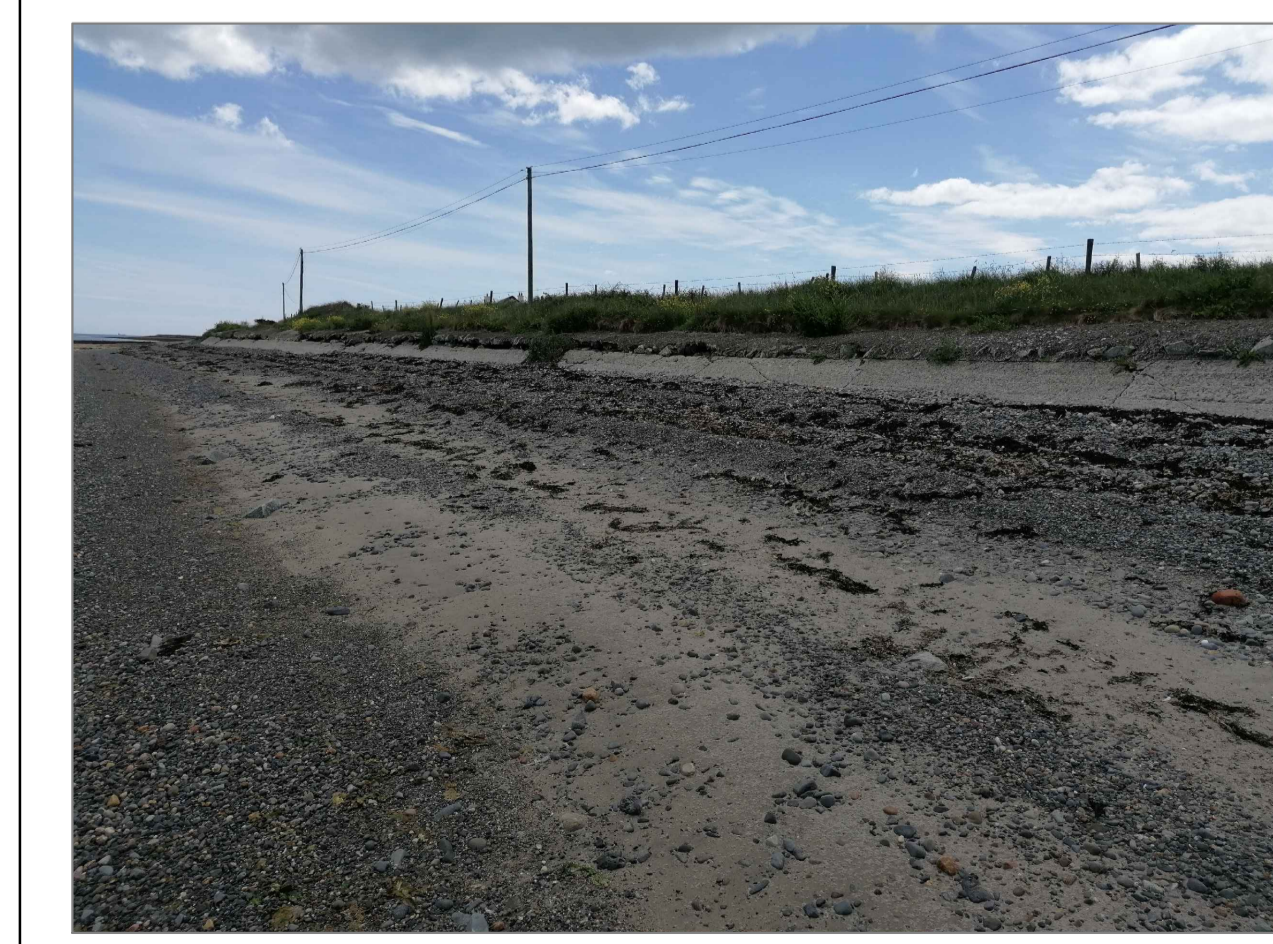
Image P1 Overview

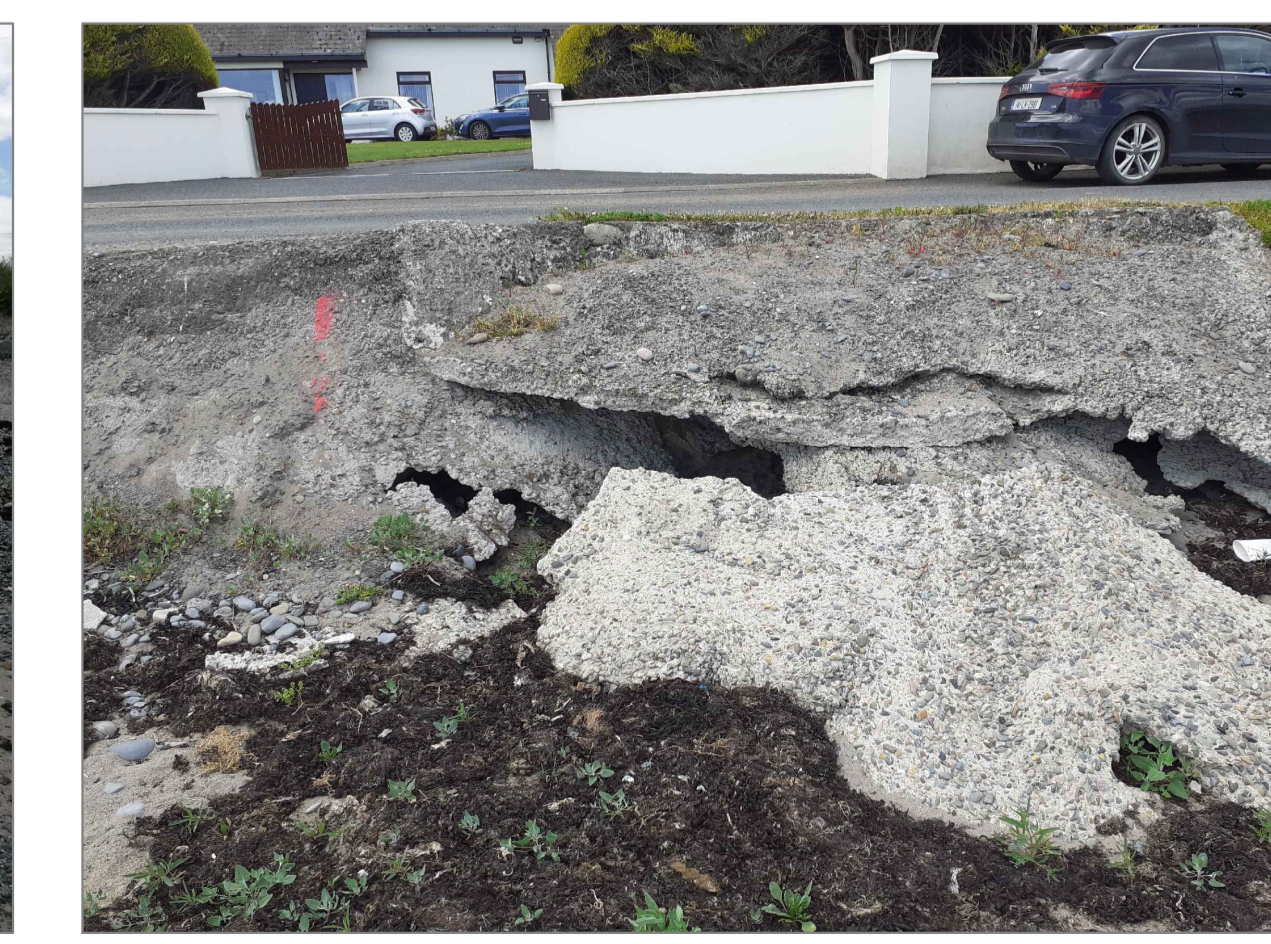
Image P2 View of Damaged Shoreline

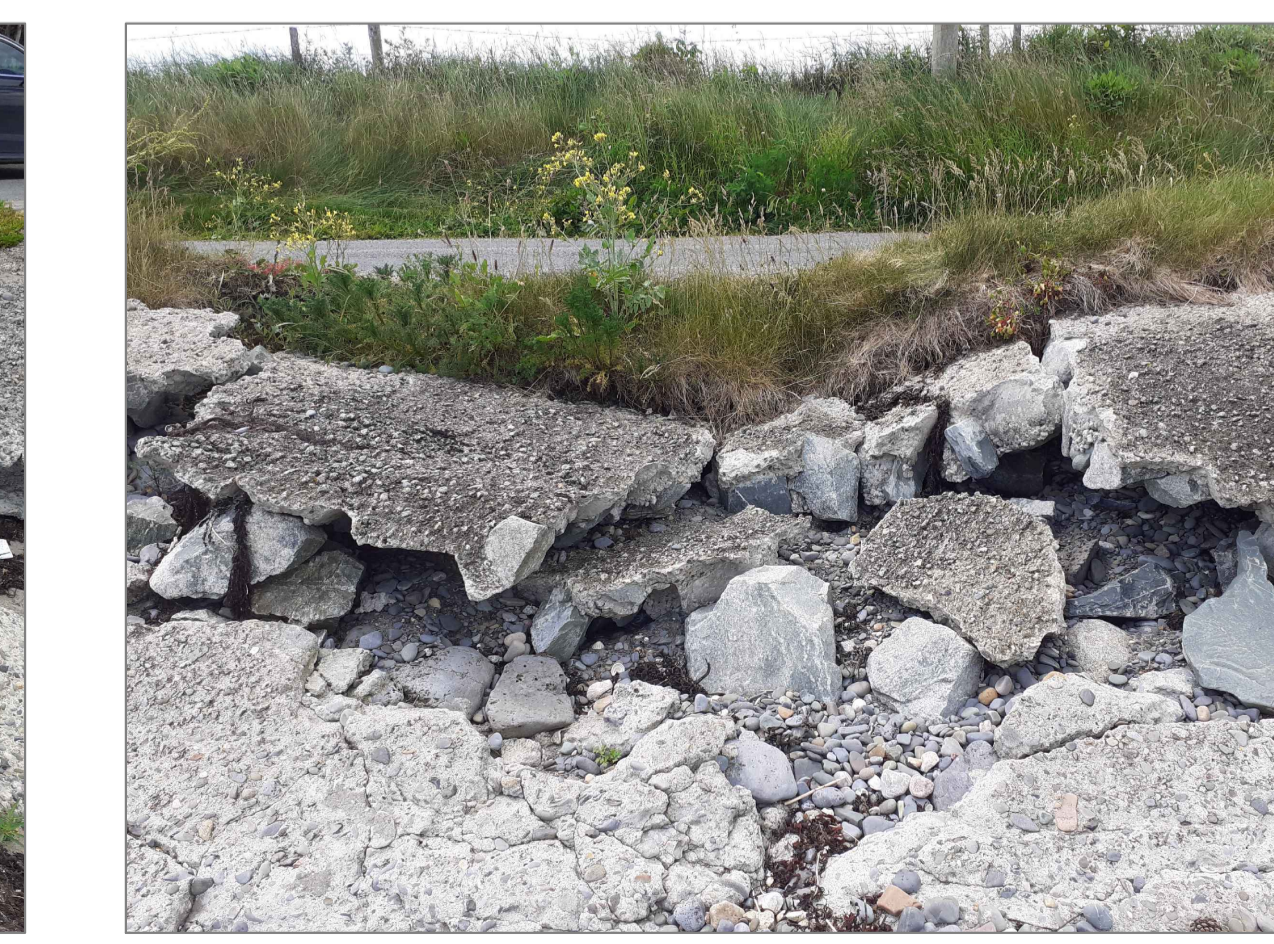
Image P3 View of Damaged Shoreline

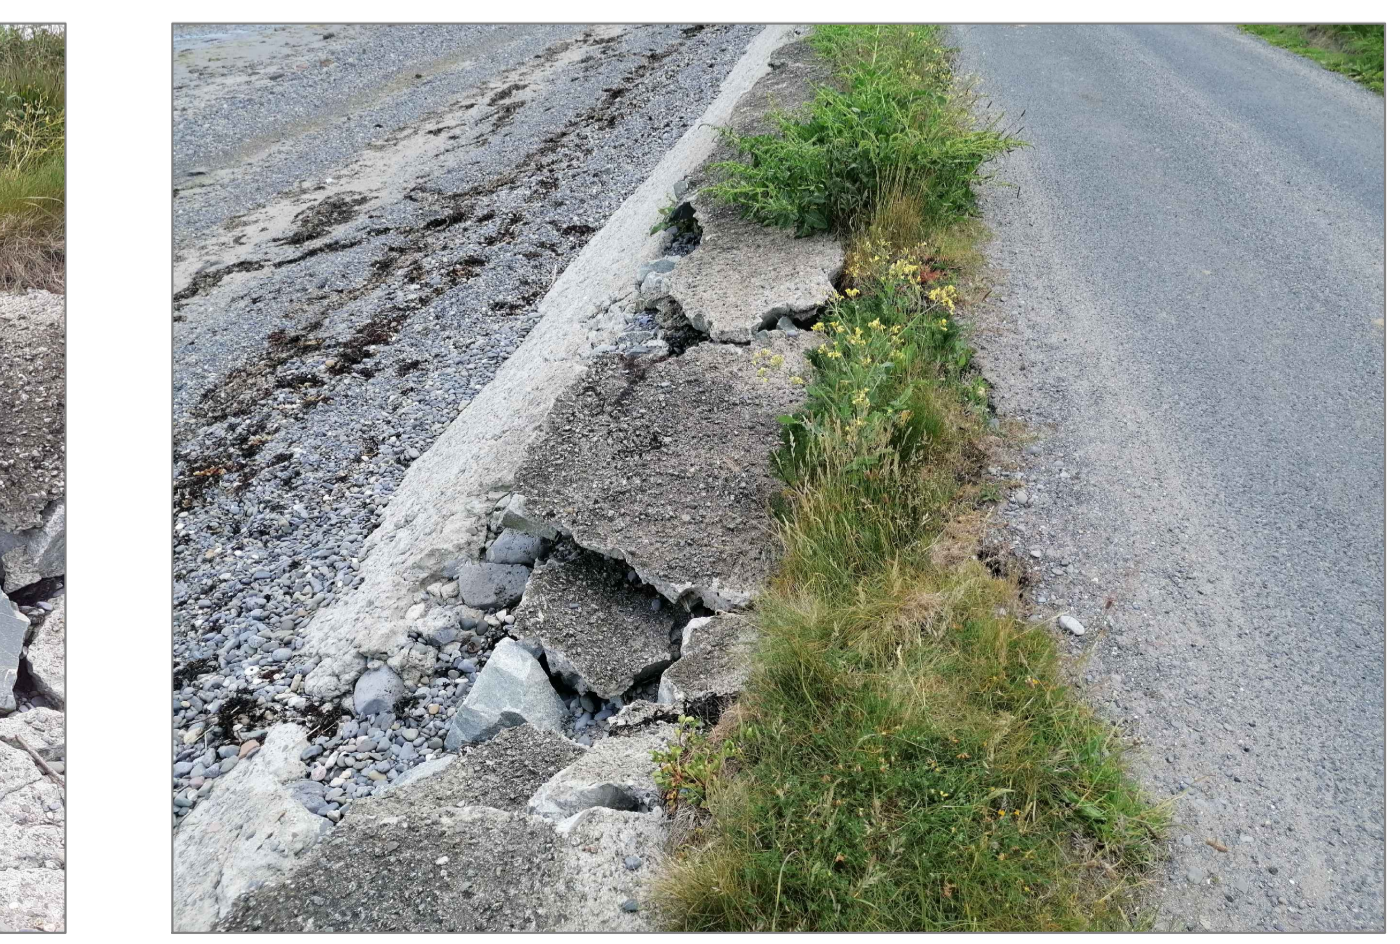
Image P4 View of shoreline
